Support bearing in flap operating mechanism (with and without flap/aileron interconnection system).

PIK-20 and 20 B models, all serial numbers.

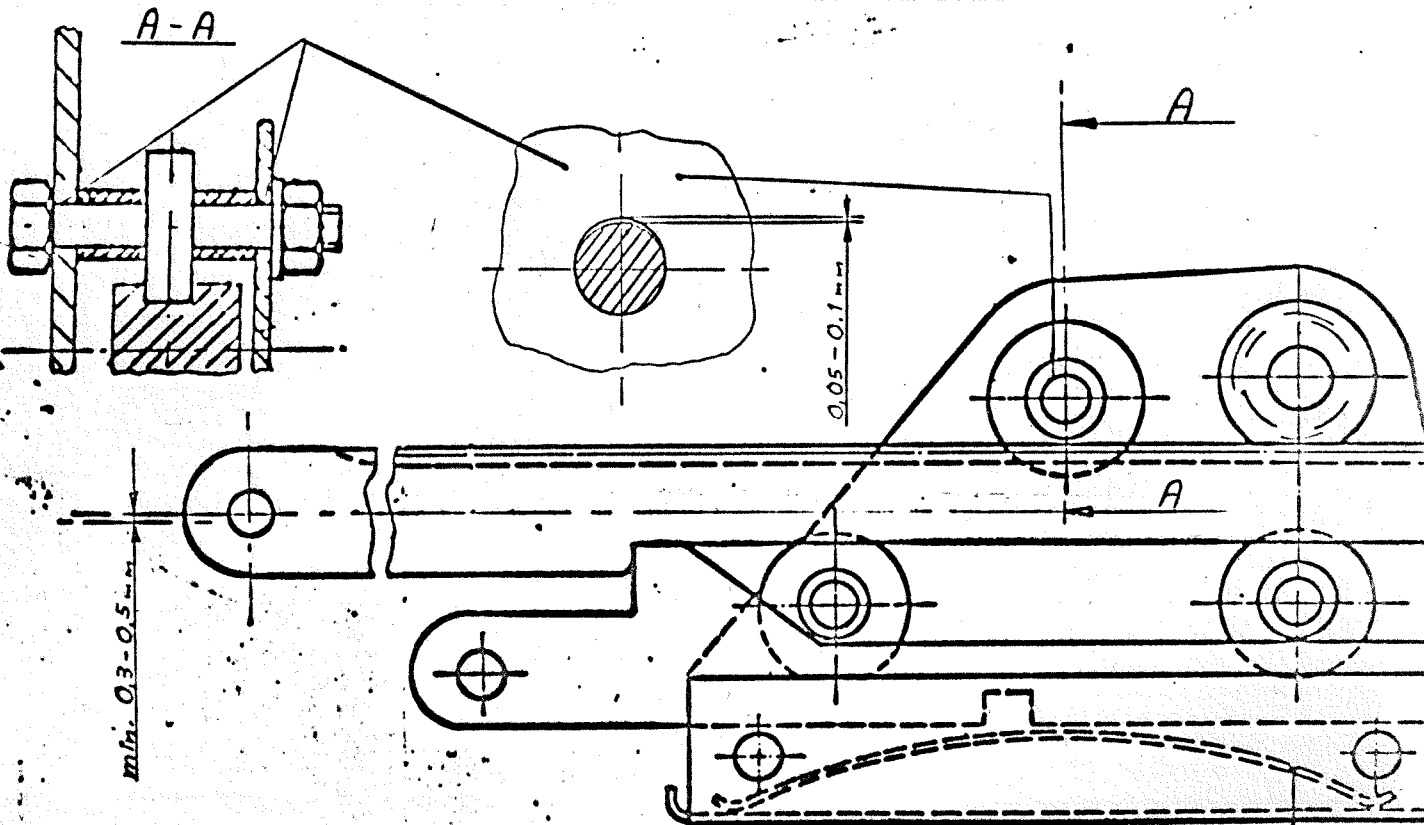
There has been some support bearing failures due to dirt on gear rack and too small tolerance between bearing and rack (See fig. 1). The broken bearing particles may lock the flap control.

1. Detach the flap push rod from the gear rack.
2. Check the free play of the gear rack with all deflections. The play must be min.  $0.3 - 0.5 \text{ mm}$  depending on the deflection. It is smallest at  $+90^\circ$  flap setting.

3. If there is play enough at all deflections, no further action is required.
4. If there is no play at any deflection, the operating mechanism must be detached (See Service Bulletin M 12 June 4, 1976 Instructions 1 to 2) and all dirt removed from the gear rack.
5. If there is still no play the rack must be detached. See M 12 instructions 3 to 4.
6. File about 0.05 to 0.1 mm carefully away from the support bearing axle holes in side plates (with fine  $\phi$  5.0 mm to 5.5 mm file). See fig. 1. Check the result with the bolt.
7. Change the support bearing type NSK or SKF 626 2Z.
8. Assemble the mechanism (See M 12 instructions 9 to 10).
9. Check the free play.
10. Continue according to M 12, instructions 11 to 13.

NOTE: Do not use any grease on the gear rack.
