# Oil-Flow and Distributed Roughness Experiments on CRM Wing Model

Erkki Soinne, Trafi

Title of publication <b>Oil-Flow and Distributed Roughness Experiments on CRM Wing Model</b>	
Author(s) Erkki Soinne	
Commissioned by, date Kari Wihlman, October 8th 2017	
Publication series and number <b>Trafı Research Reports 3/2018</b>	ISSN (online) 2342-0294 ISBN (online) ISBN 978-952-311-247-6 URN <a href="http://urn.fi/URN:ISBN:978-952-311-247-6">http://urn.fi/URN:ISBN:978-952-311-247-6</a>
Keywords aircraft, aerodynamics, anti-icing fluids	
Contact person Erkki Soinne	Language of the report English
Abstract This research report summarizes the oil-flow, sandpaper, anti-icing fluid and PVC plastic sheet wind tunnel experiments on the Common Research Model (CRM). The aerodynamic measurements were made with a force balance on lift and two wake rakes on the upper surface boundary layer displacement thickness aft of the model main wing. The oil-flow measurements investigated the qualitative flow characteristics.

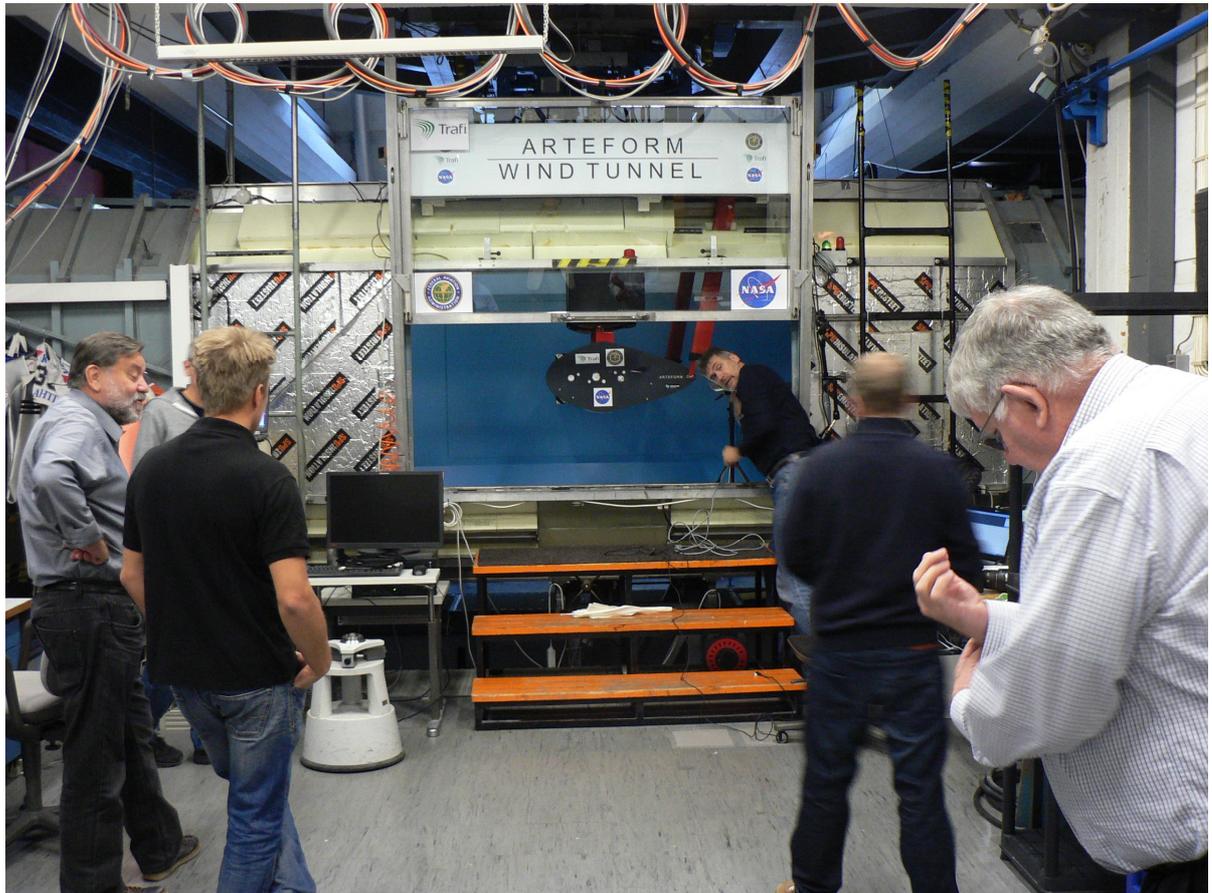
**Figure 1.** Arteform wind tunnel test section.

Arteform Low Speed Wind Tunnel is a closed circuit wind tunnel with an octagonal test section with dimensions of 2 m x 2 m and a test section length of 4 m. The test section is shown in Figure 1. The flow uniformity in the test section is better than 0.14 %, and the turbulence level is less than 0.28 % at a constant wind tunnel speed of 60 m/s. However, during acceleration the turbulence level is somewhat higher, see Figure 2. The turbulence level is relevant when a clean airfoil reference test is made. When the airfoil is contaminated (with frost or anti-icing fluid) it is not too sensitive for the tunnel turbulence level as the boundary layer is already much disturbed by the contamination.

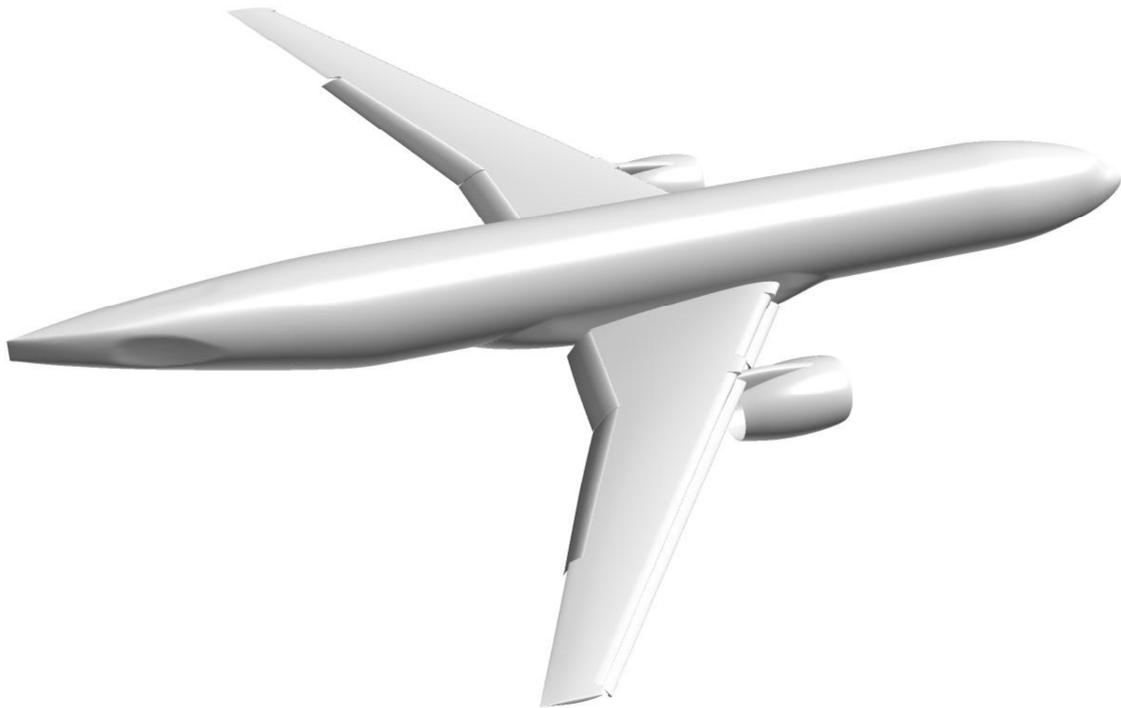
**Figure 3.** Common Research Model of a modern jet aircraft configuration.

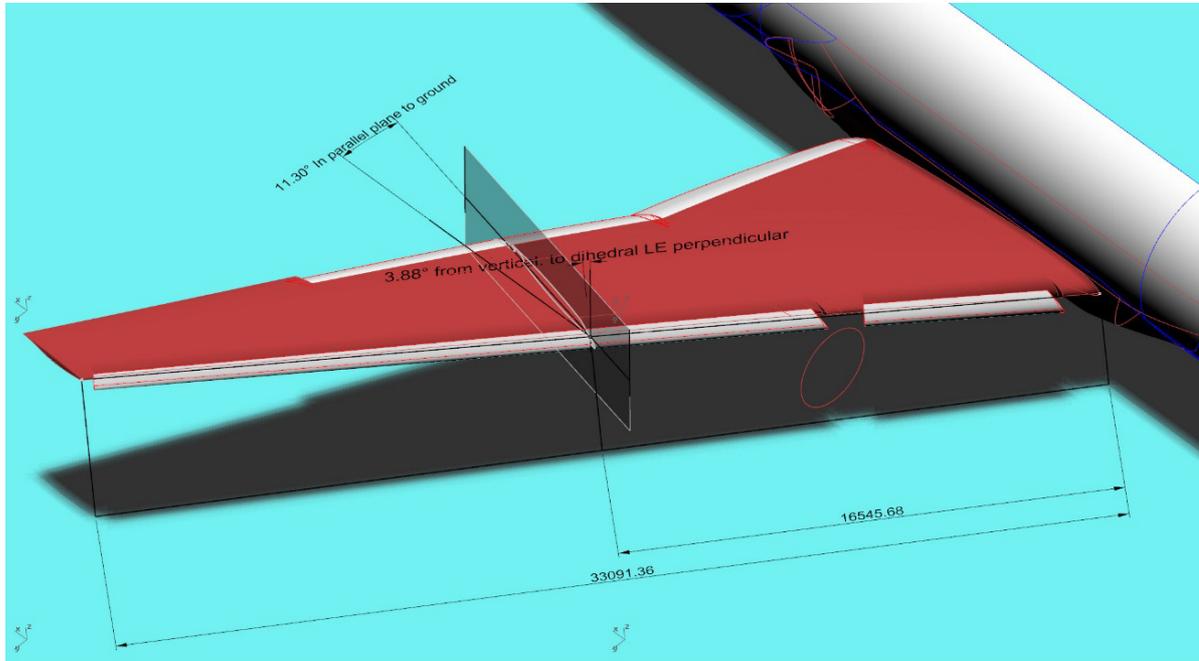
**Figure 4.** Representative wing section selection in the Common Research Model.

A representative section for the present studies was selected outboard of the wing planform kink as shown in Figure 4. The section was selected in the vicinity of the wing Mean Aerodynamic Chord and is free from the local flow conditions due to the engine and wing kink. In a wind tunnel test the critical flow conditions should be reproduced. Anti-icing fluid is applied on the wing upper surface only and also the possible frost on the wing upper surface is critical due to the upper surface retarding flow at high angle of attack. For this reason the section was taken in the local upper surface stream line direction. On a wing at subsonic speeds the local streamlines are directed inboard on the upper surface and outboard on the lower surface. CFD calculations in ref. [4] fig. 22 showed that in take-off configuration at high angle of attack the streamlines on the wing upper surface at the station for the representative wing section were directed  $11,3^\circ$  inboard. The wing section was taken in this direction and perpendicular to the wing leading edge to take into account the wing dihedral.

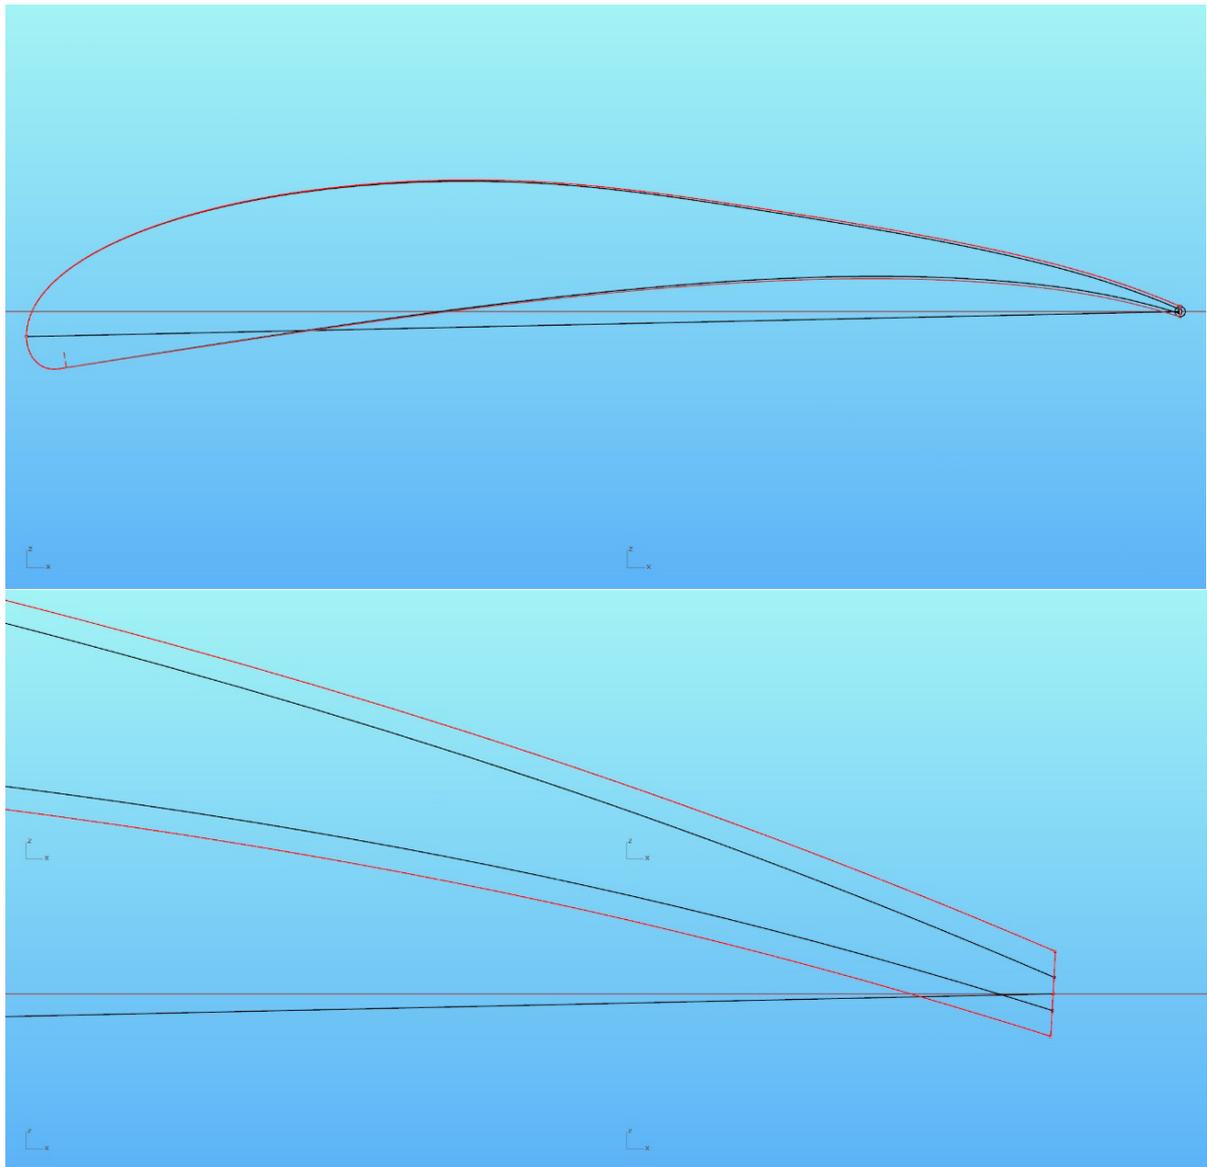
**Figure 7.** Comparison at the flap area of the theoretical HL-CRM configuration (black line) and the thickened HL-CRM configuration (red line).

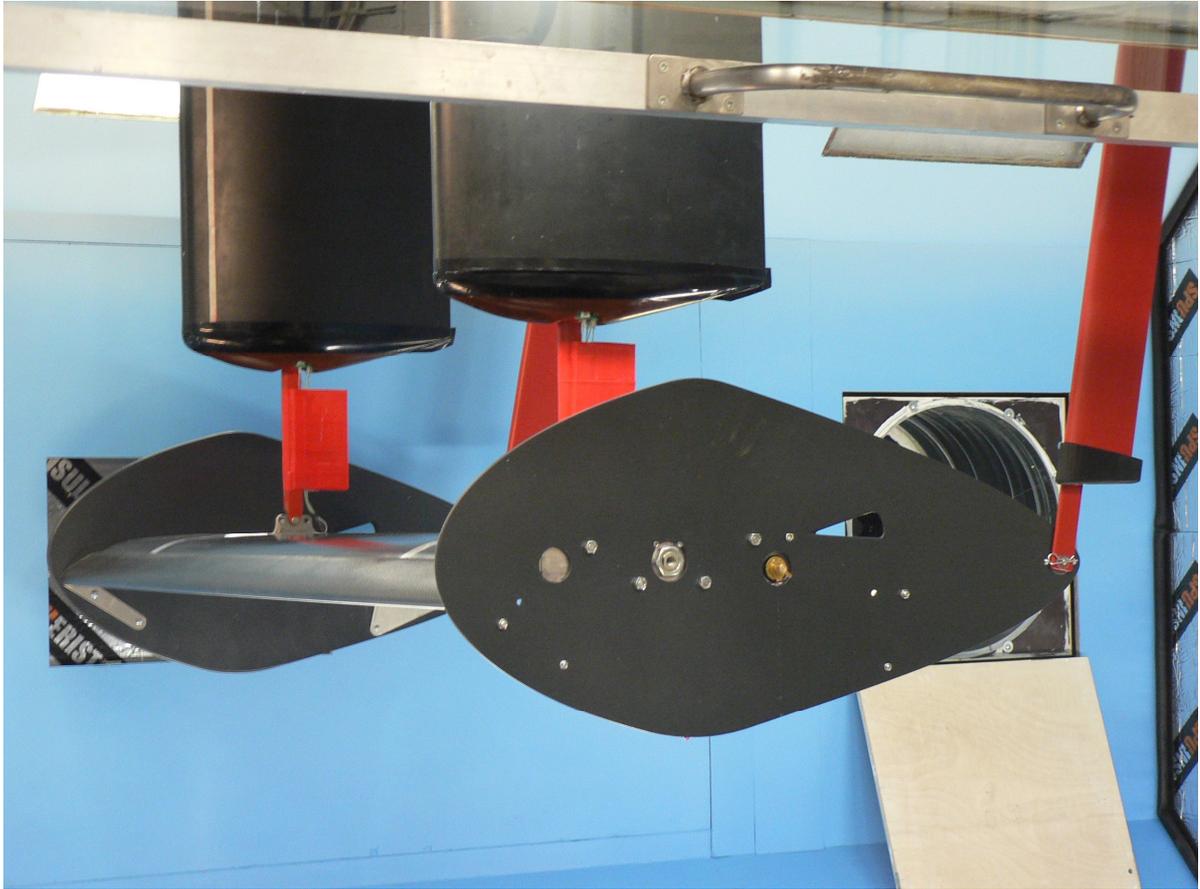
**Figure 9.** HL-CRM Mod wing model in the Arteform wind tunnel test section.

increase the lift at moderate lift coefficients whereas at high values there is a reduction in lift due to a decrement in the local flow velocity. The airfoil pressure distribution may change considerably in the vicinity of ground in particular when effective trailing edge flaps are used. The end plates contain a hole in the vicinity of the flap leading edge to ensure flow attachment. The wing model is shown in Figure 9.

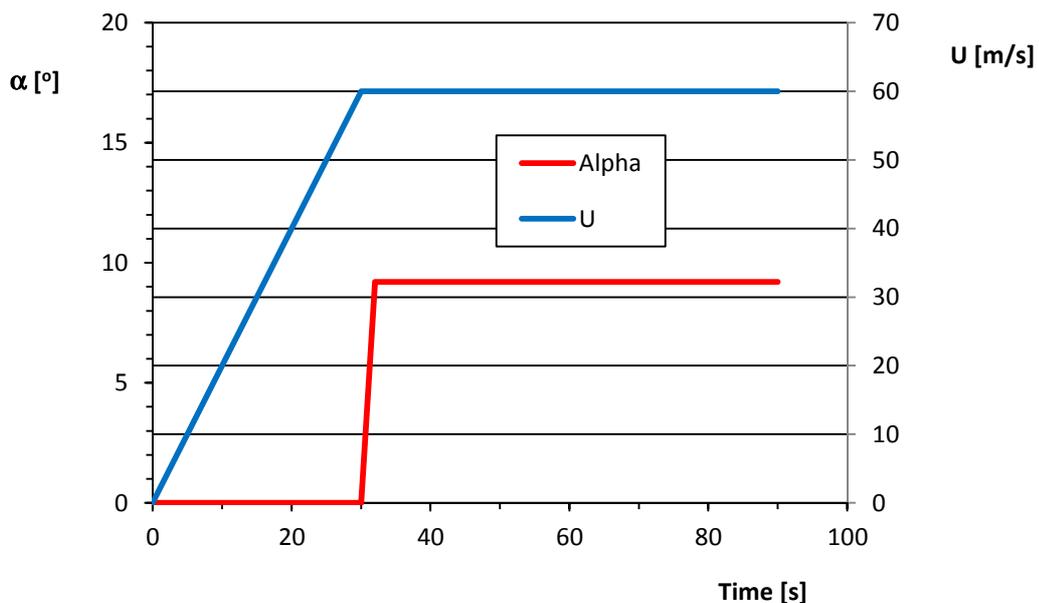
**Figure 10.** Variation of wind tunnel velocity  $U$  and model angle of attack  $\alpha$  during the simulated take-off sequence.

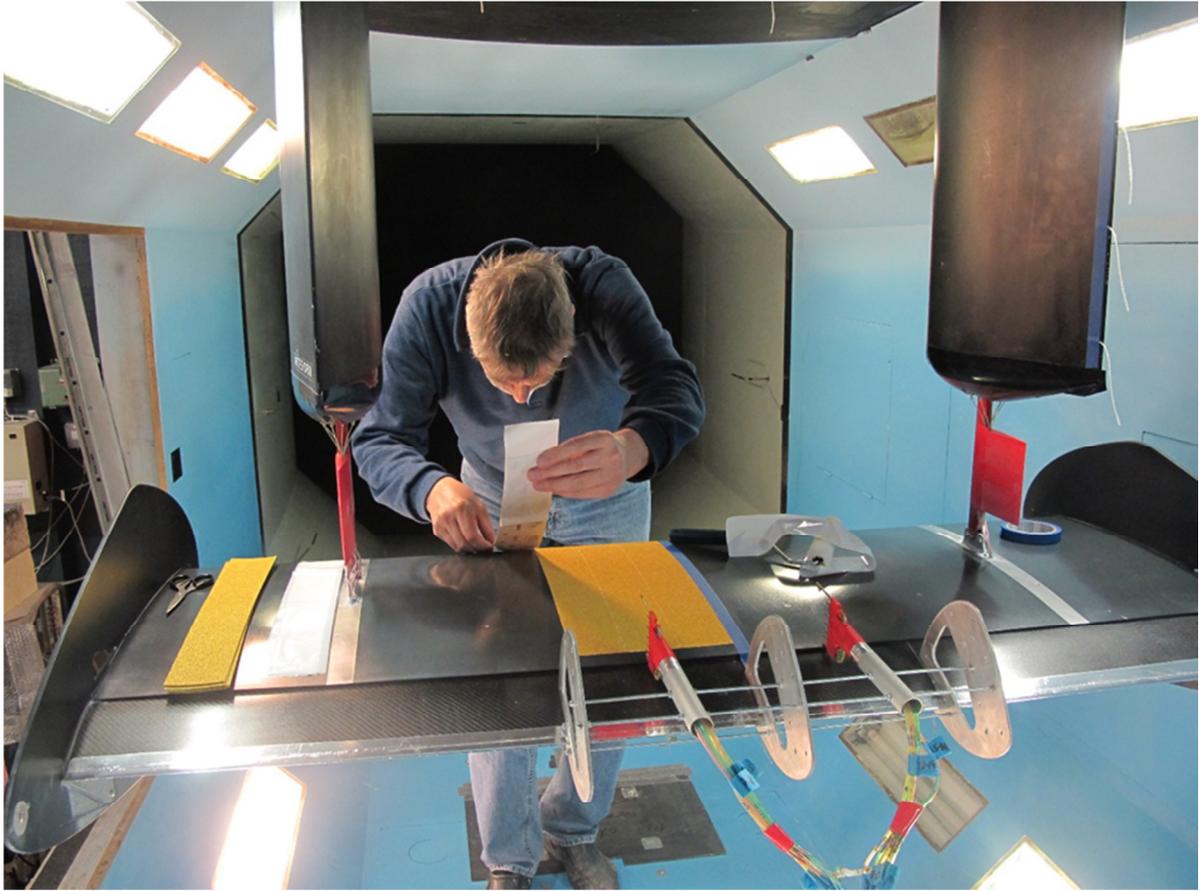
**Figure 11.** Installation of sandpapers.

The sandpaper was positioned on the wing model upper surface to cover the area with rough frost at about  $x/c=0.12$  to  $0.65$ . The sandpapers were installed as  $70 \times 450$  mm strips with adhesive backing as shown in Figure 11. The number of strips was 22 in the spanwise direction covering the entire upper surface except two narrow strips at the model support stations, see Figure 12. The sandpaper fore edge was positioned 30 mm aft of the slat trailing edge (Figure 13). The sandpaper was not applied on the model lower surface as the effect of frost on the lower surface is expected to be small

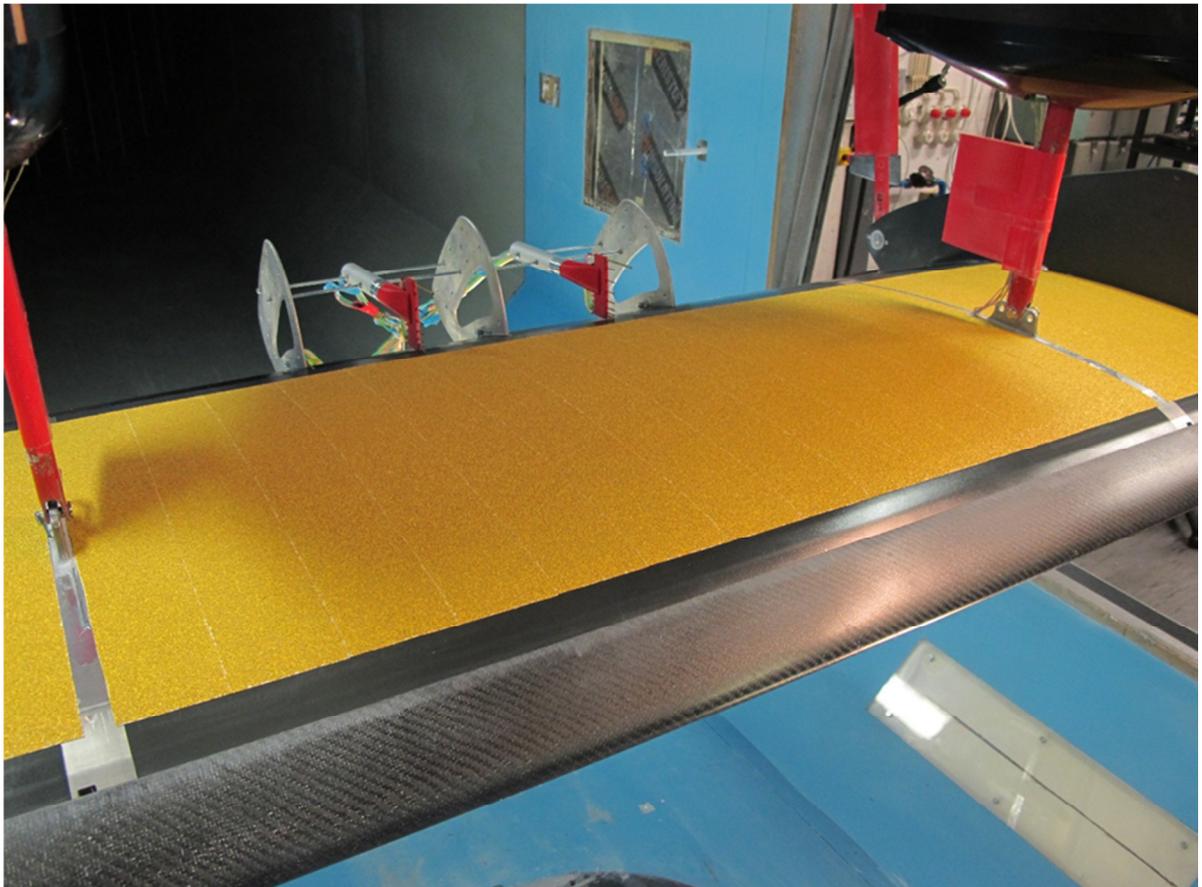
**Figure 12.** Overview of the wing model covered with P40 sandpaper.

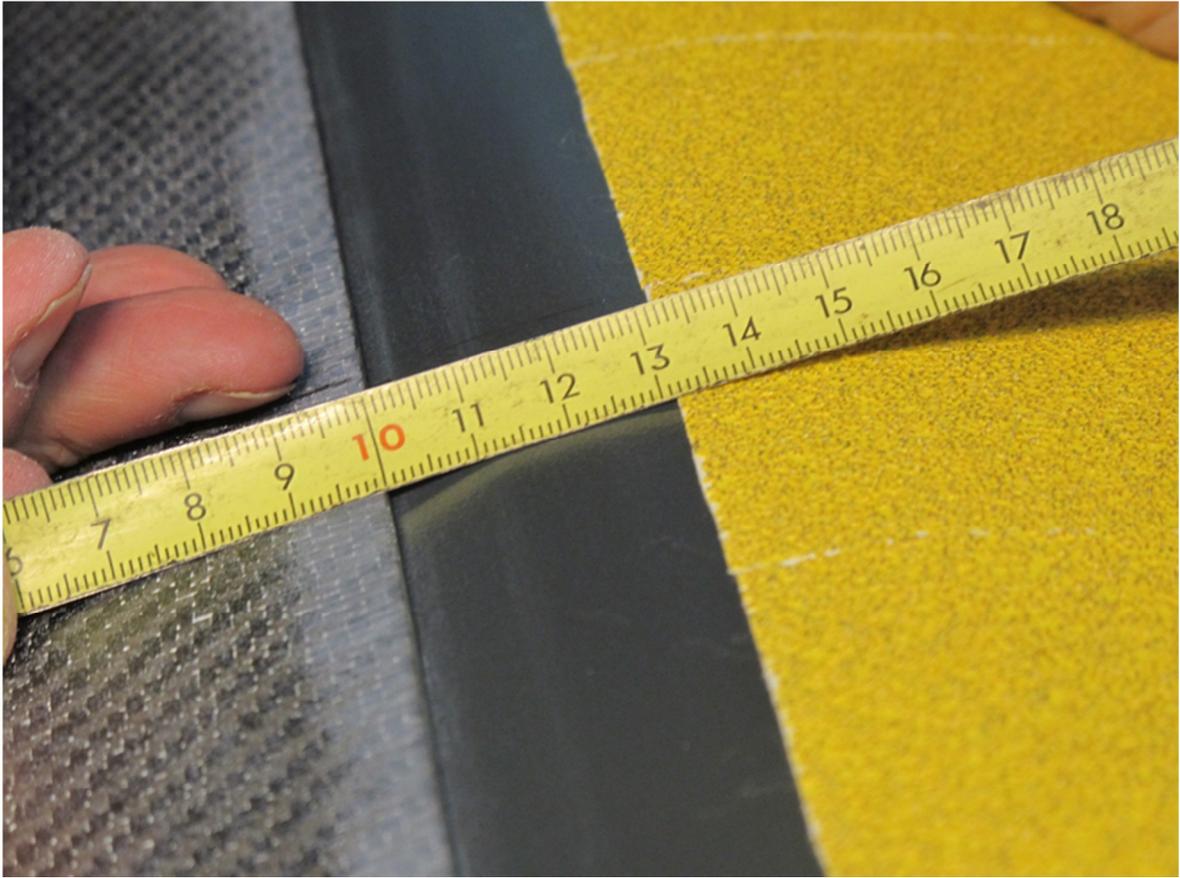
**Figure 13.** The gap between the slat and the sandpapers was about  $30\pm 1$  mm.

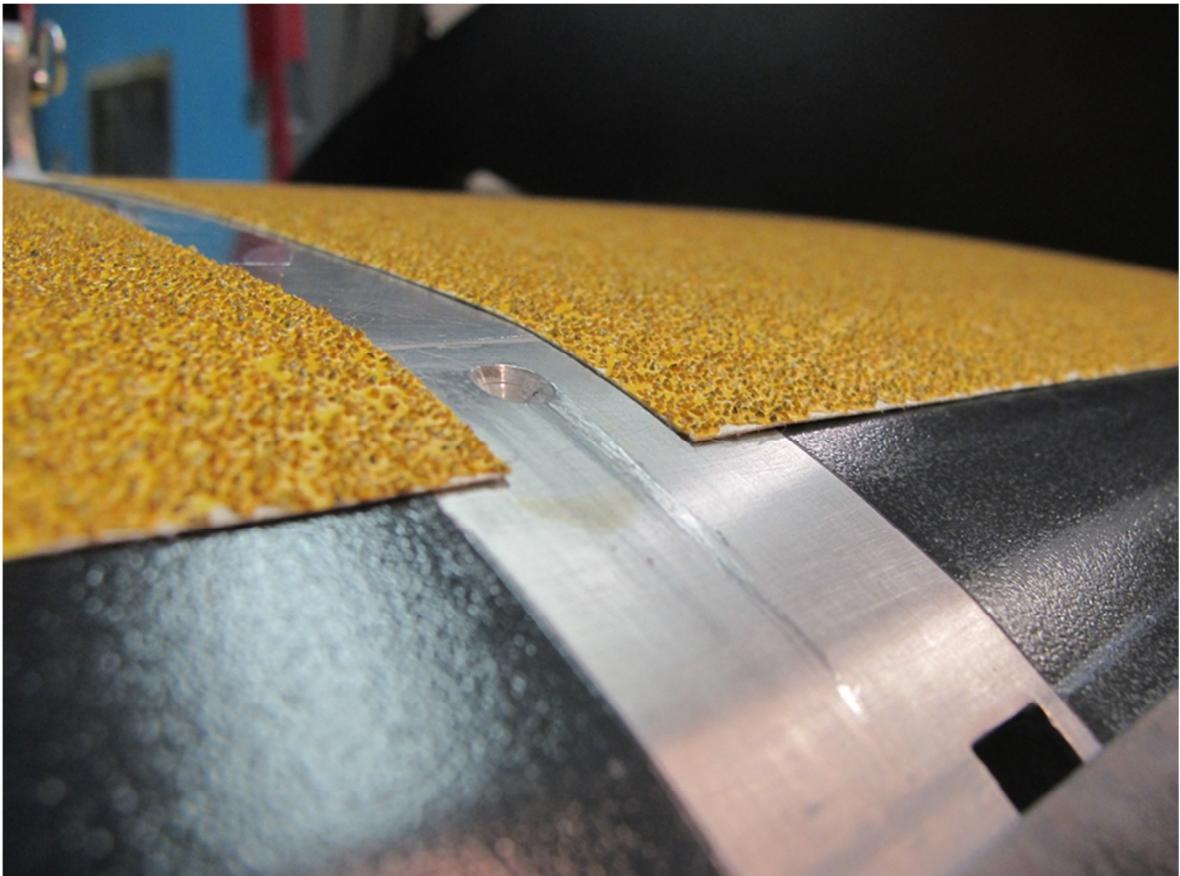
**Figure 14.** Close-up view of the wing leading edge area with the fore edge of the P40 sandpapers. Note the large grit/particle size.

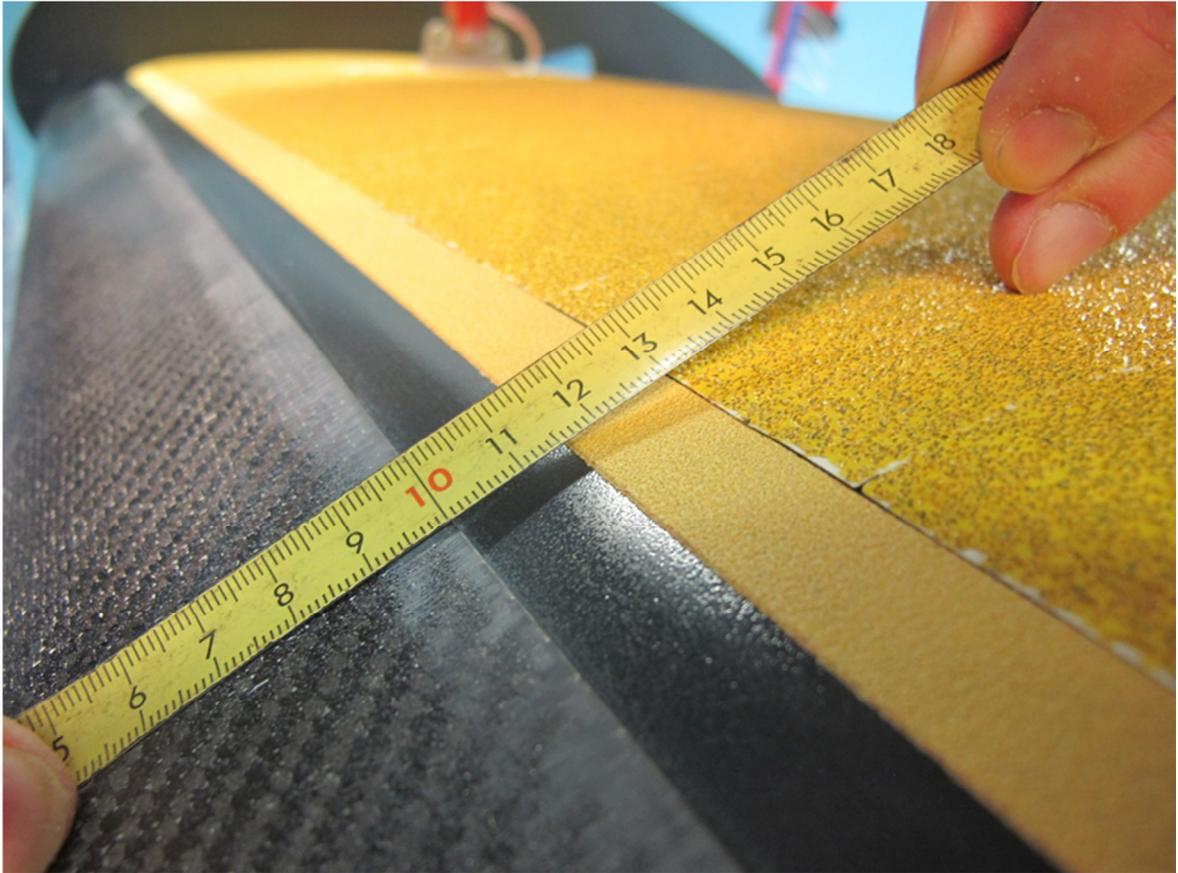
**Figure 15.** Narrow P120 sandpaper strip in front of the P40 sandpaper.

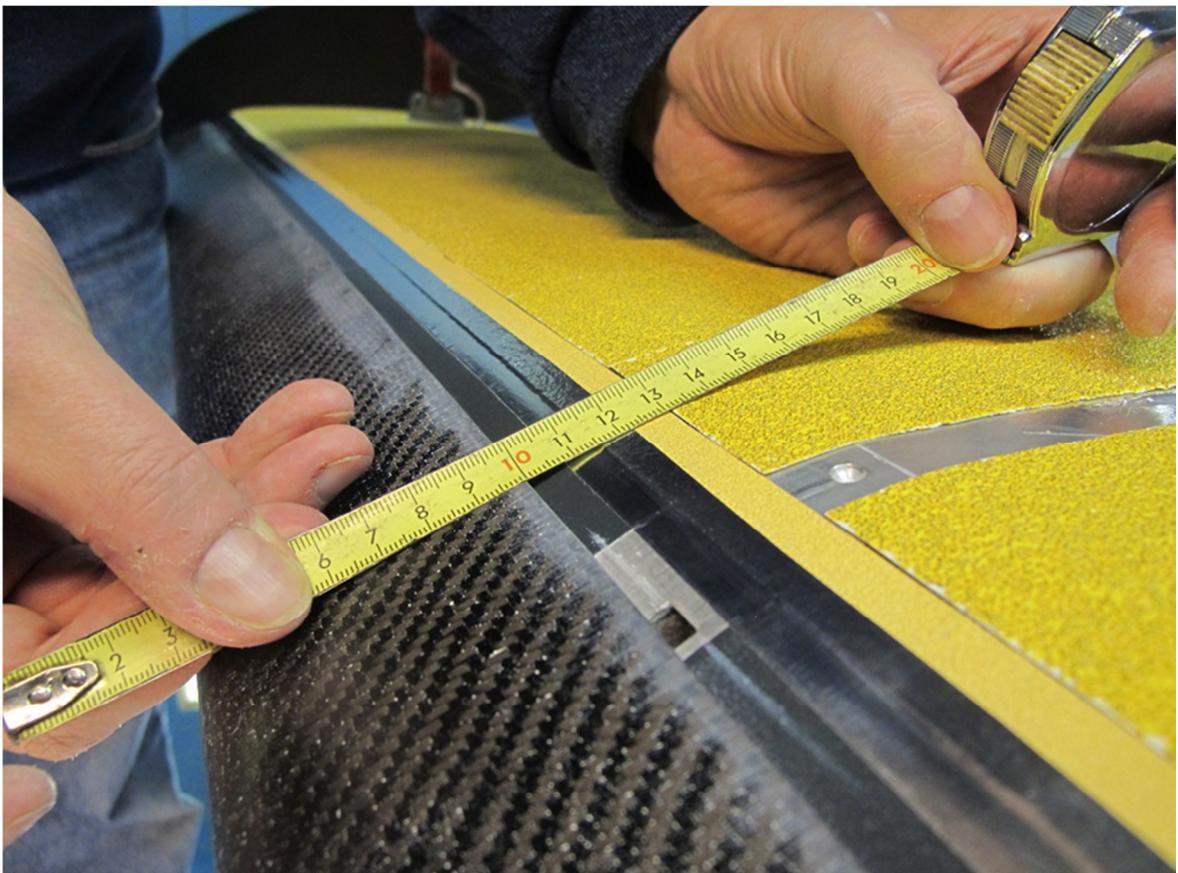
**Figure 16.** P120 sandpaper strip in front of the P40 sandpaper with additional aluminum tape to prevent the P120 strip from lifting off.

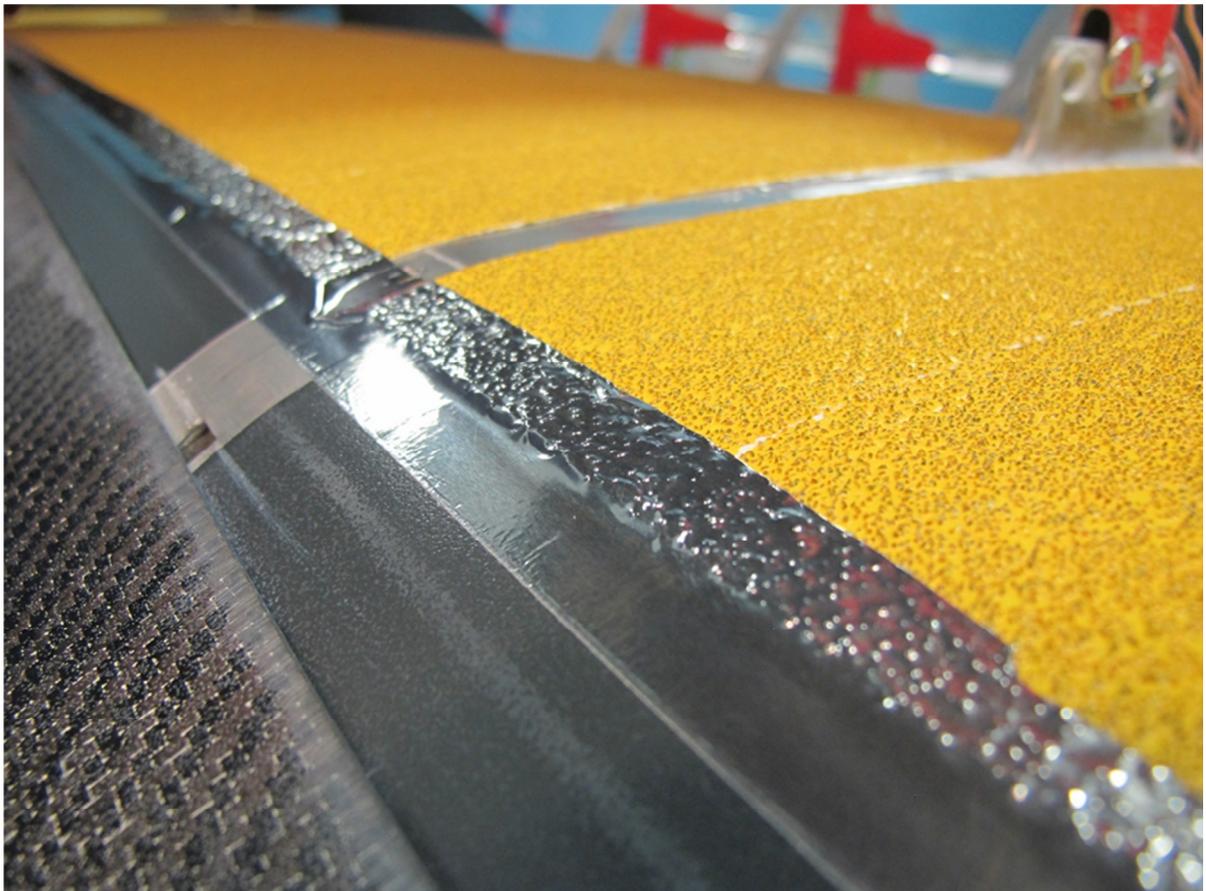
**Figure 17.** The P40 sandpaper fore edge of taped over with aluminum tape.

surface and was secured during the runs with aluminum tape. P40 sandpaper could be tested without the aluminum tape but the effect of the tape was also tested. The aluminum tapes at the fore edges of P40, P80 and P120 sandpapers are shown in Figure 17, Figure 18 and Figure 19.

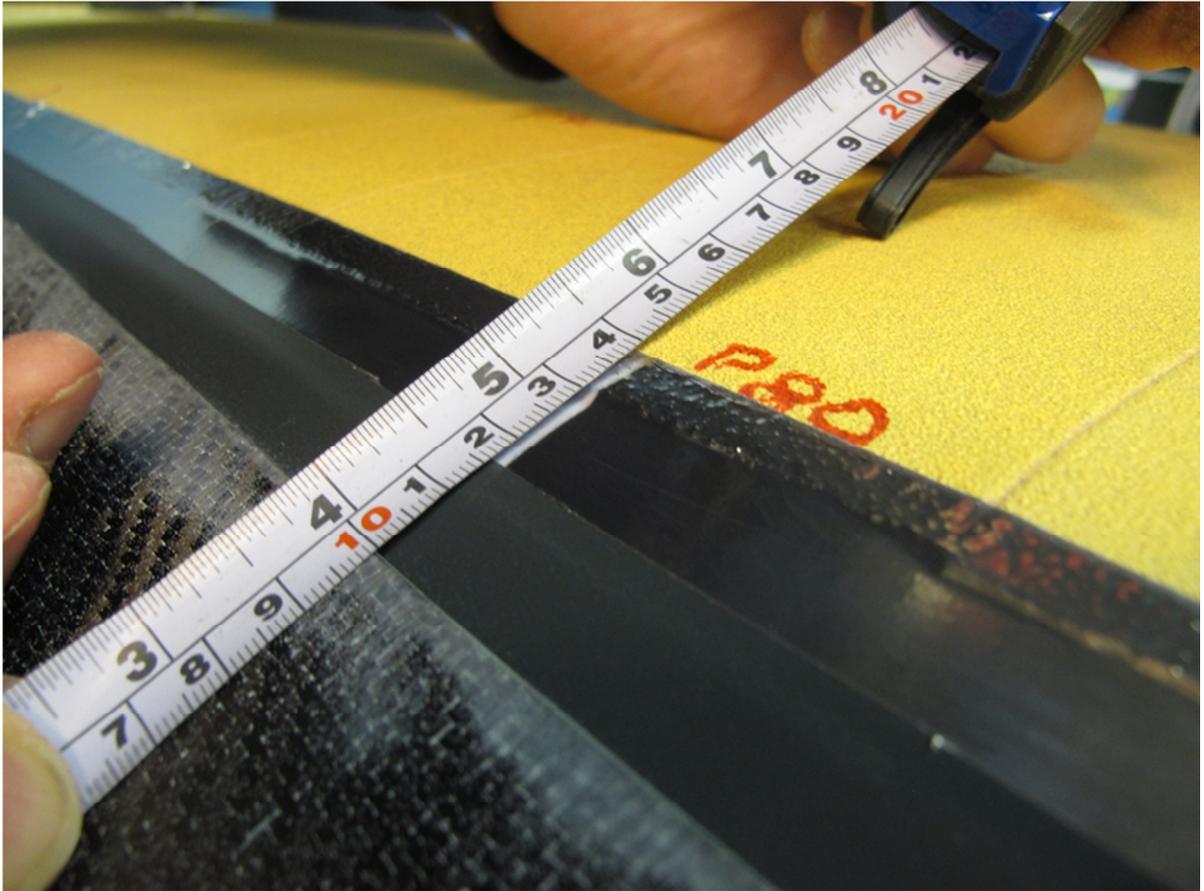
**Figure 18.** The P80 sandpaper fore edge taped over with aluminum tape.

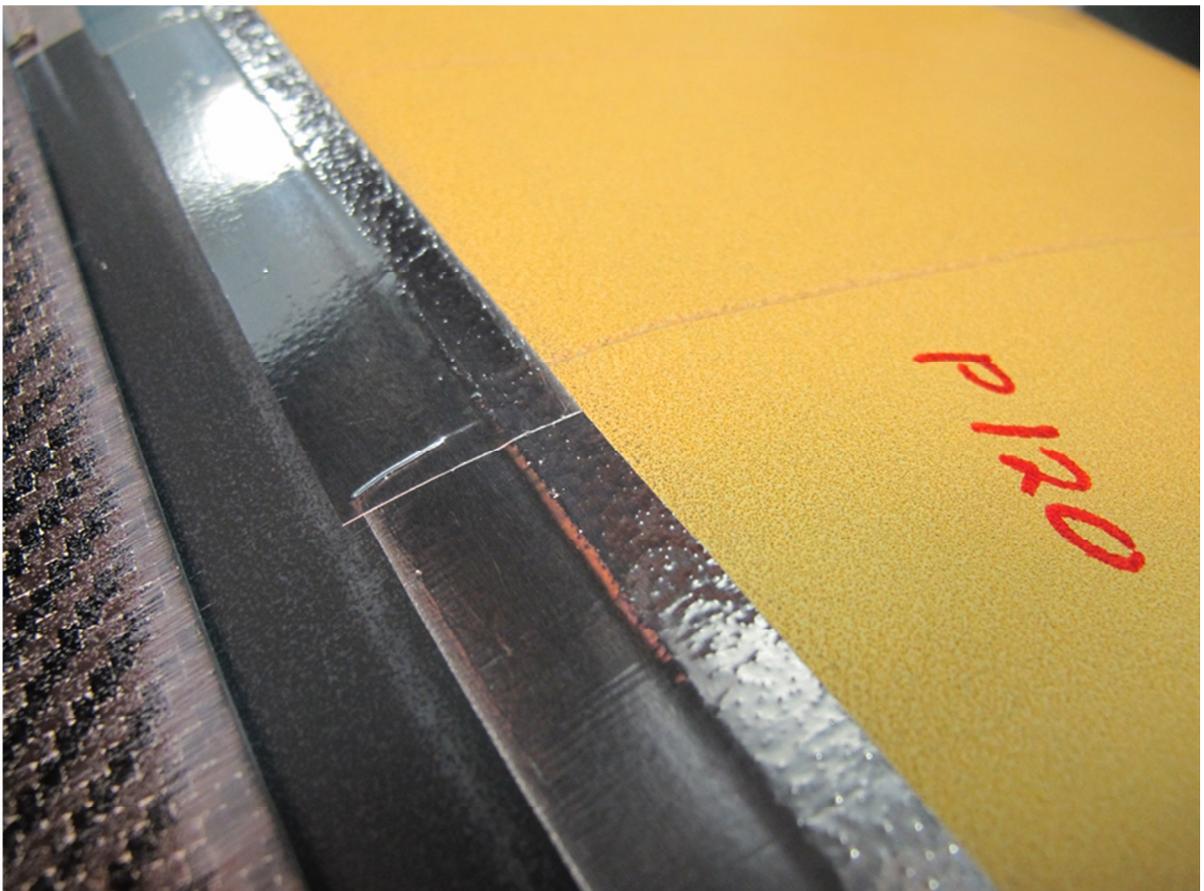
**Figure 19.** The P120 sandpaper fore edge taped over with aluminum tape.

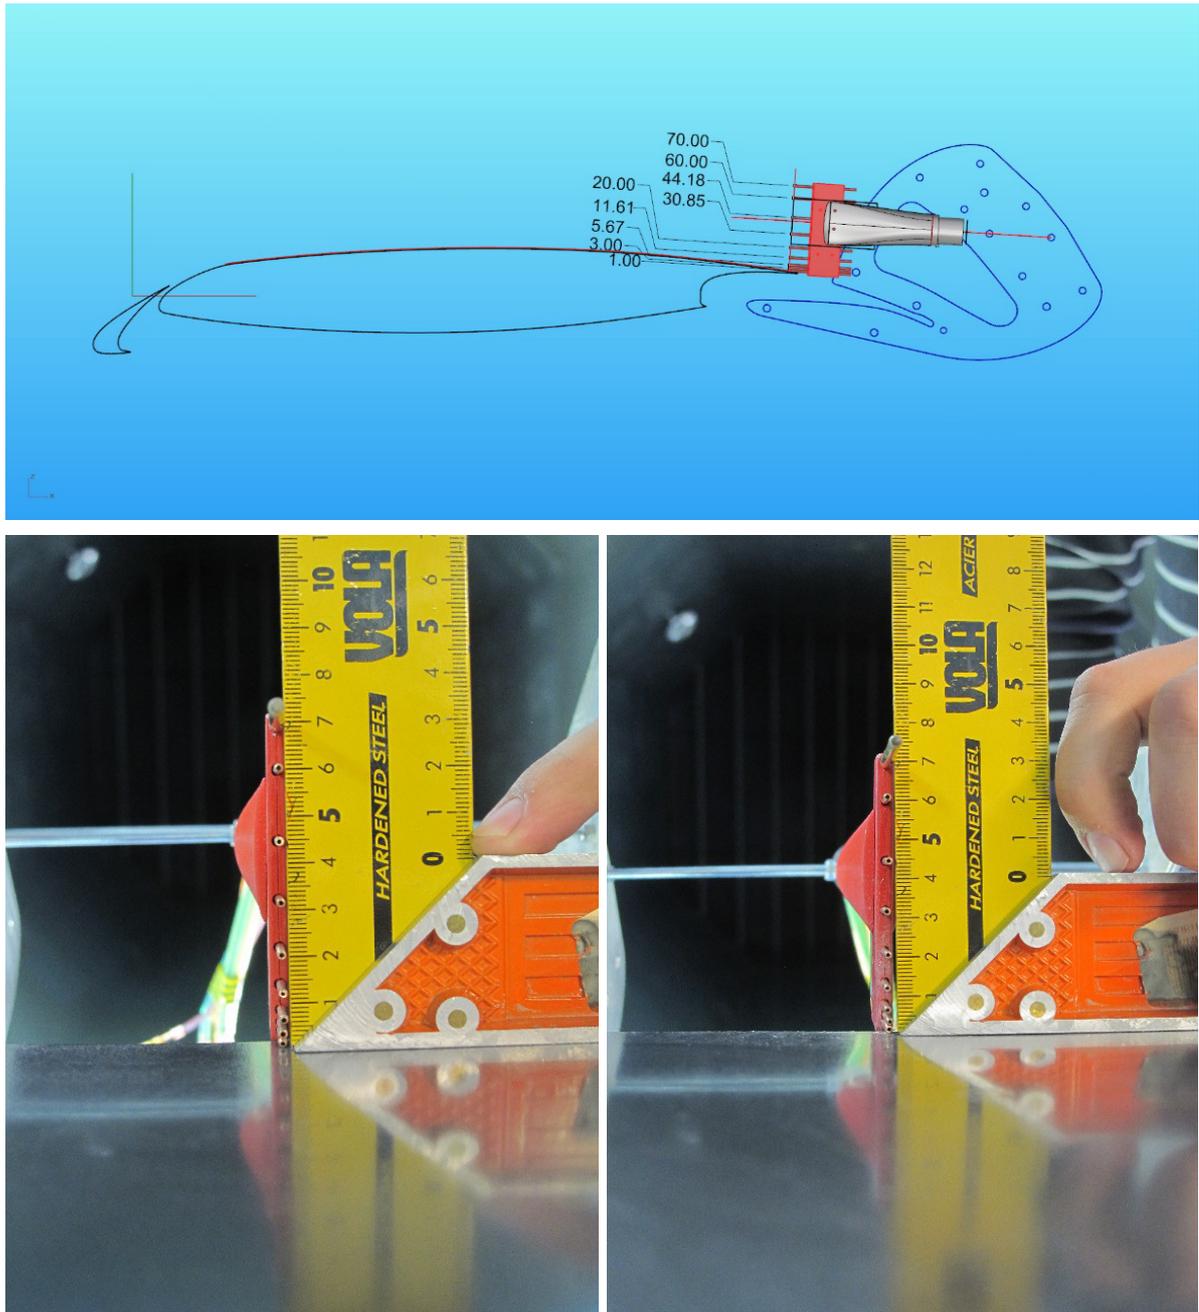
**Figure 20.** Rakes shown in their positions. The top most tube (70mm) is the static pressure tube. Being the most sensitive tube to incidence it defined the rake angle. All the others are total pressure tubes, which are not sensitive to local incidence. The left and right pictures show the rake tubes on the model left and right hand sides respectively (Kivekäs ref. [12]).

The aerodynamic measurements consisted of the wing lift coefficient  $C_L$  and the corresponding boundary layer displacement thickness  $\delta^*$ . The lift coefficient was determined by measuring the wing lift force with the tunnel balance. The interesting time period is just after the take-off rotation when the CSFF has caused largest lift losses. However, with a sandpaper covered model the lift coefficient does not change when the model angle of attack is constant after the rotation. The boundary layer displacement thickness was measured at the aft end of the wing model main plane upper surface using two boundary layer rakes. The rakes were positioned in the spanwise direction symmetrically 120 mm from the wing model center line. The rake set up is shown in Figure 11 and Figure 12 and the rake tube locations in Figure 20.

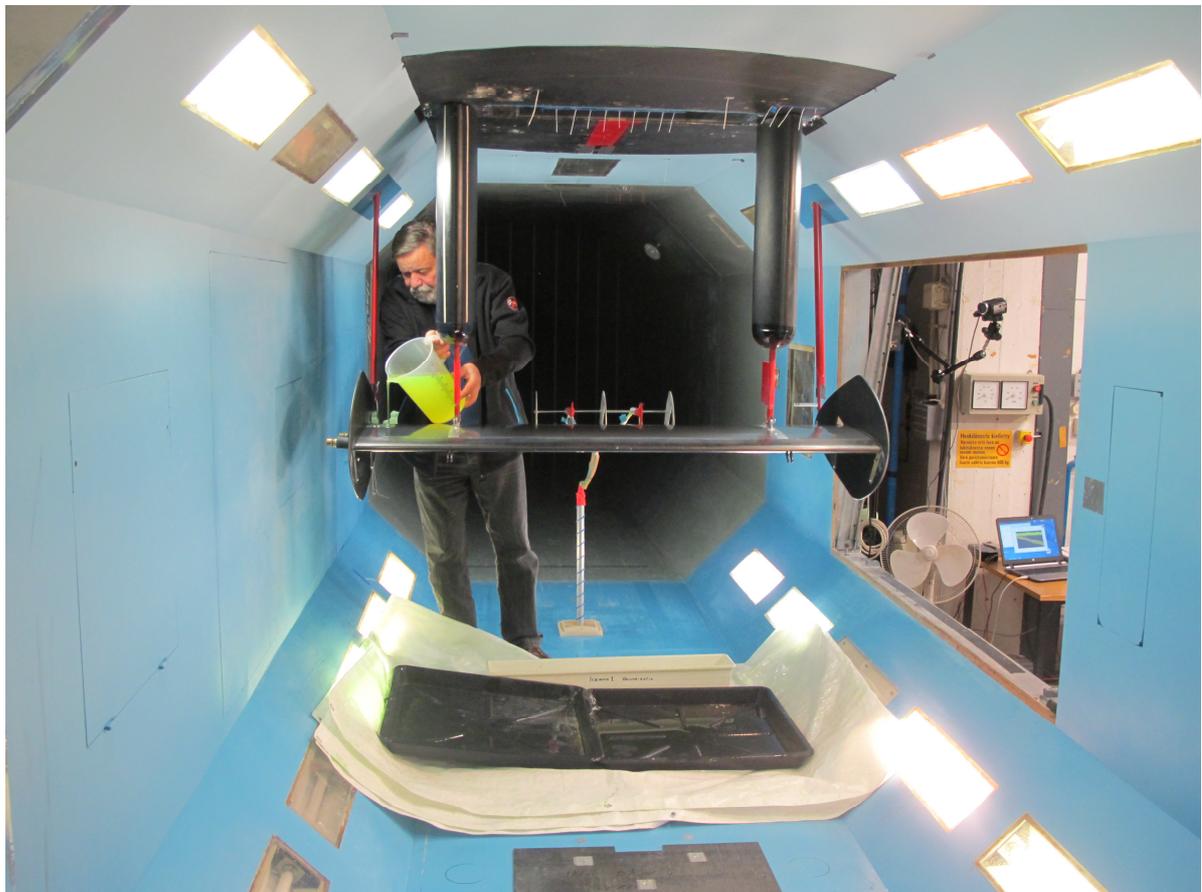
**Figure 21.** Applying anti-icing fluid on the wing model.

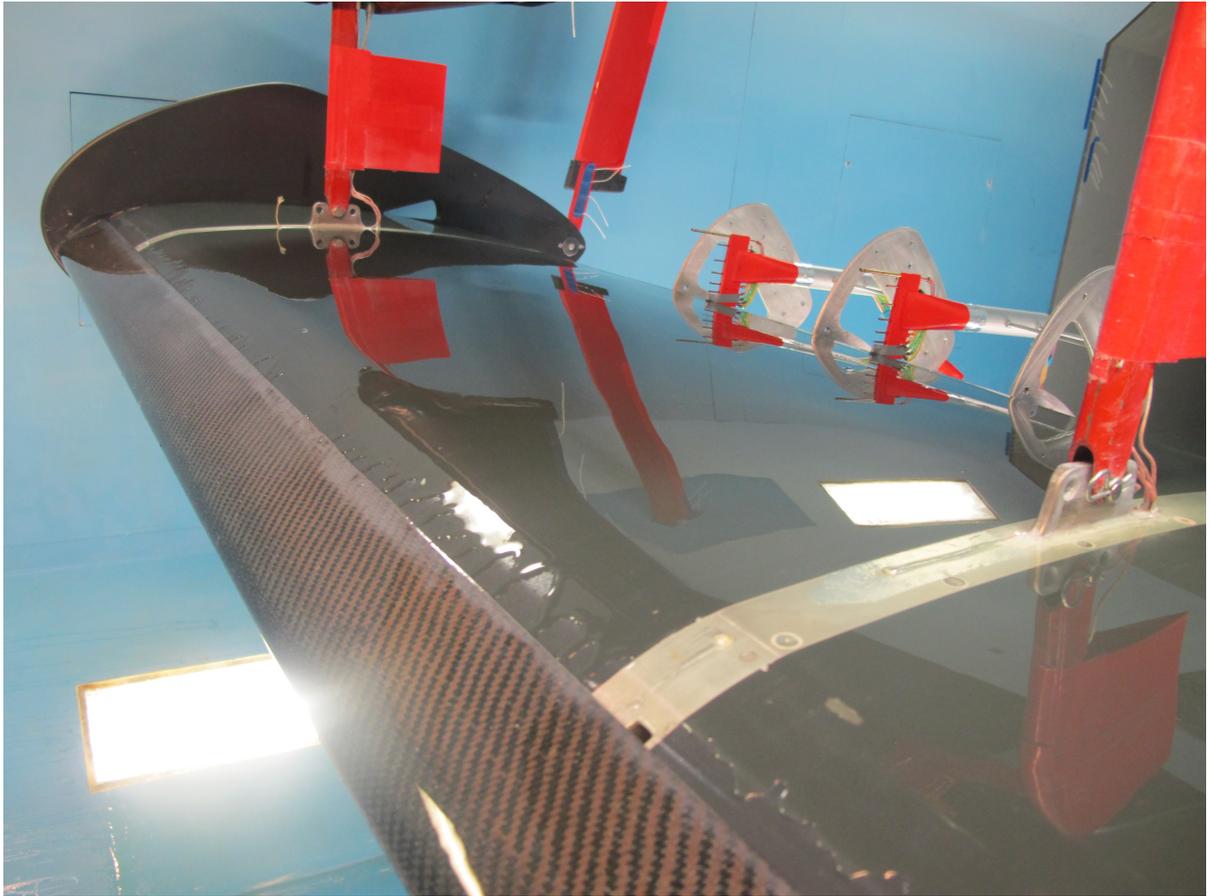
**Figure 22.** Type IV anti-icing fluid on the wing model.

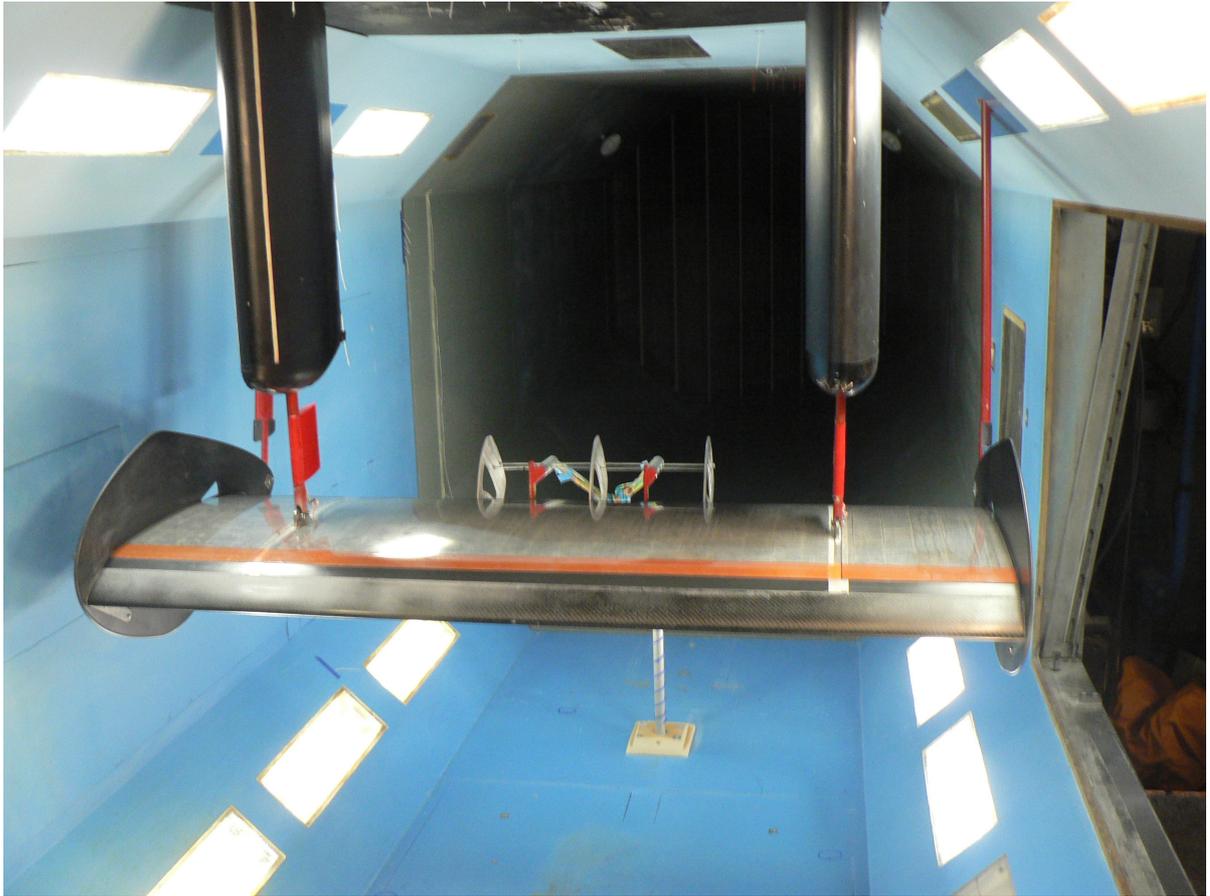
**Figure 23.** Overview of the wing model covered with PVC plastic sheet.

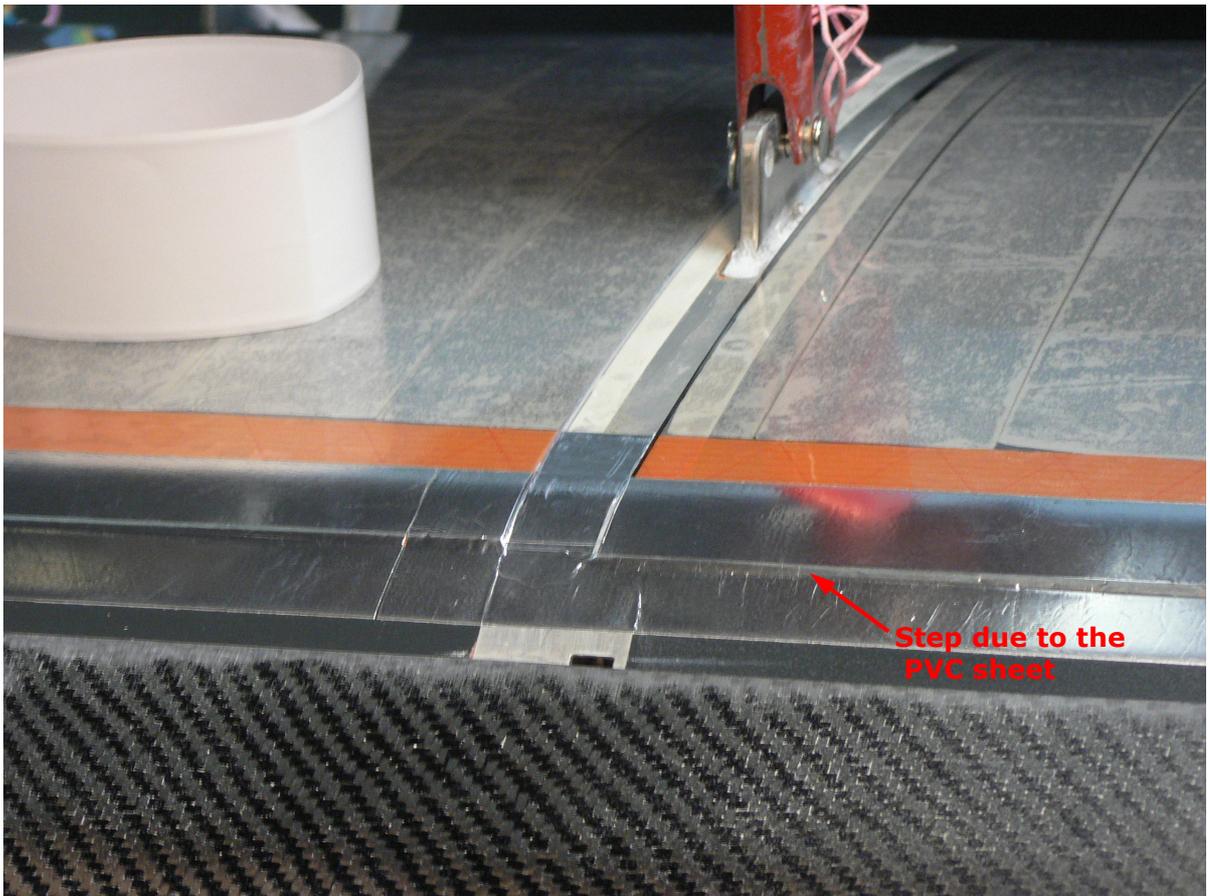
**Figure 25.** The PVC plastic sheet fore edge taped over with aluminum tape.
