# Oil-Flow and Distributed Roughness Experiments on CRM Wing Model

Erkki Soinne, Trafi

Title of publication <b>Oil-Flow and Distributed Roughness Experiments on CRM Wing Model</b>	
Author(s) Erkki Soinne	
Commissioned by, date Kari Wihlman, October 8th 2017	
Publication series and number <b>Trafı Research Reports 3/2018</b>	ISSN (online) 2342-0294 ISBN (online) ISBN 978-952-311-247-6 URN <a href="http://urn.fi/URN:ISBN:978-952-311-247-6">http://urn.fi/URN:ISBN:978-952-311-247-6</a>
Keywords aircraft, aerodynamics, anti-icing fluids	
Contact person Erkki Soinne	Language of the report English
Abstract This research report summarizes the oil-flow, sandpaper, anti-icing fluid and PVC plastic sheet wind tunnel experiments on the Common Research Model (CRM). The aerodynamic measurements were made with a force balance on lift and two wake rakes on the upper surface boundary layer displacement thickness aft of the model main wing. The oil-flow measurements investigated the qualitative flow characteristics.

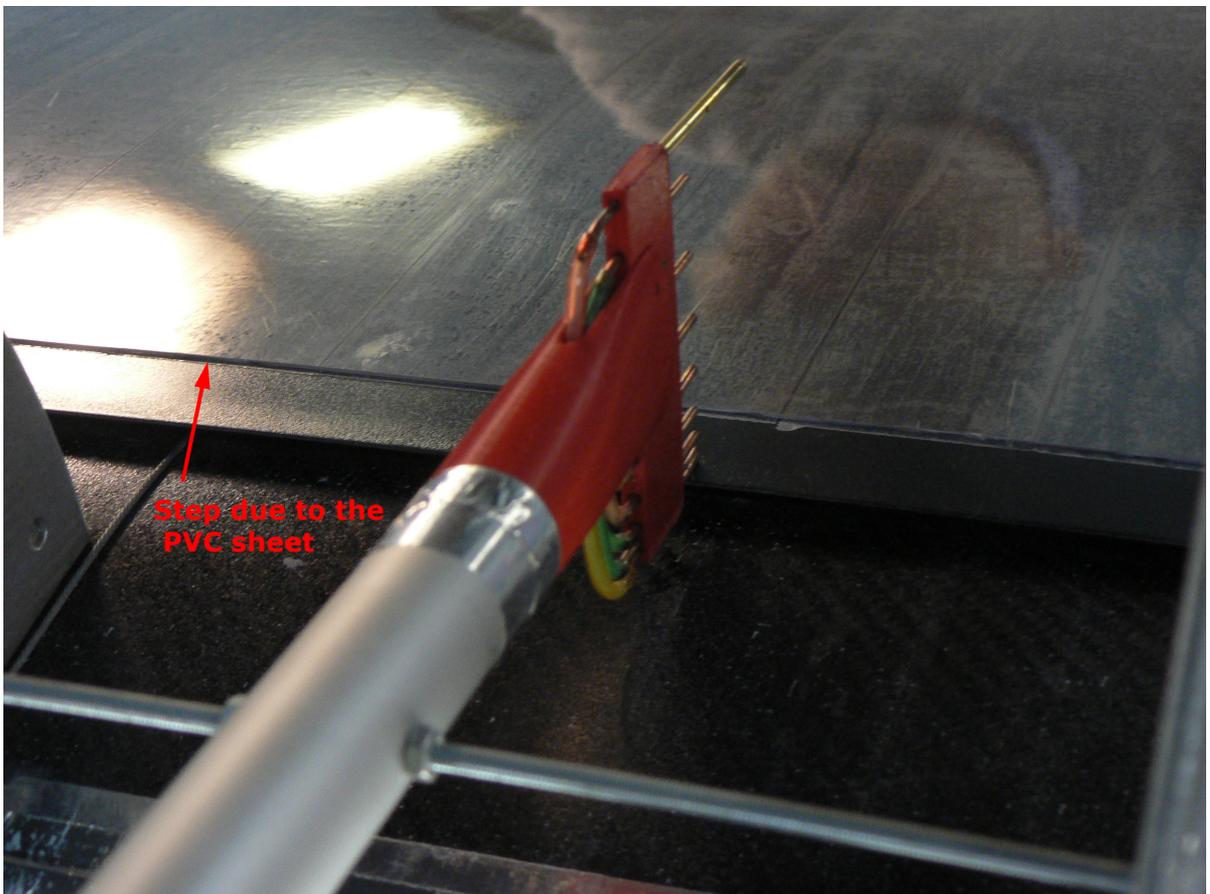
**Figure 26.** The PVC plastic sheet aft edge step.

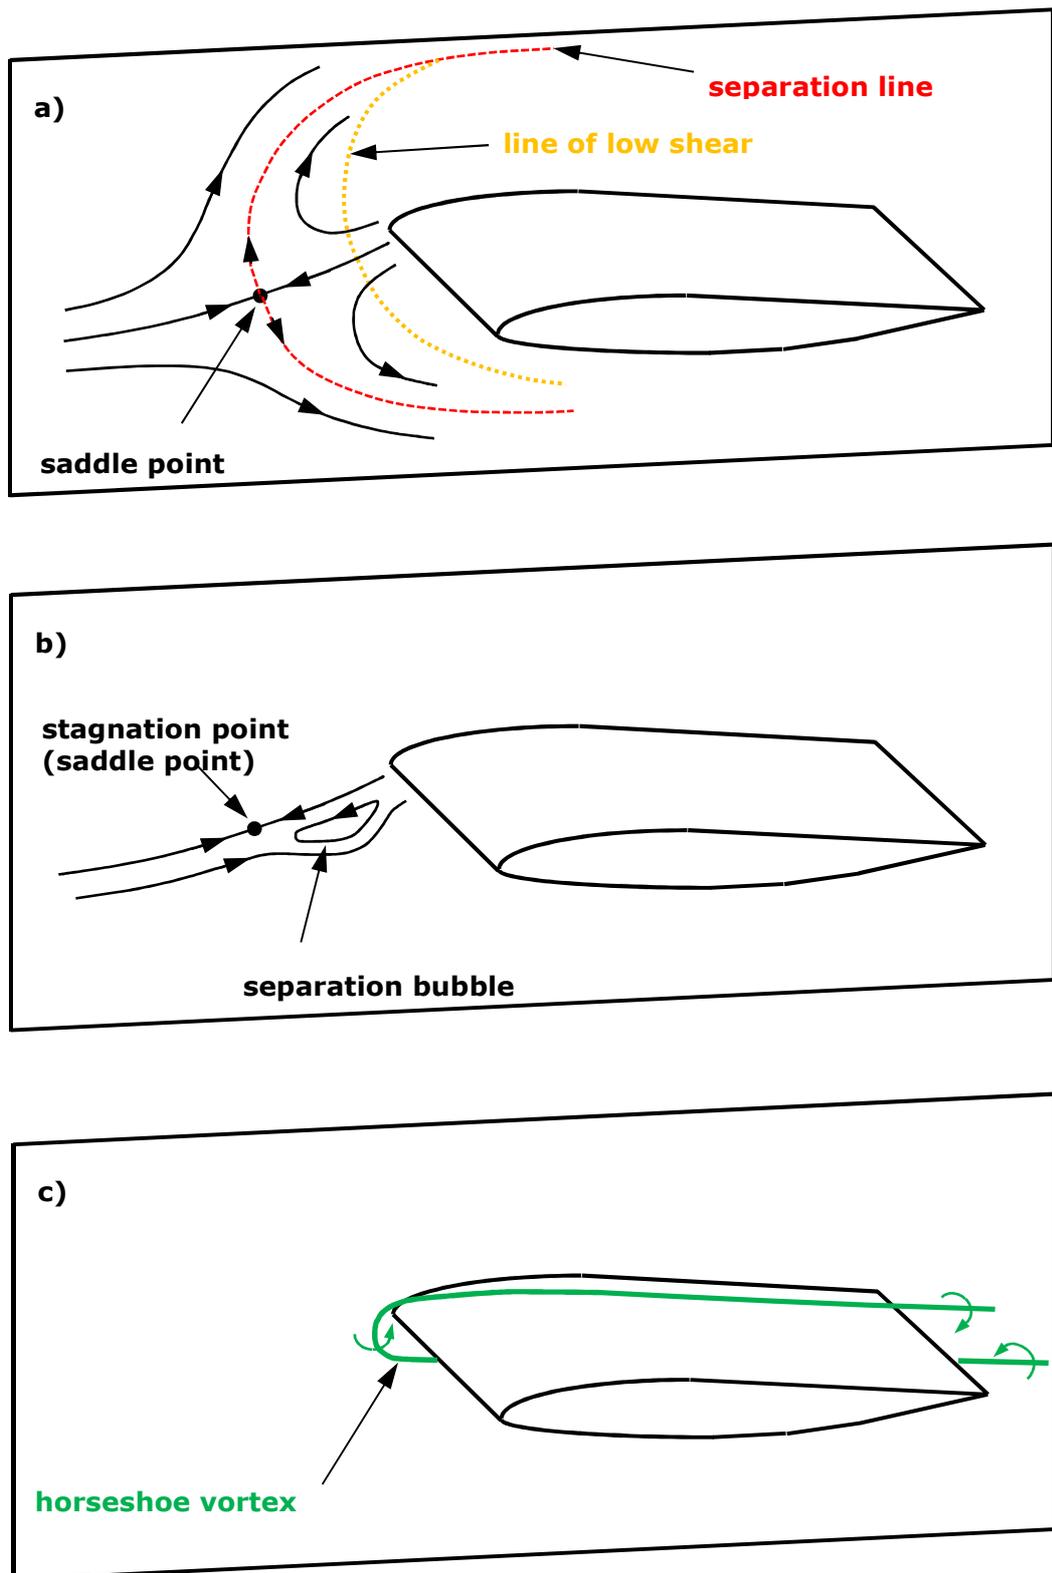
**Figure 27.** Wing-end plate junction flow with a) skin friction lines on the vertical surface, b) streamlines on a horizontal surface and c) formation of a horseshoe vortex.

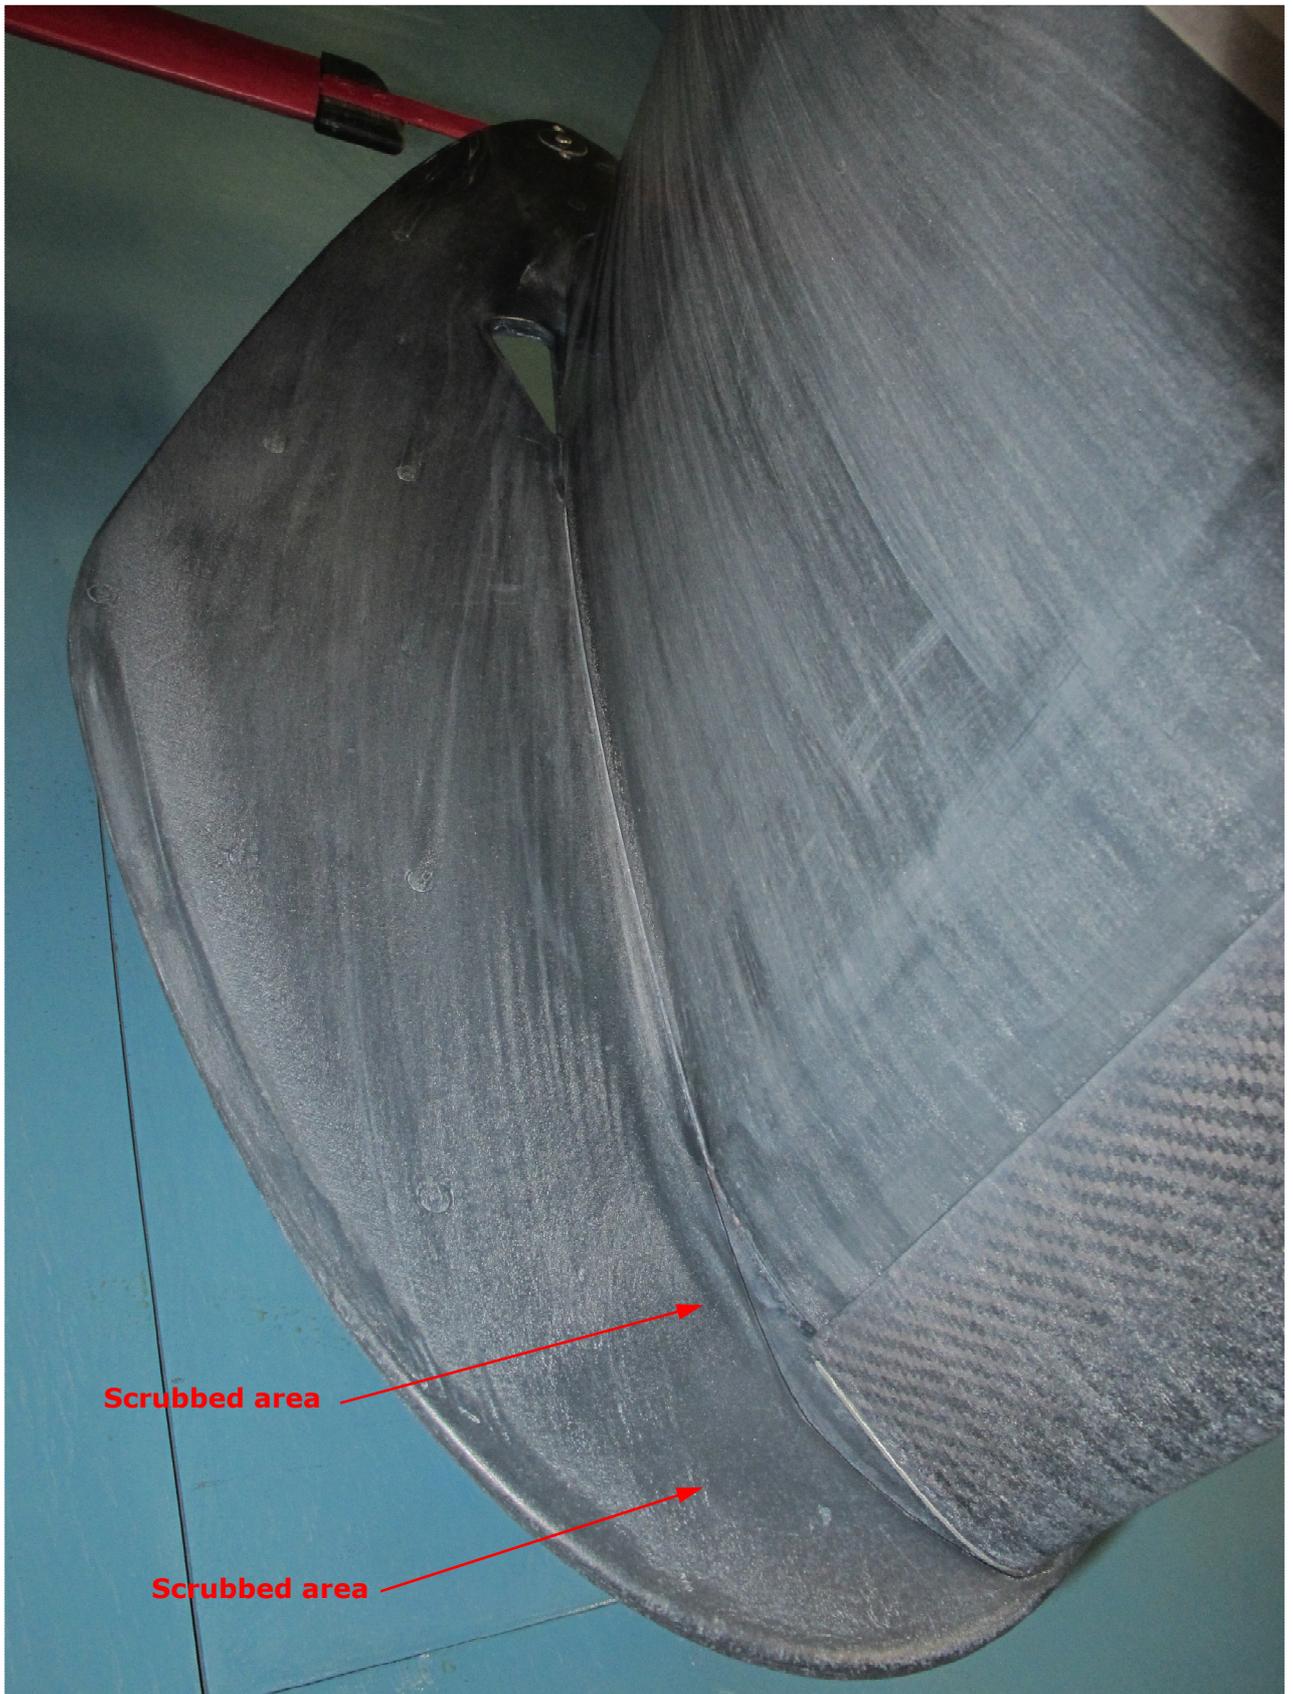
**Figure 28.** Overview of the oil flow pattern on the HL-CRM Mod wing model at  $Re=1,3$  million.

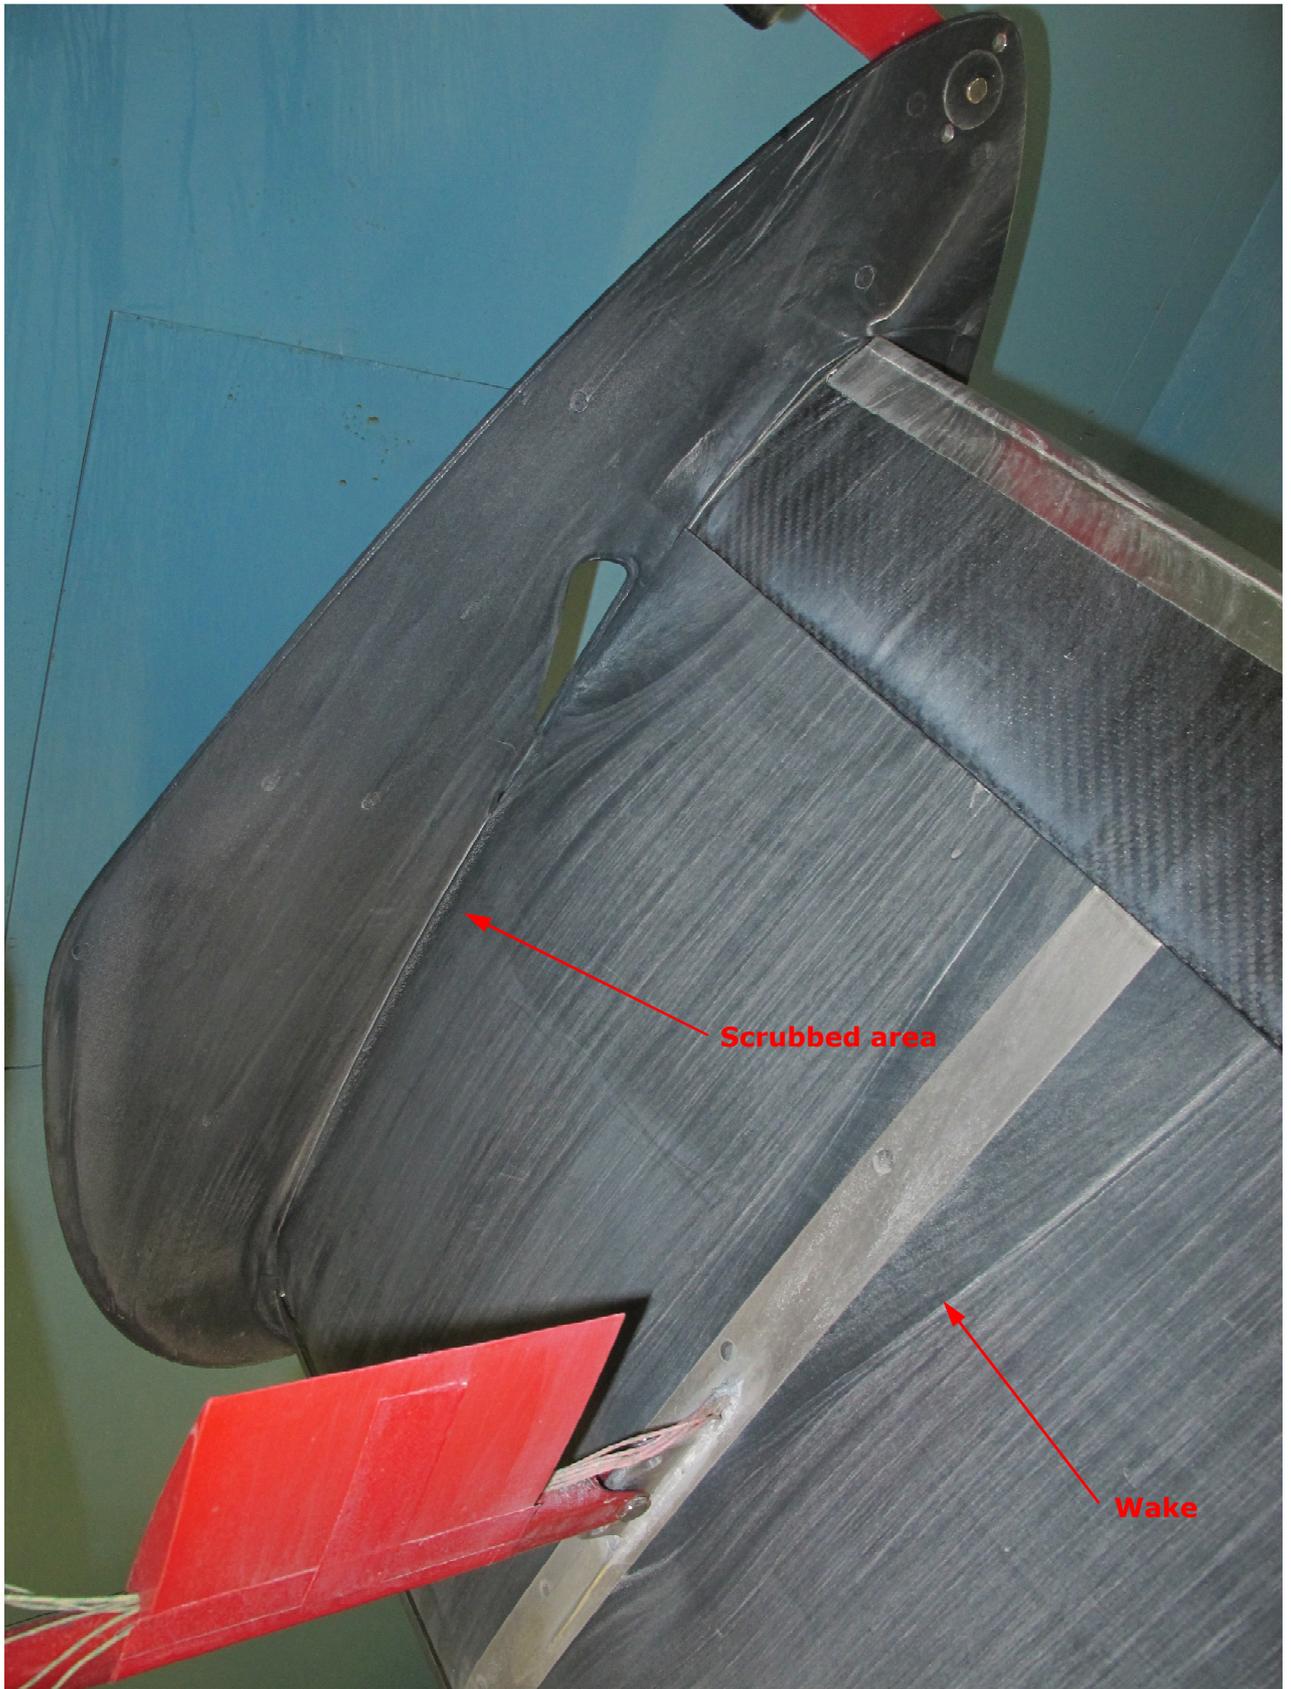
**Figure 29.** Overview of the oil-flow pattern on the HL-CRM Mod wing model at  $Re=1,3$  million.

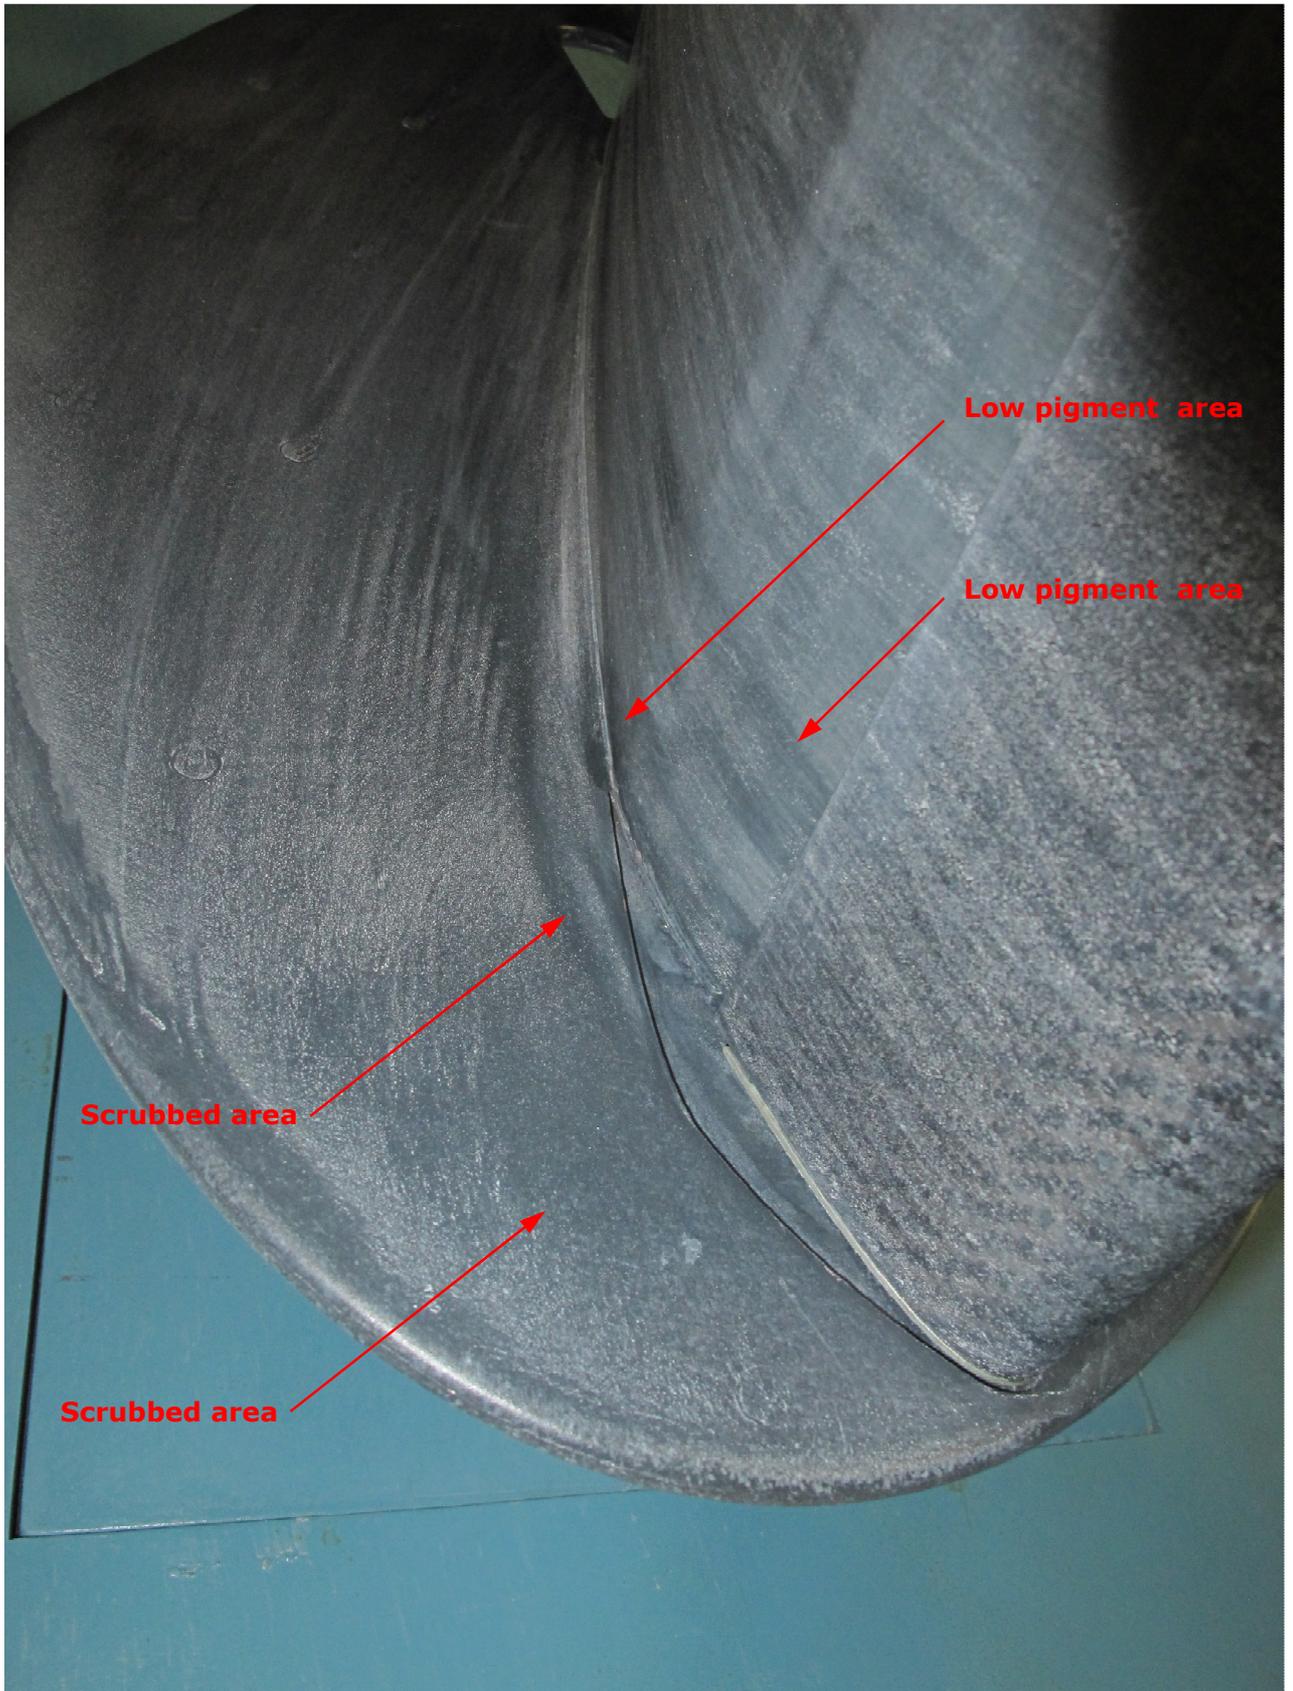
**Figure 30.** Oil flow pattern on the nose area of the HL-CRM Mod wing model at  $Re=1,3$  million.

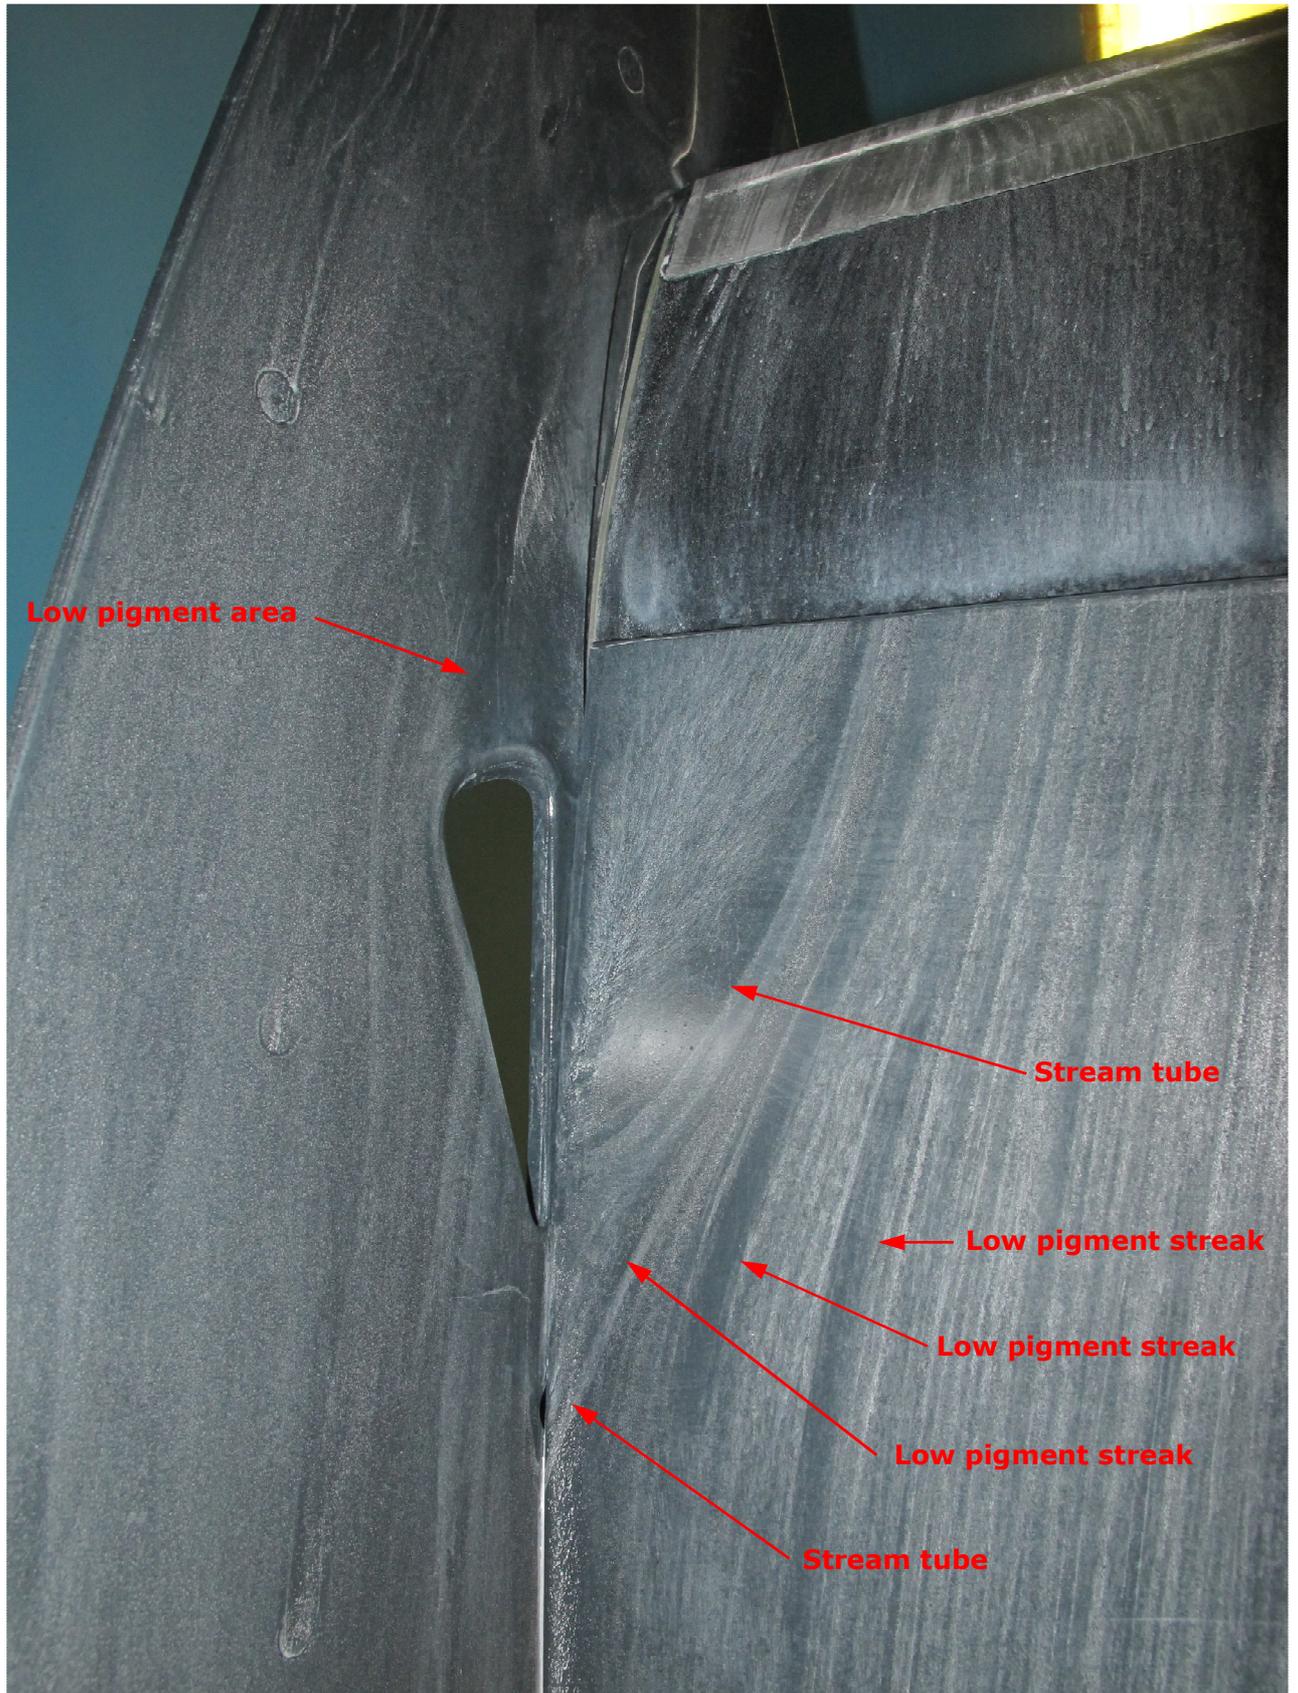
**Figure 31.** Oil flow pattern on the aft area of the HL-CRM Mod wing model at  $Re=1,3$  million.

Figure 31 shows a close up view of the end plate hole. Upstream of the hole is a small hole leaking air from the outboard side of the end plate where the pressure is higher. This small flow and the larger flow through the bigger end plate hole form visible stream tubes with increasing widths. Aft of the larger hole there is a low pigment area indicating a flow separation on the end plate surface aft of the hole corner creating a very turbulent flow. There is no sign of flow separation on the flap or the wing upper surface, but there are three streaks of low pigment. One starts from the upstream end of the conical end plate hole. The second one is inboard of the first one and the third somewhat further inboard. The conical hole end may cause a disturbance or vortex which scrubs the wing surface. The second low pigment streak may be due to the horseshoe vortex which is pushed more inboard due to the flow through the end plate hole. The third low pigment area is probably not due to a counter rotating vortex as it is situated some distance inboard of the second one. There is also a low pigment area upstream of the third streak downstream of the slat slot. The cause is unknown but the area is not aft of the slat track bracket.

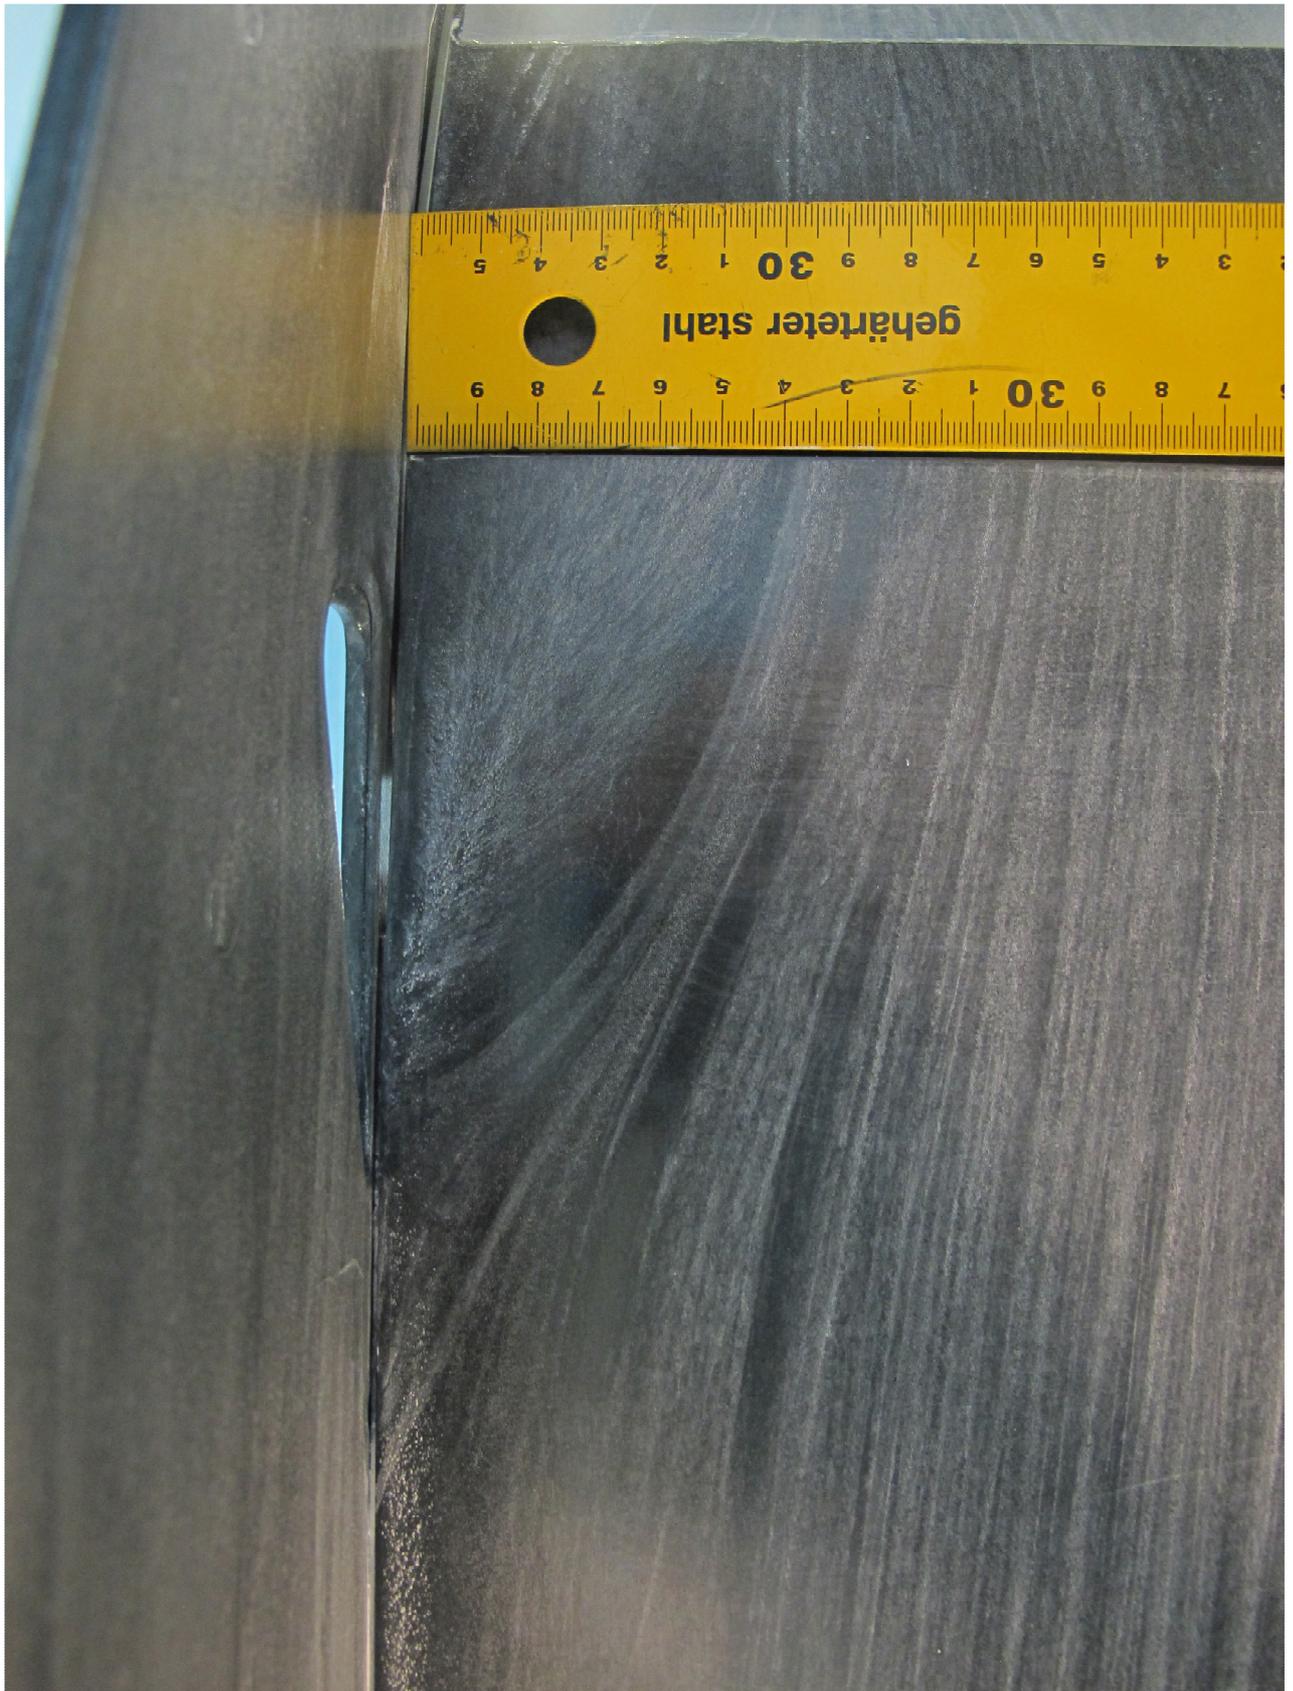
**Figure 32.** Oil flow pattern on the aft area of the HL-CRM Mod wing model at  $Re=1,3$  million. The ruler scale is 1 cm.

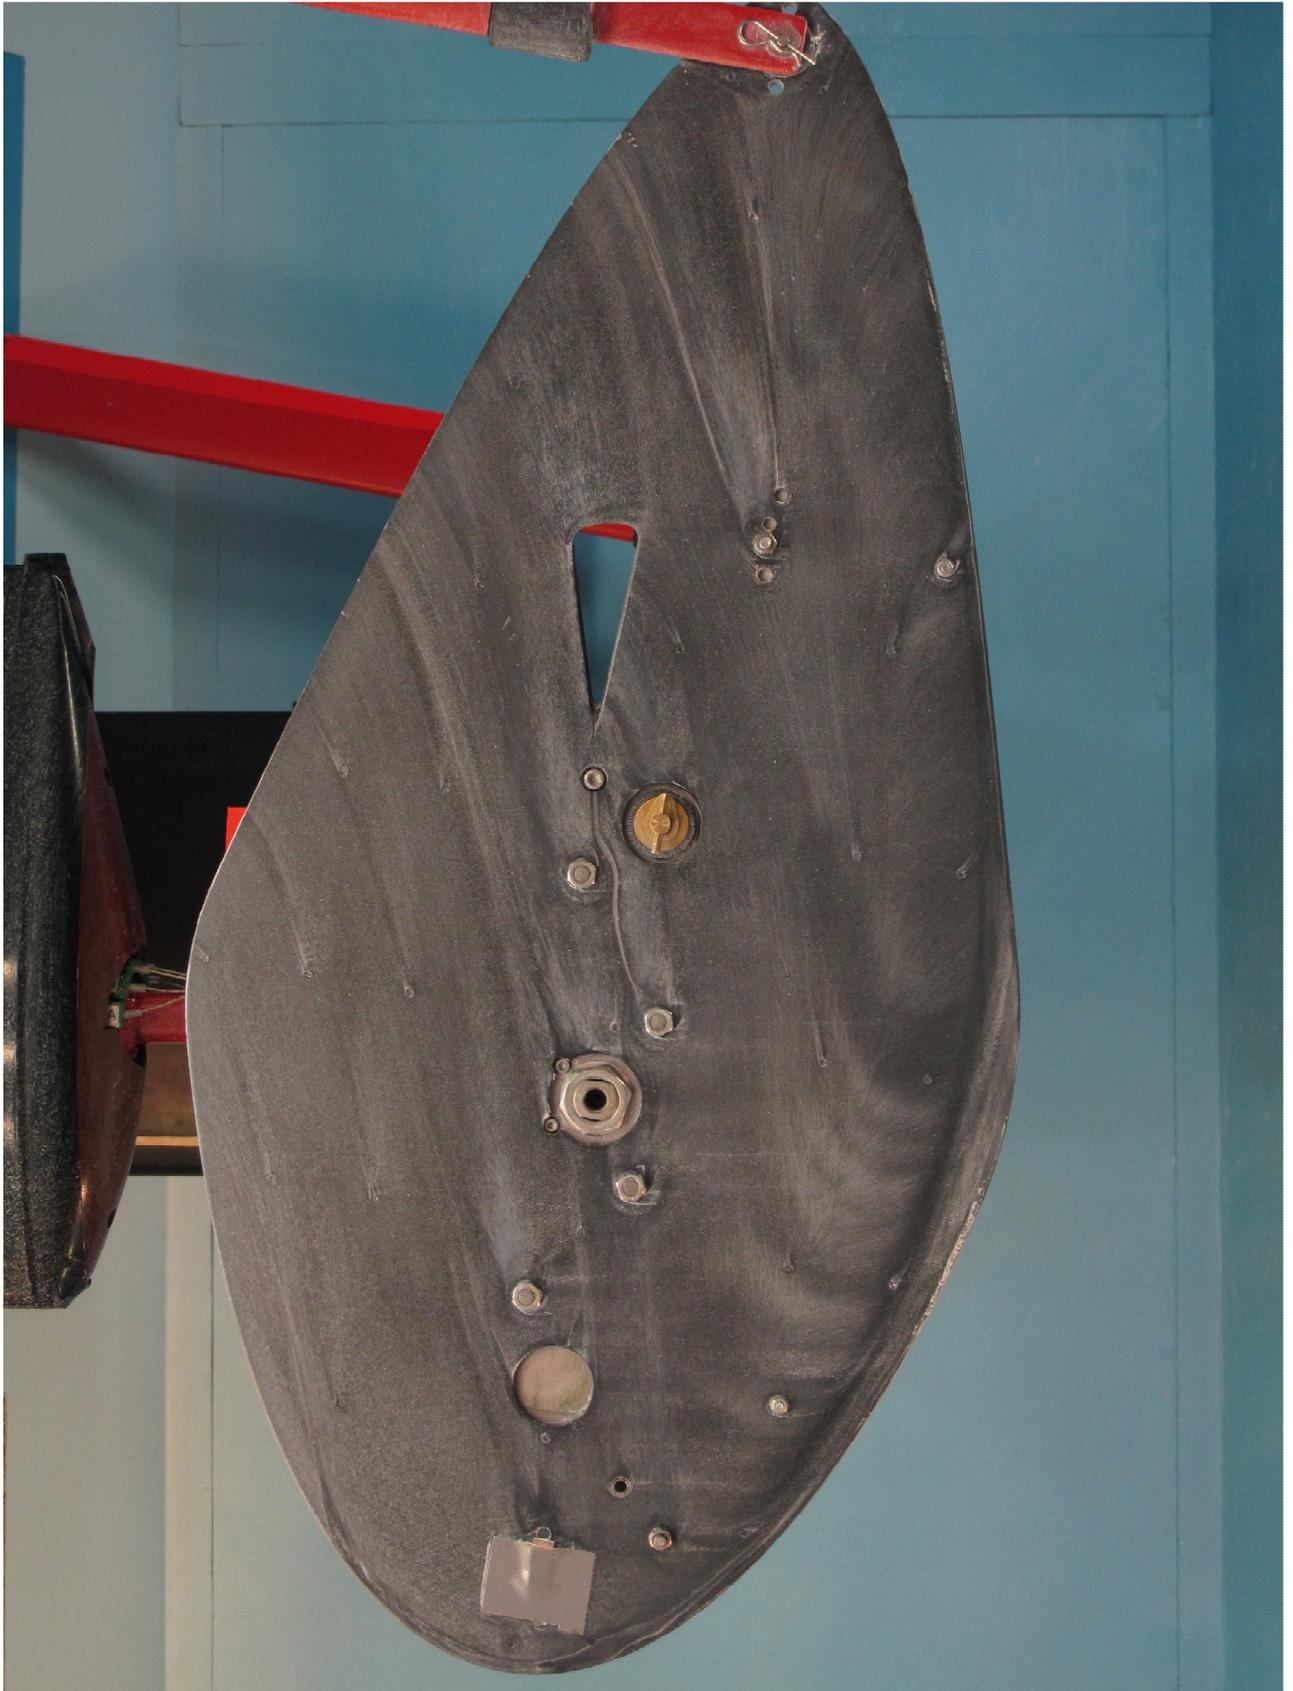
**Figure 33.** Oil flow pattern on the end plate of the HL-CRM Mod wing model at  $Re=1,3$  million.

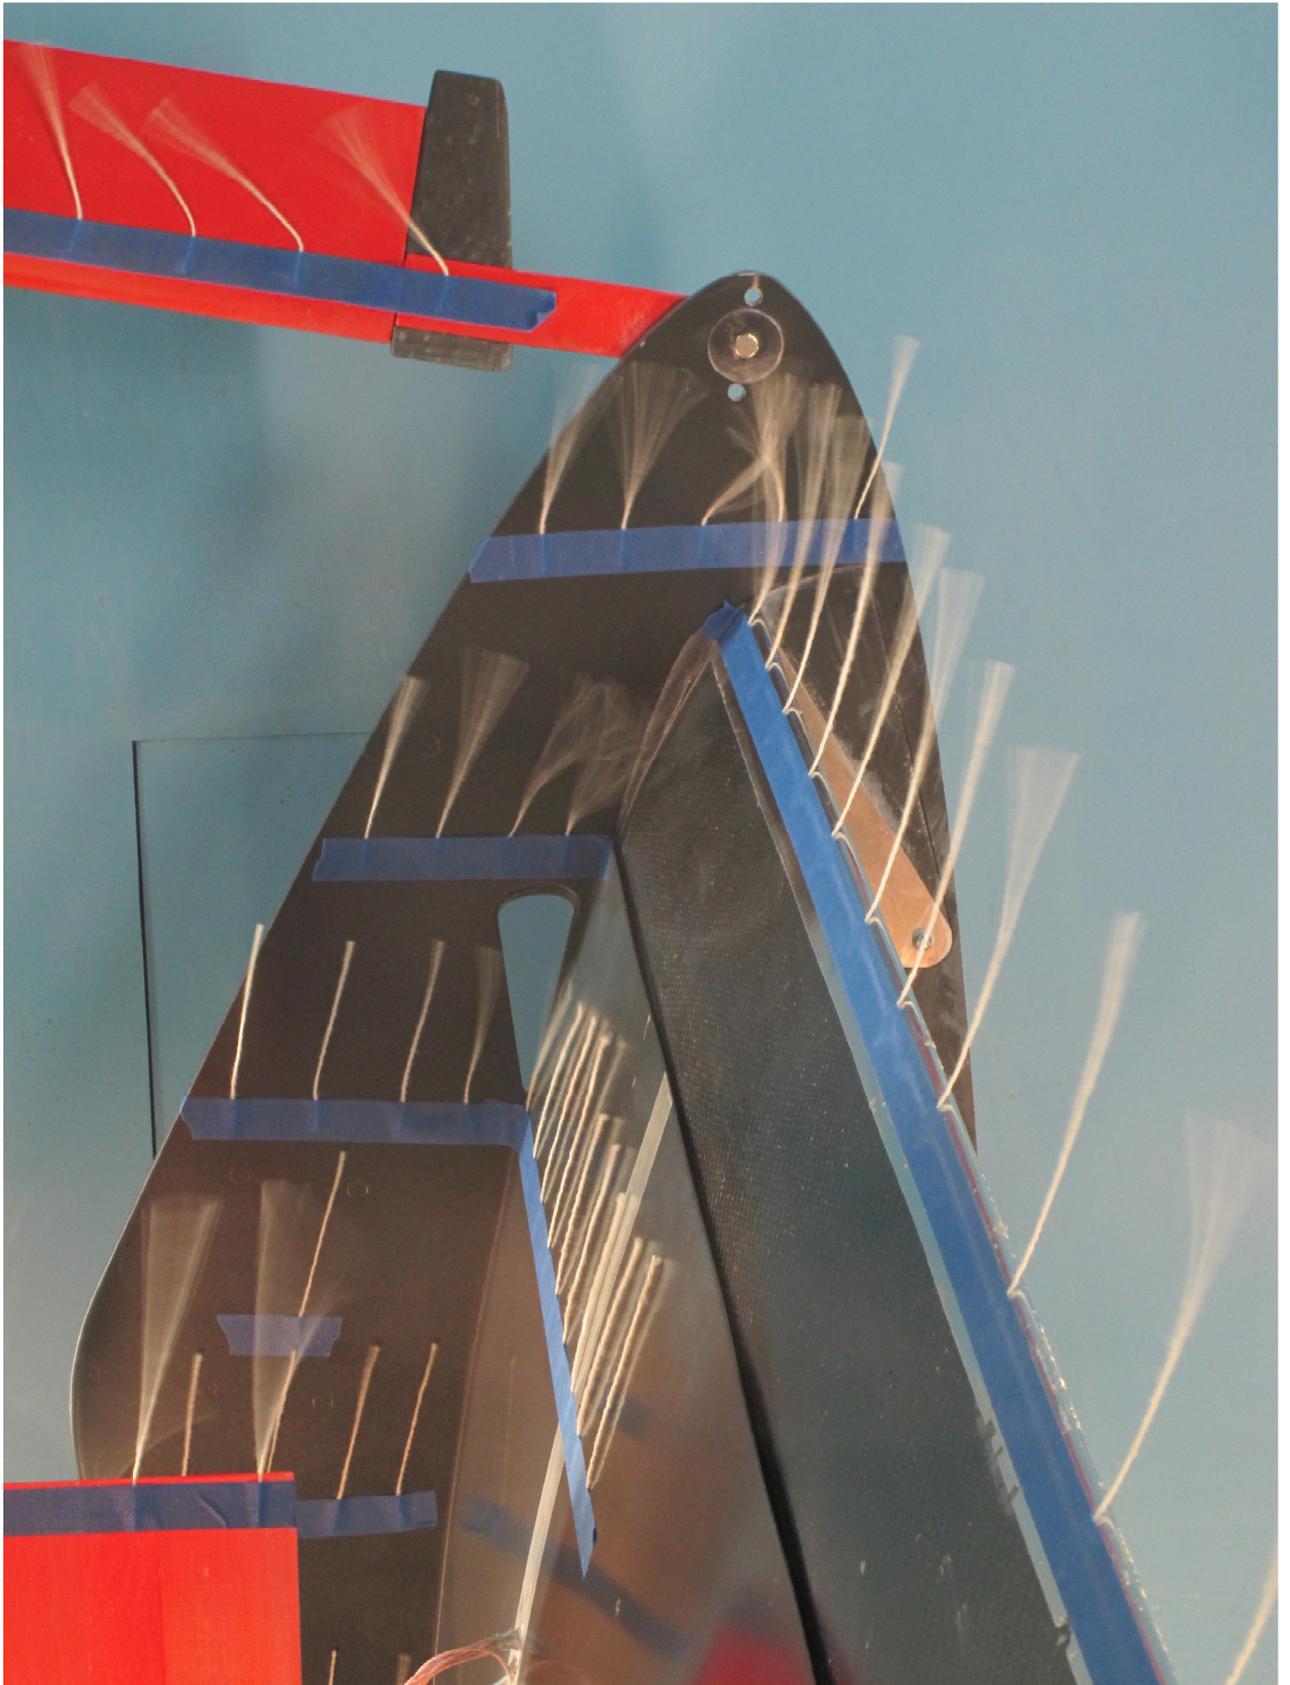
**Figure 34.** Overview of the flow pattern, visualized with tufts, on the HL-CRM Mod wing model at  $Re=1,3$  million.

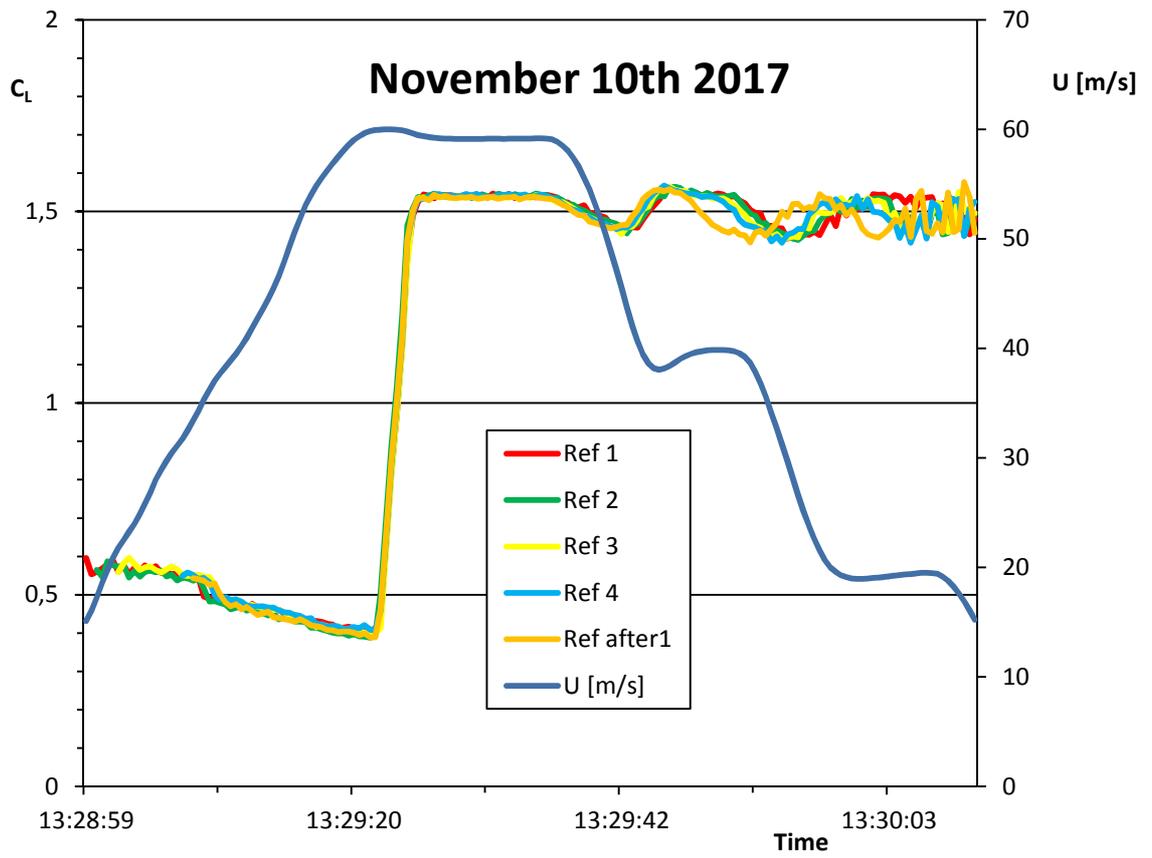
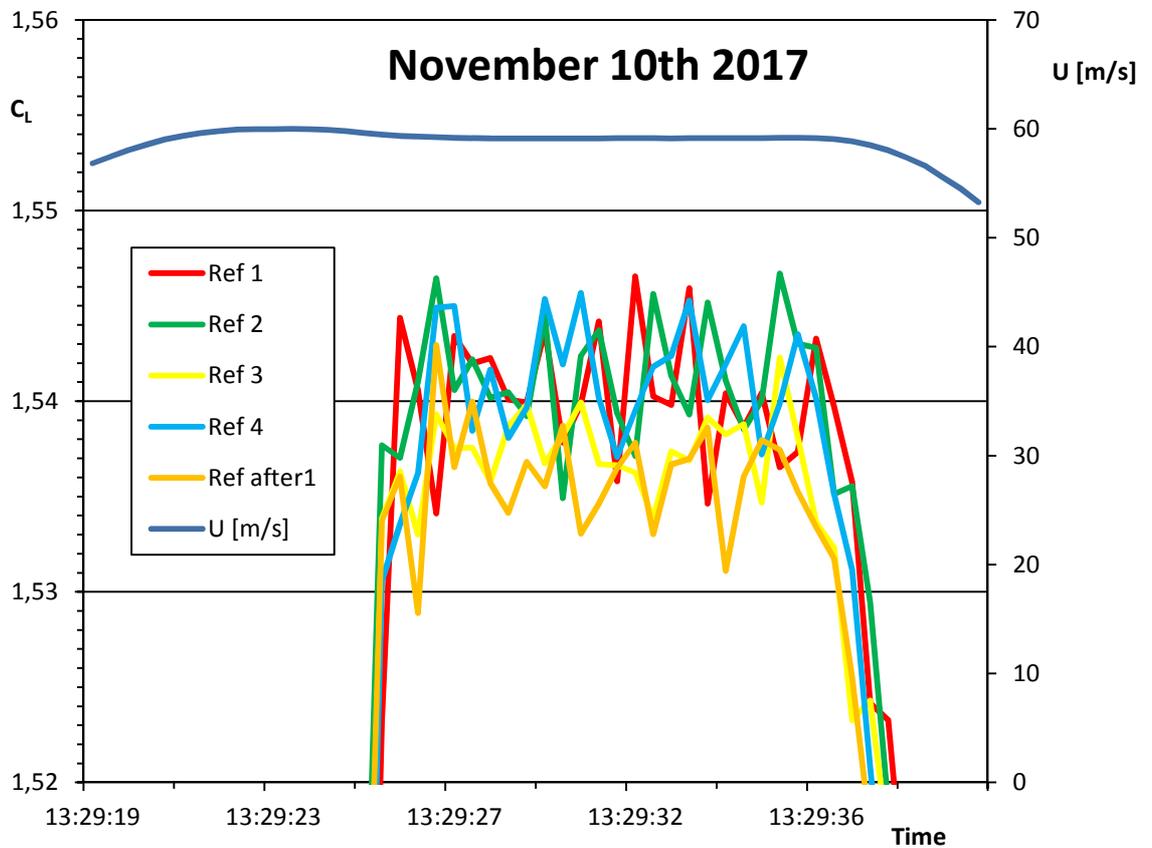
**Figure 35.** Lift coefficient  $C_L$  as function of time during a simulated take-off on a clean wing during the measurements on November 10th.

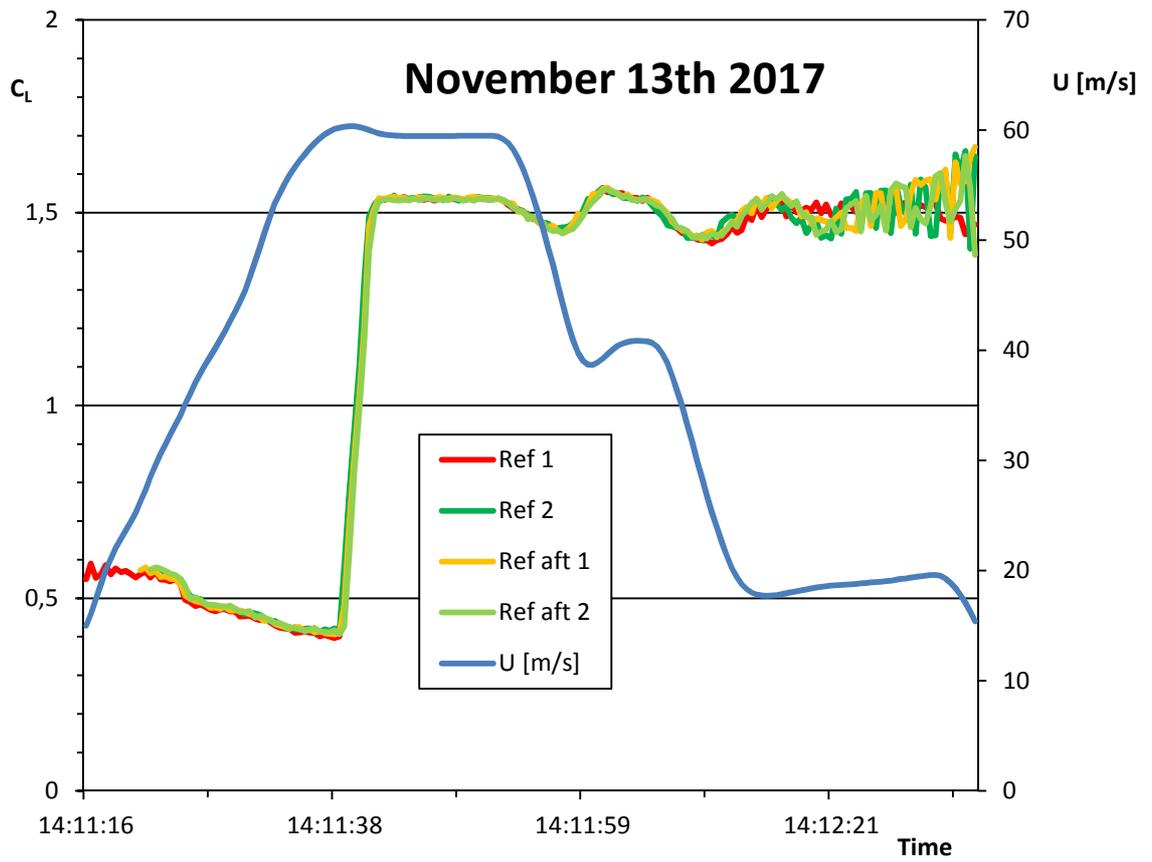
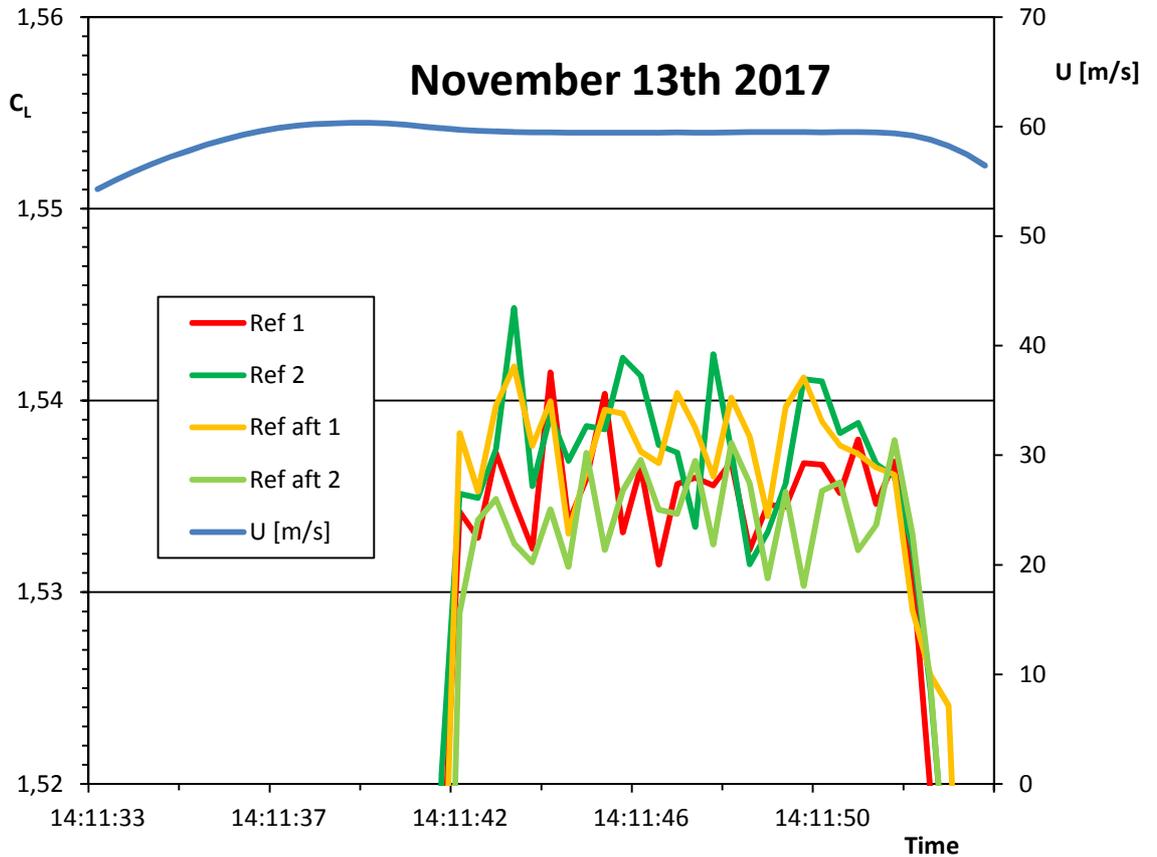
**Figure 36.** Lift coefficient  $C_L$  as function of time during a simulated take-off on a clean wing during the measurements on November 13th.
