# Oil-Flow and Distributed Roughness Experiments on CRM Wing Model

Erkki Soinne, Trafi

Title of publication <b>Oil-Flow and Distributed Roughness Experiments on CRM Wing Model</b>	
Author(s) Erkki Soinne	
Commissioned by, date Kari Wihlman, October 8th 2017	
Publication series and number <b>Trafı Research Reports 3/2018</b>	ISSN (online) 2342-0294 ISBN (online) ISBN 978-952-311-247-6 URN <a href="http://urn.fi/URN:ISBN:978-952-311-247-6">http://urn.fi/URN:ISBN:978-952-311-247-6</a>
Keywords aircraft, aerodynamics, anti-icing fluids	
Contact person Erkki Soinne	Language of the report English
Abstract This research report summarizes the oil-flow, sandpaper, anti-icing fluid and PVC plastic sheet wind tunnel experiments on the Common Research Model (CRM). The aerodynamic measurements were made with a force balance on lift and two wake rakes on the upper surface boundary layer displacement thickness aft of the model main wing. The oil-flow measurements investigated the qualitative flow characteristics.

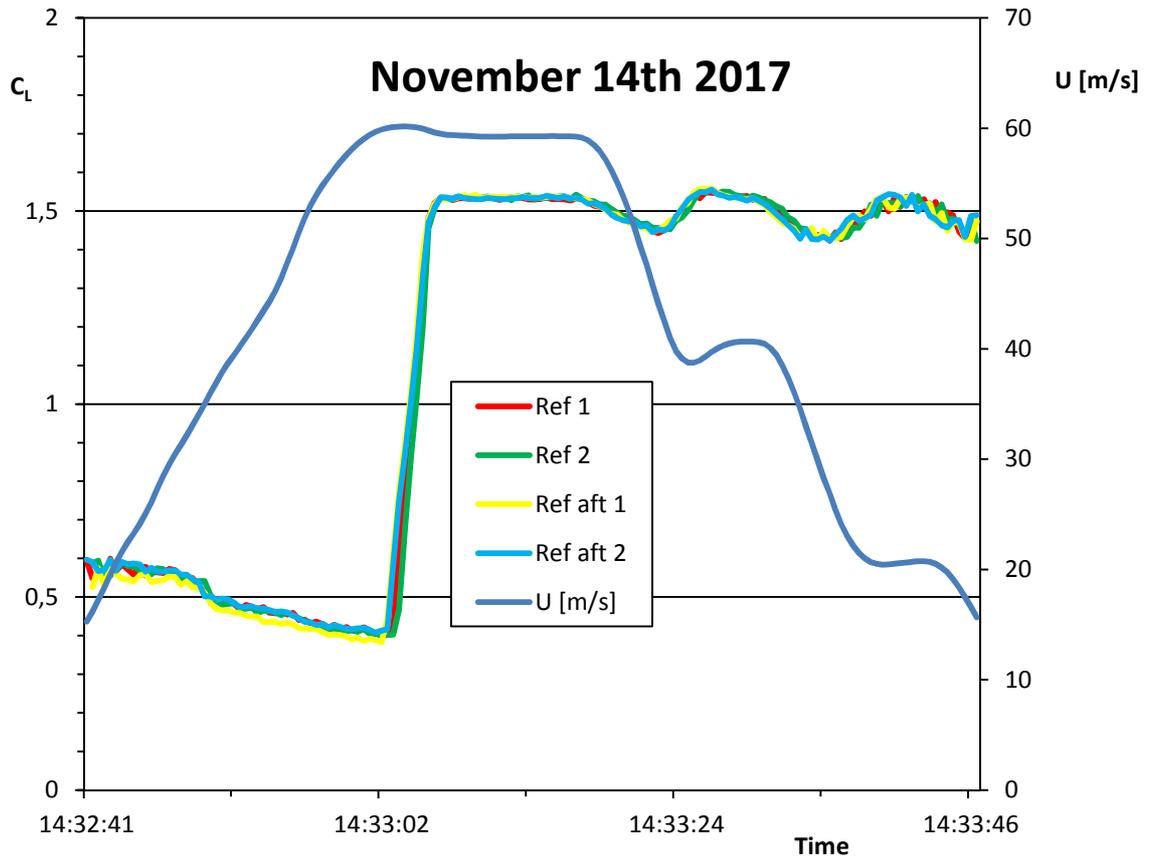
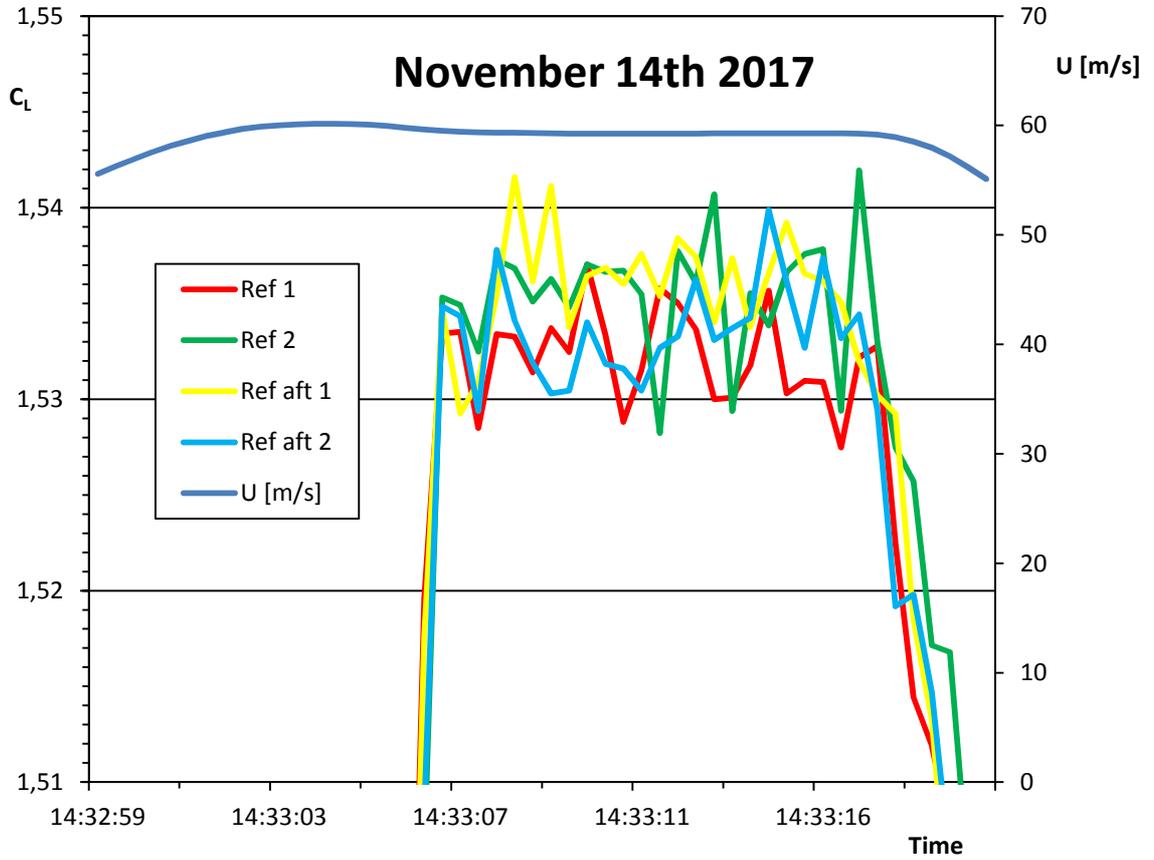
**Figure 37.** Lift coefficient  $C_L$  as function of time during a simulated take-off on a clean wing during the measurements on November 14th.

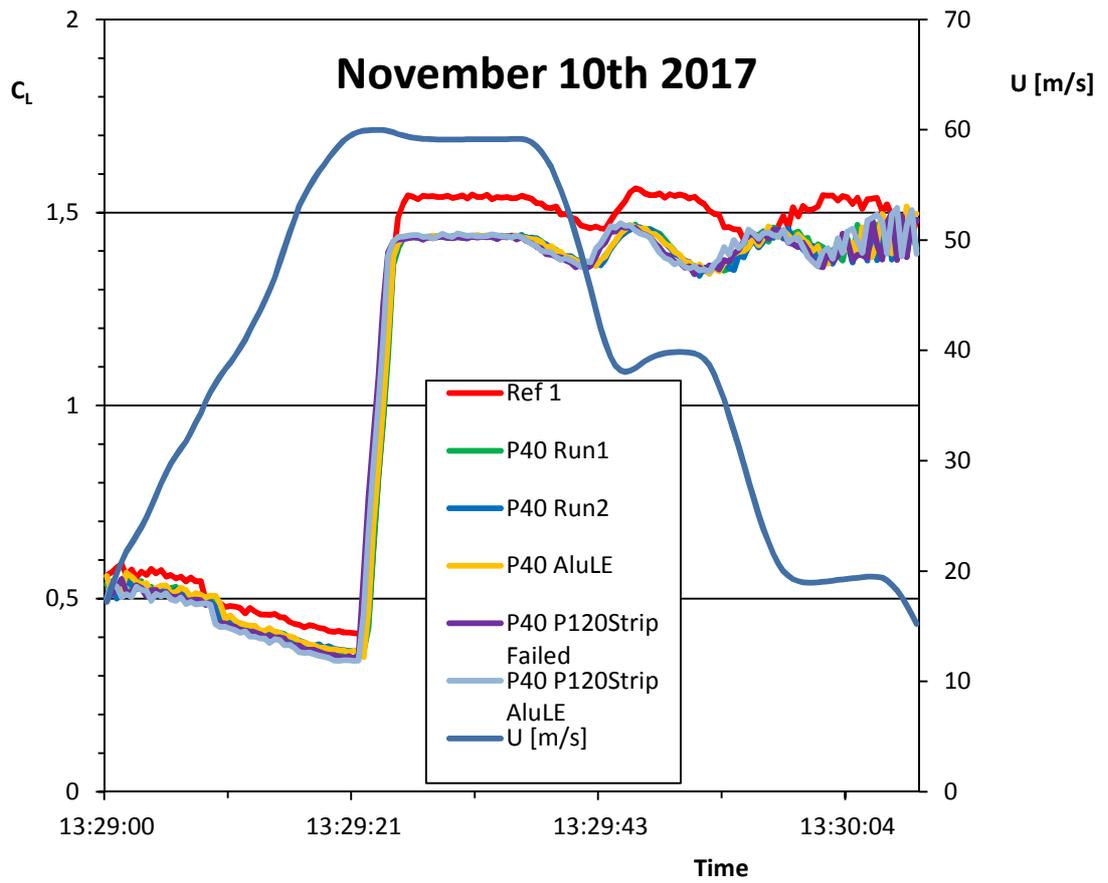
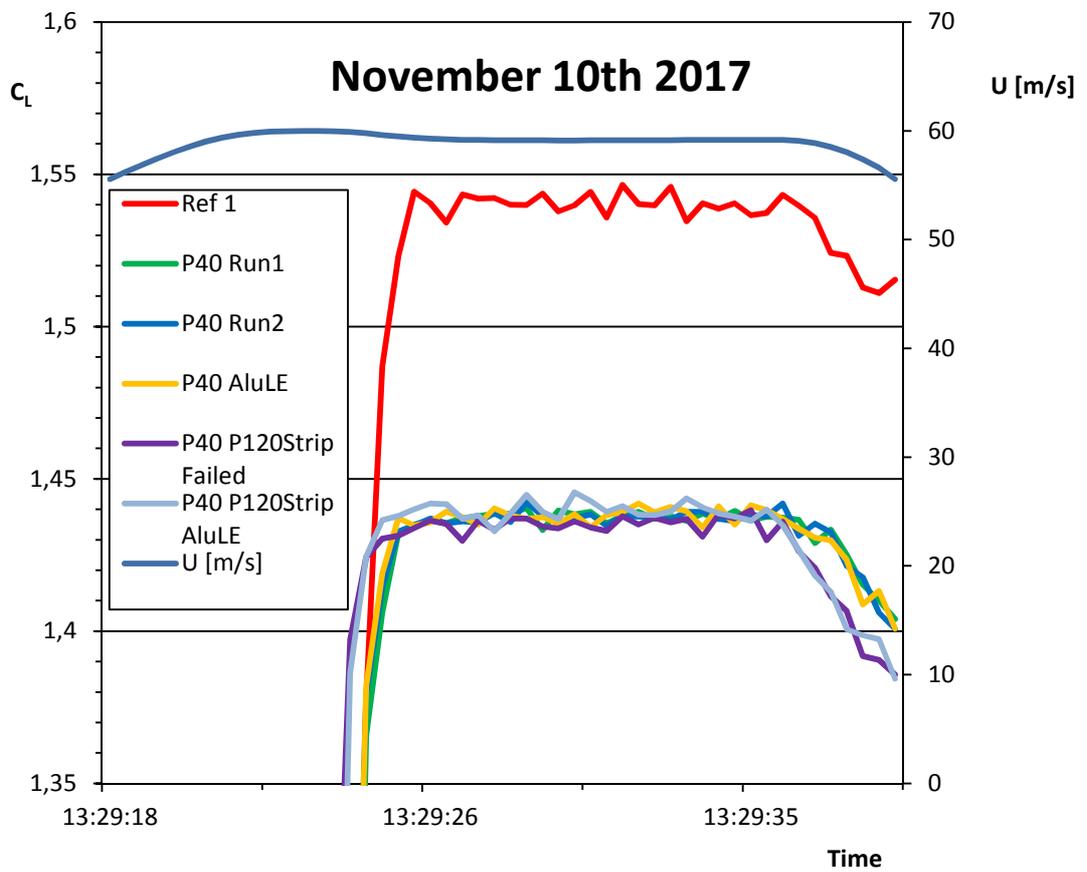
**Figure 38.** Lift coefficient  $C_L$  as function of time during a simulated take-off of P40 sandpaper measurements.

As is seen in Figure 38 the lift coefficient of the wing model with P40 sandpaper is hardly dependent on the sandpaper fore edge configurations. The average lift coefficient of the three wind tunnel runs with P40 sandpaper (including the one with the P120 Strip Failed, the strip detached from the surface) was  $C_L=1,437$  with a range of lift coefficient values  $\Delta C_L=0,0023$ . For the wing model with P40 sandpaper and aluminum tape at the sandpaper fore edge the lift coefficient was  $C_L=1,438$ . P40 sandpaper with a P120 strip and aluminum tape increased the lift coefficient only slightly to  $C_L=1,440$ . The changes due to the tape are in a logical order, but only marginal and below the measurement accuracy.

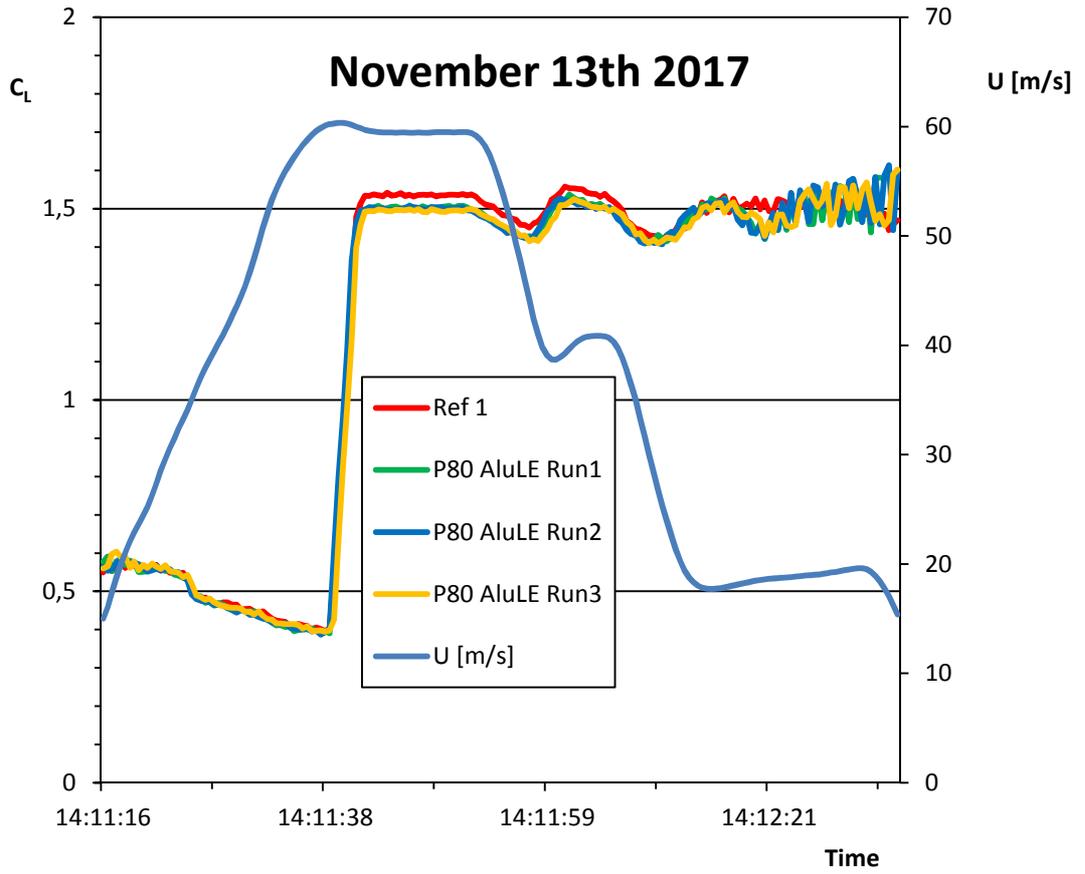
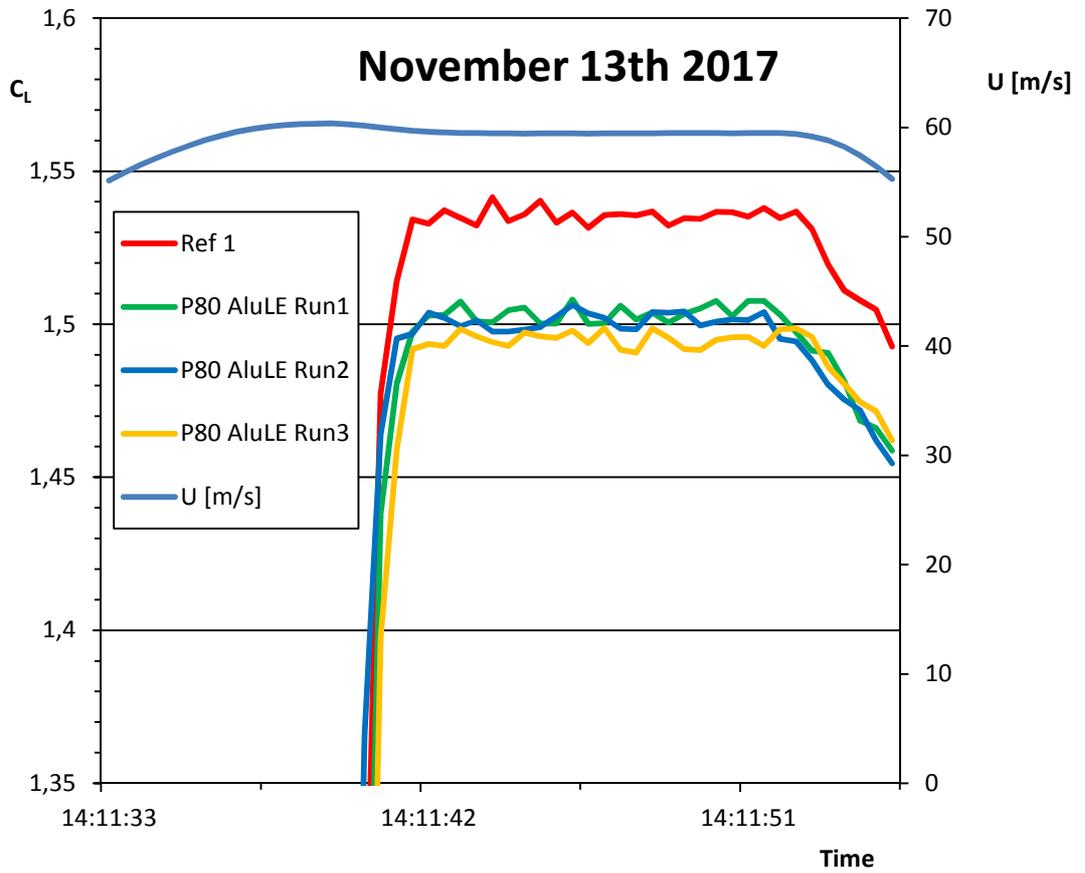
**Figure 39.** Lift coefficient  $C_L$  as function of time during a simulated take-off of P80 sandpaper measurements.

Figure 39 shows three wind tunnel runs with P80 sandpaper and aluminum tape on the sandpaper fore edge. The average lift coefficient for the three runs was  $C_L=1,500$  with a range of lift coefficients of values  $\Delta C_L= 0,0084$  which was within the established measurement accuracy.

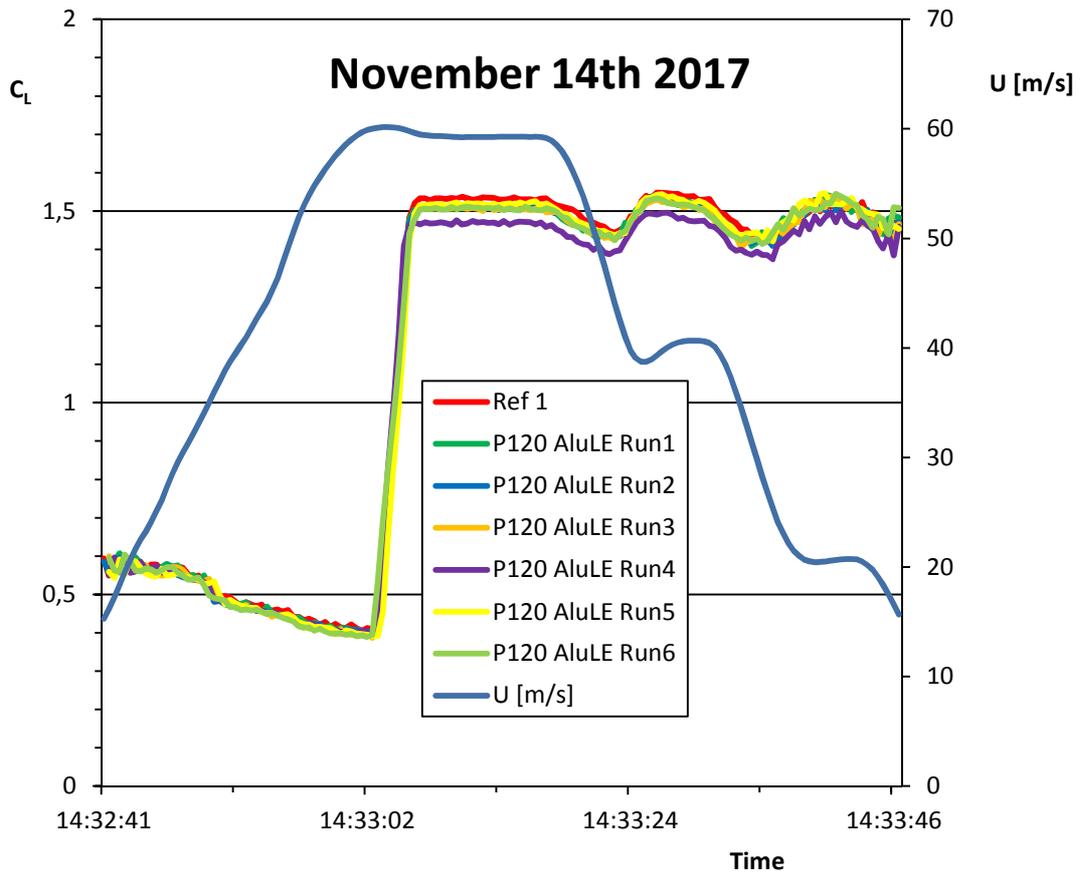
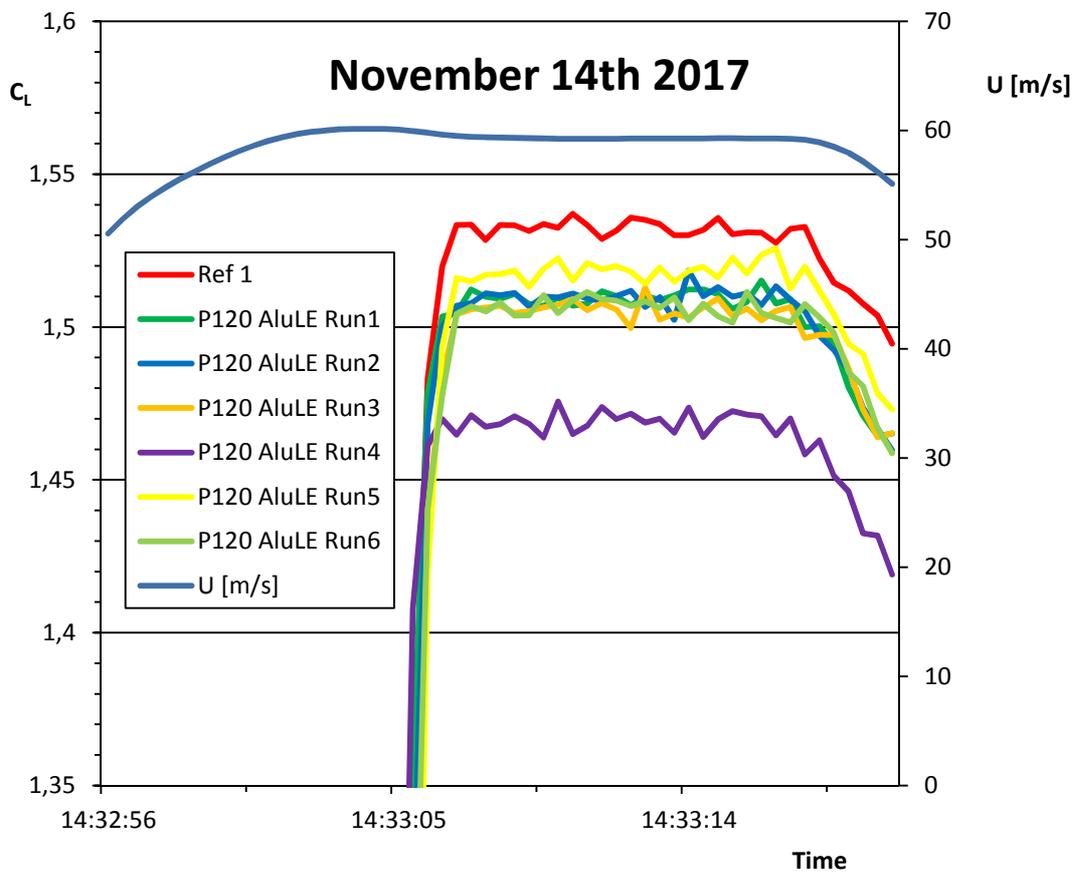
**Figure 40.** Lift coefficient  $C_L$  as function of time during a simulated take-off of P120 sandpaper measurements.

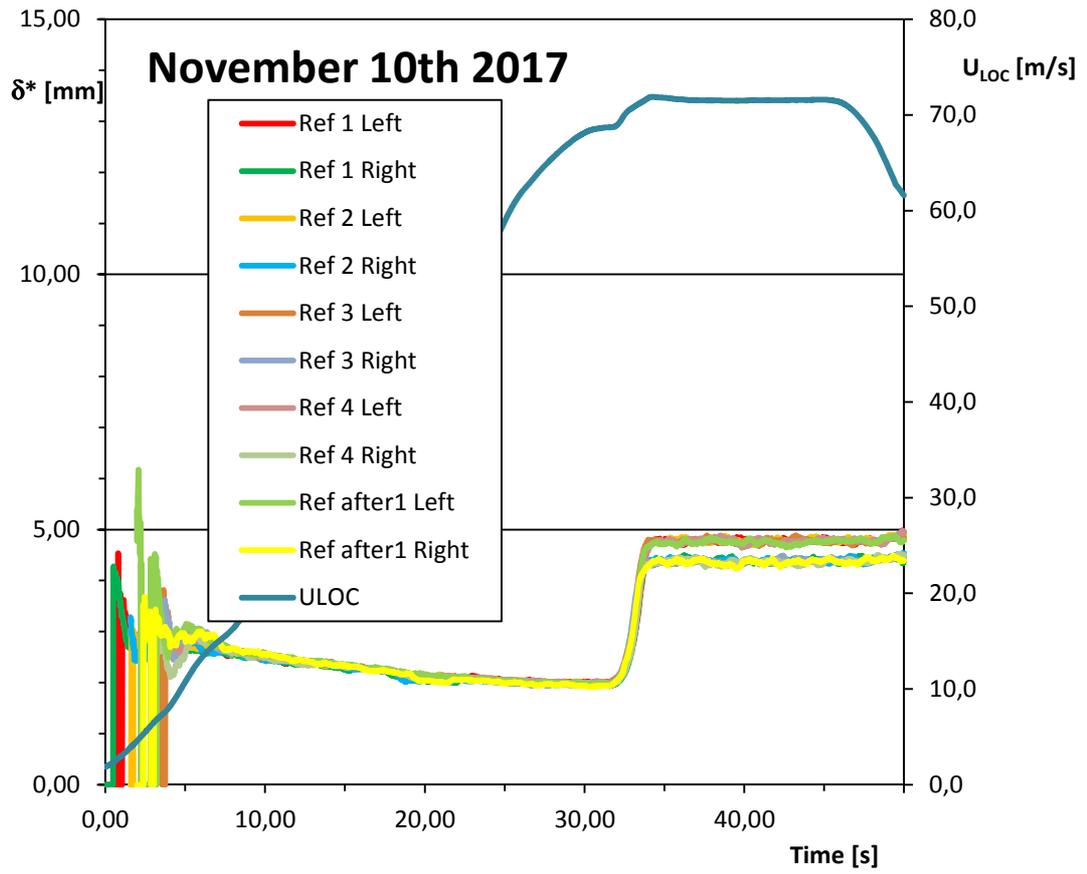
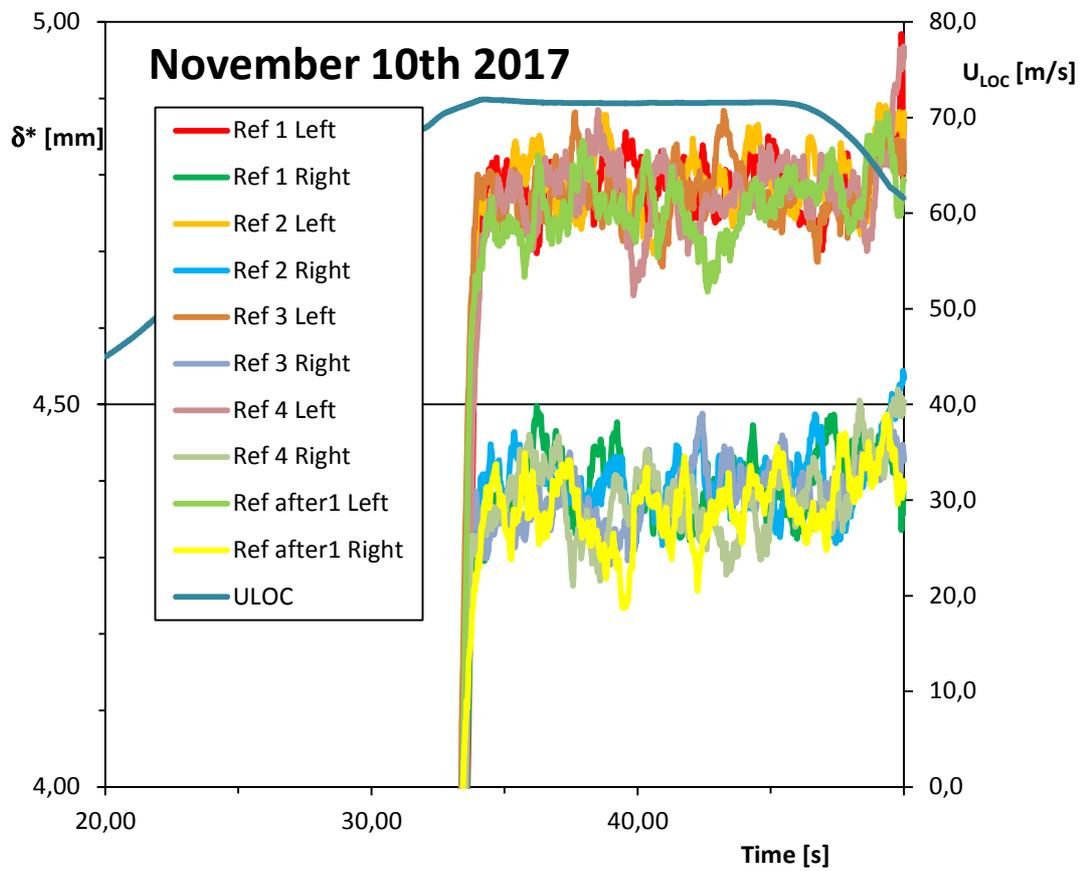
**Figure 43.** Boundary layer displacement thickness  $\delta^*$  as function of time during a simulated take-off on clean wing measurements.

The measured boundary layer displacement thicknesses on clean wing are collected into Figure 43, Figure 44 and Figure 45. The measurements show a small variation at constant angle of attack after the rotation although the results should be the same. This is due to inaccuracies in pressure measurements, angle of attack after rotation and all other sources of possible variations. A small extra inaccuracy was caused by the missing outermost pressure value on the right hand side rake, which had to be taken the same as the corresponding value on the left hand rake. It is evident in the figures that the displacement thickness results of the left and right hand side rakes are grouped at slightly different levels of about 0,4 mm. Obviously the rakes are slightly different or are positioned at slightly different levels from the wing surface or in slightly different directions. Due to the limited number of wind tunnel runs this was not obvious in the previous spring measurements of ref. [2] Soenne et al, in which the rakes were suspected to have moved. Then it looked like only one measured curve of six was affected by rake movement as only one curve was aside from the group of other measurements. Now it seems that the isolated right hand measurement was done with a rake which had not moved during the measurements. The other two right hand side rake results probably contain inaccuracy due to rake movement as the curves were grouped together with the left hand measurements. Besides this the new data does not change anything in the ref. [2] report, but the repeatability seems now to be better on an individual rake.

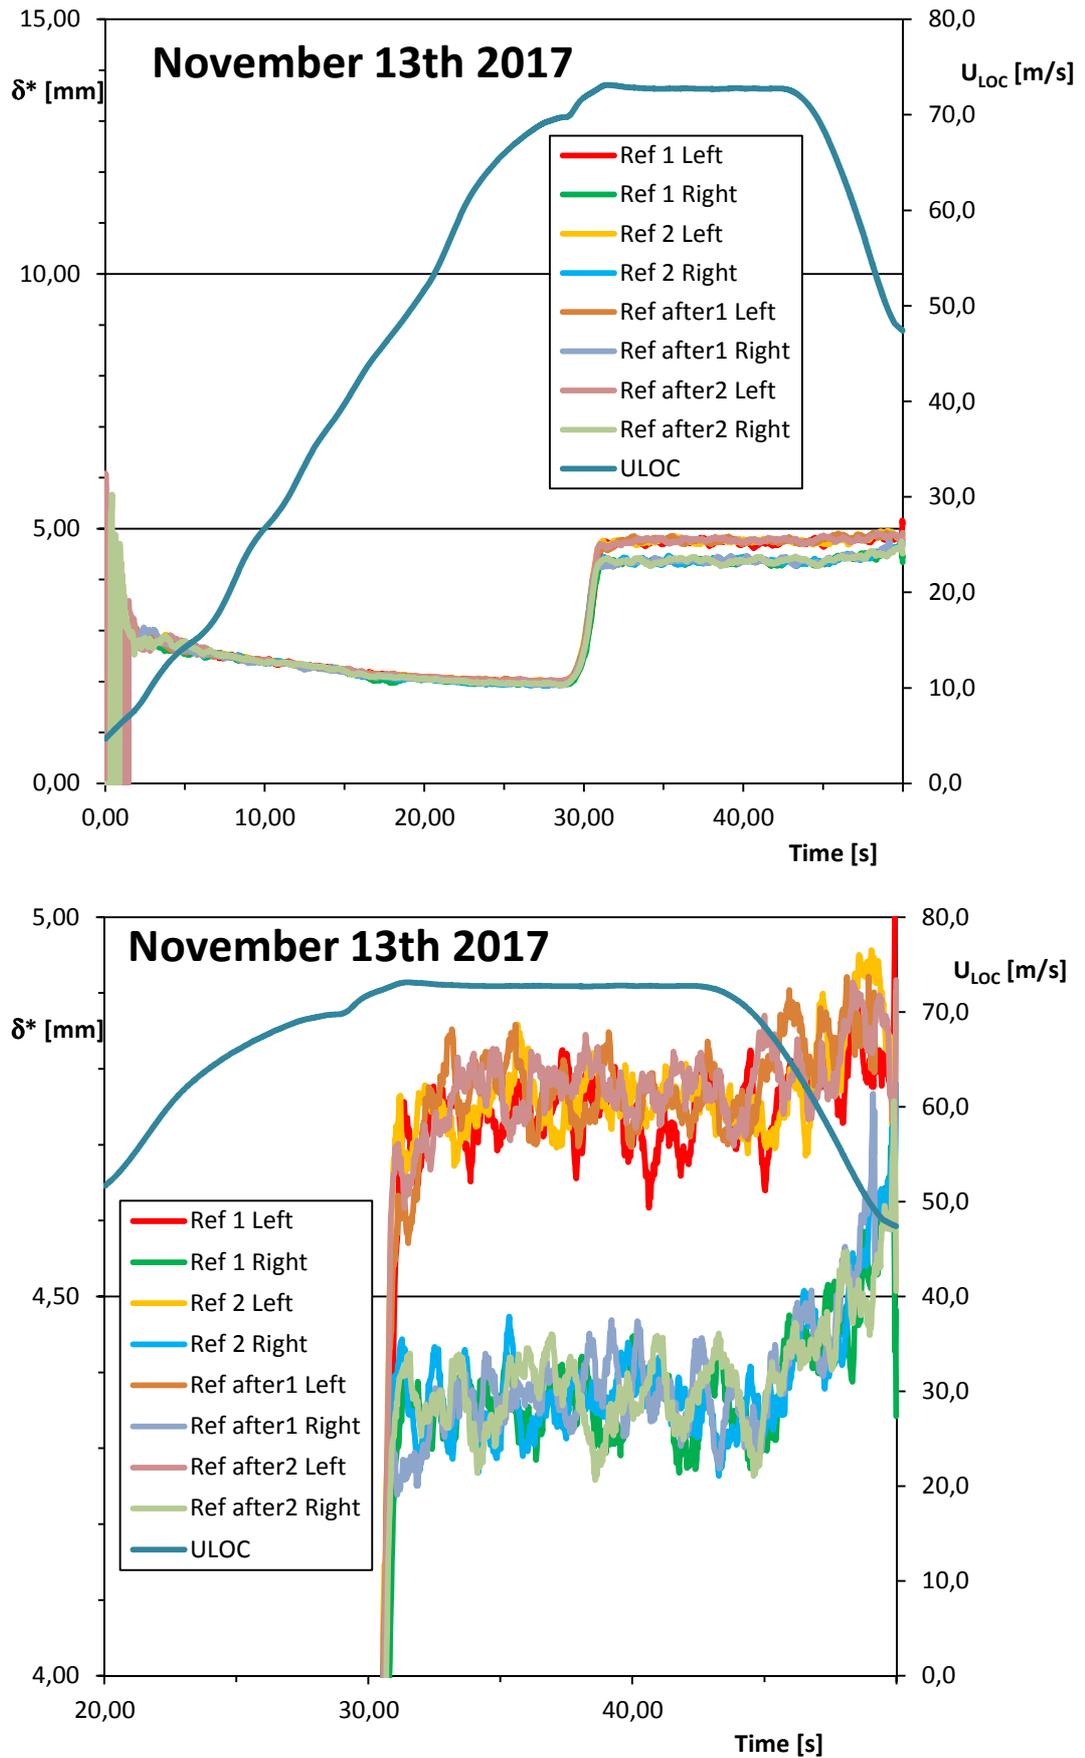
**Figure 44.** Boundary layer displacement thickness  $\delta^*$  as function of time during a simulated take-off on clean wing measurements.

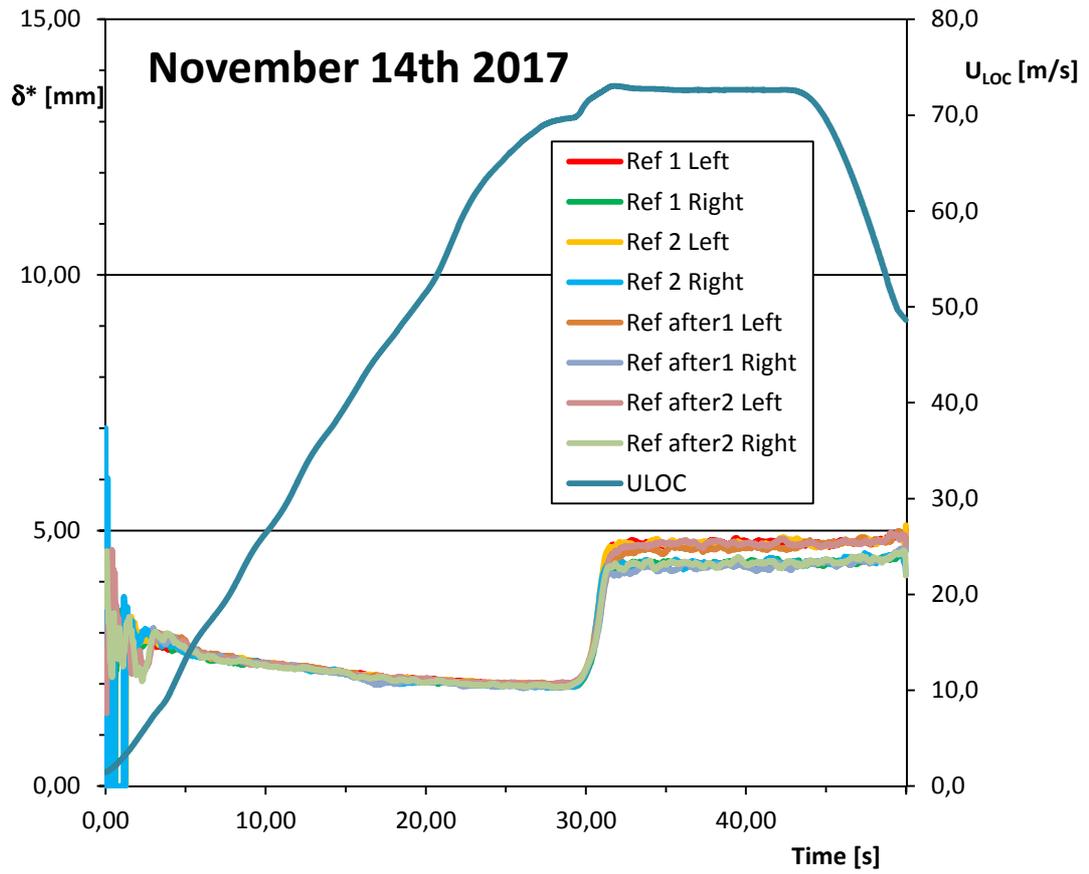
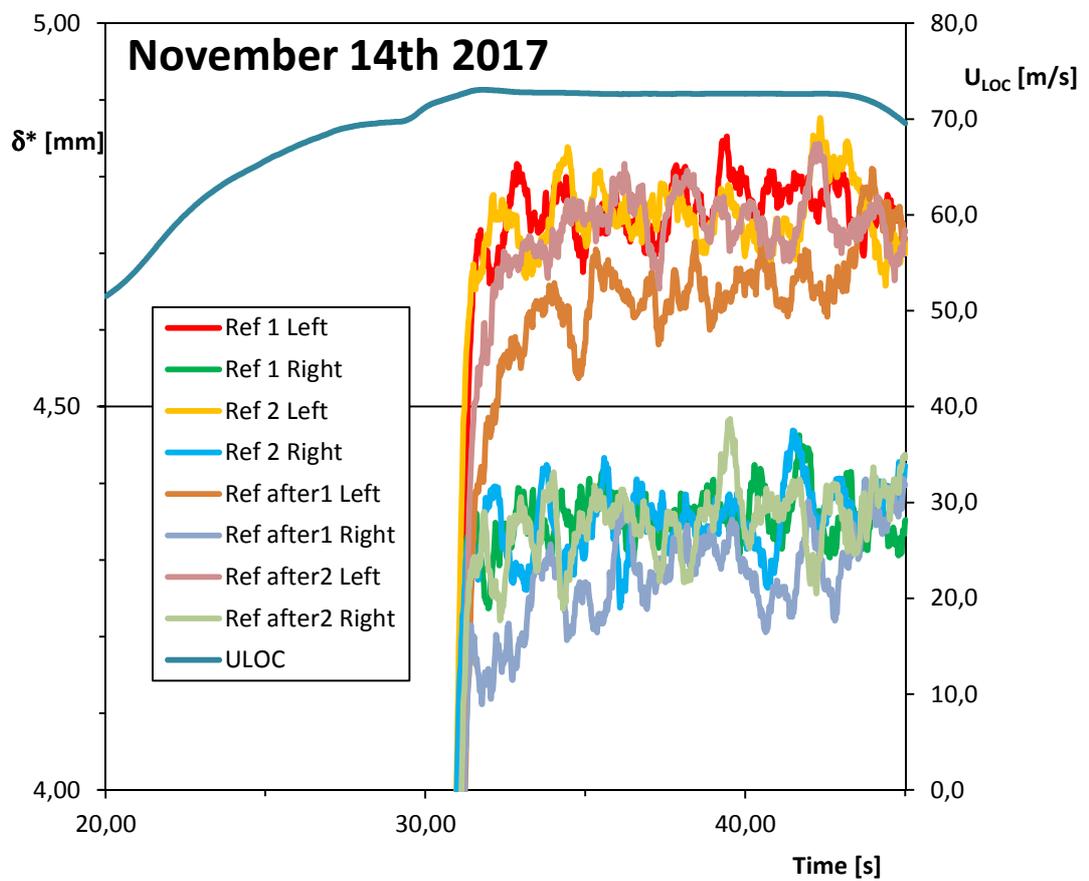
**Figure 45.** Boundary layer displacement thickness  $\delta^*$  as function of time during a simulated take-off on clean wing measurements.

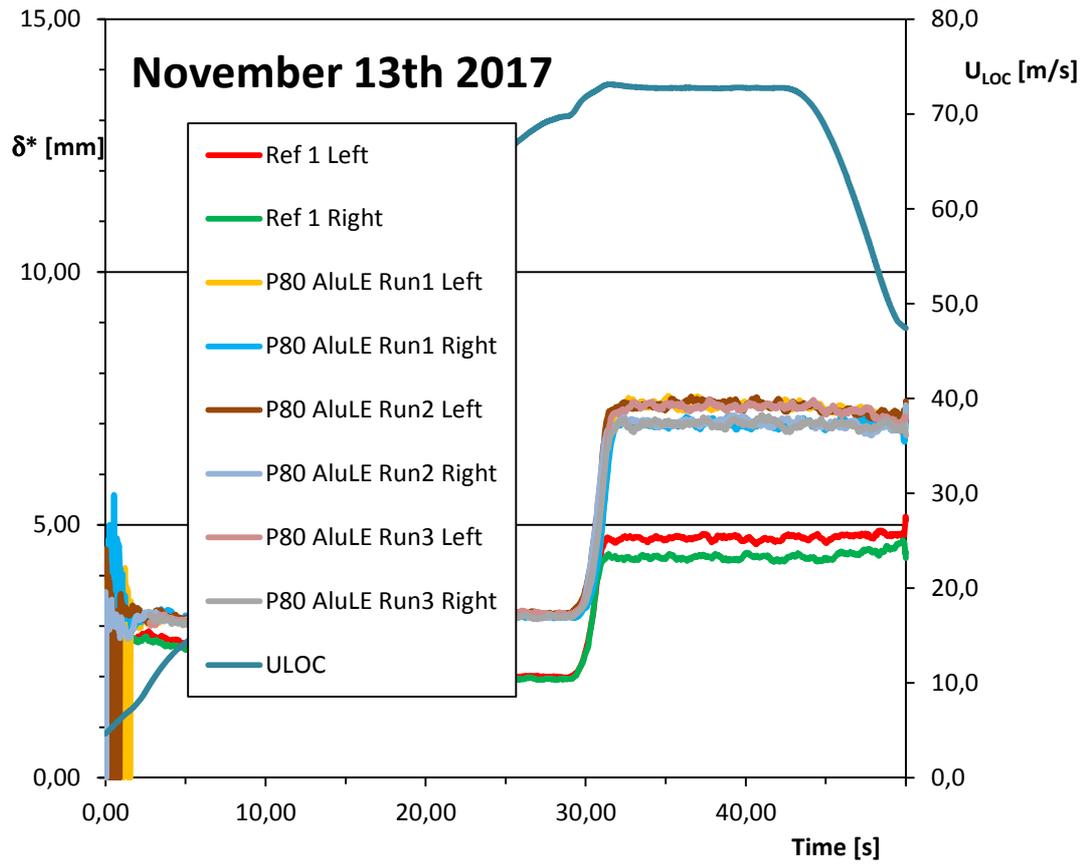
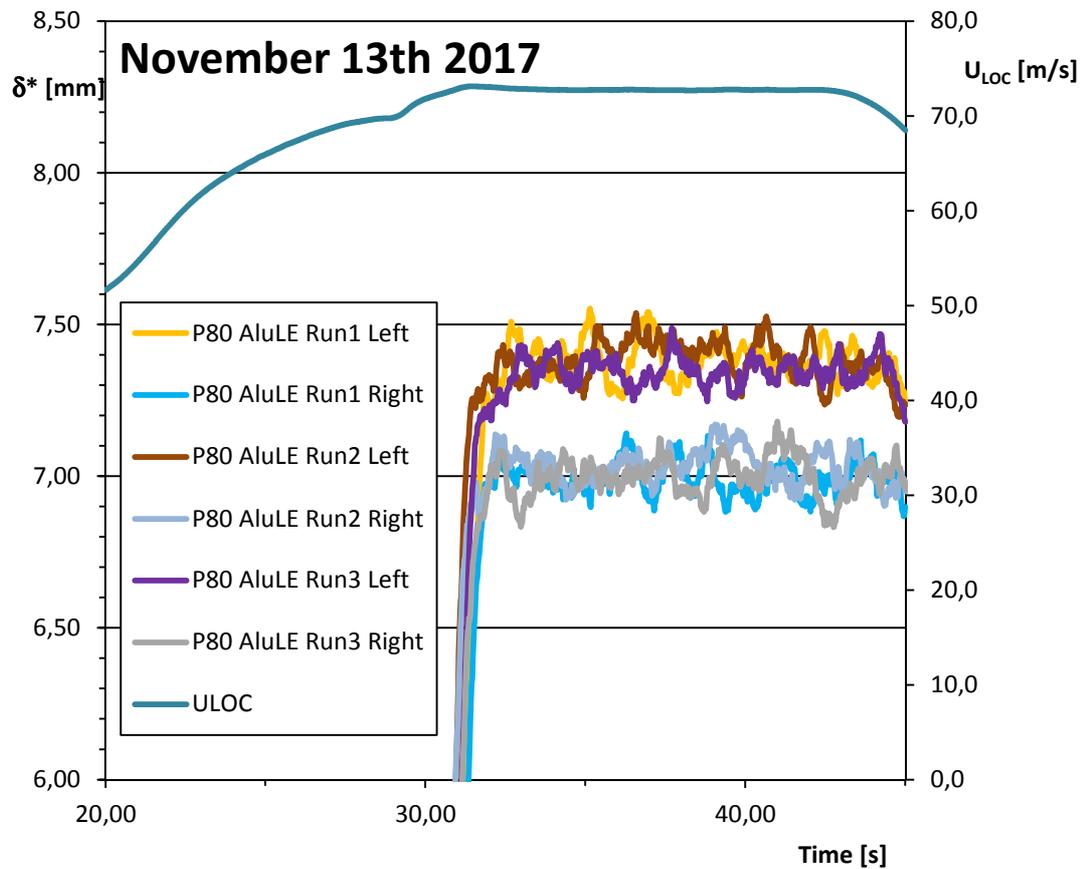
**Figure 47.** Boundary layer displacement thickness  $\delta^*$  as function of time during a simulated take-off with P80 sandpaper on the wing model.

Time histories of the boundary layer displacement thickness with sandpaper are presented in Figure 46 to Figure 48. The average 250 point displacement thickness values, corresponding to a time period of 5 seconds, were calculated for the flow conditions after the model rotation. Boundary layer velocity profiles for the different sandpapers at a selected time instant after the model rotation are presented in Figure 49 to give some feel for the precision needed in the measurements. One can see that the straight line profiles are somewhat angular polygons due to limiting the number of pressure tubes to eight. The definition of the displacement thickness is

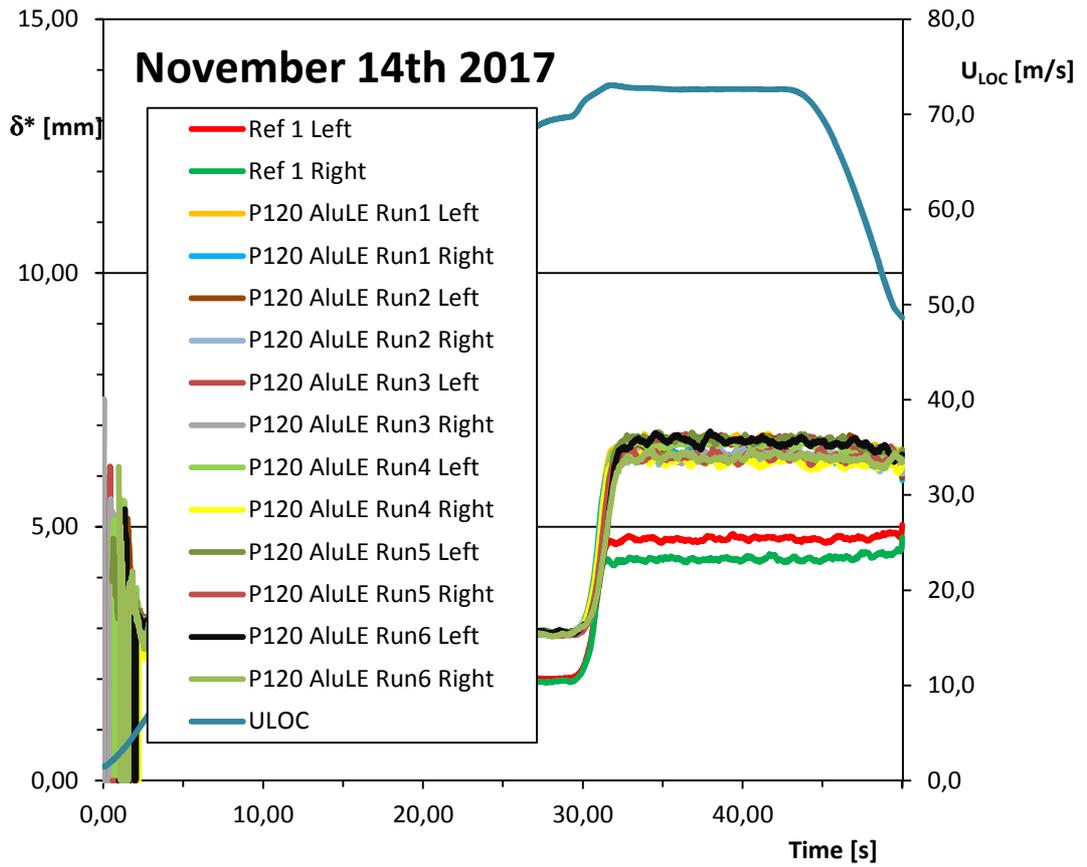
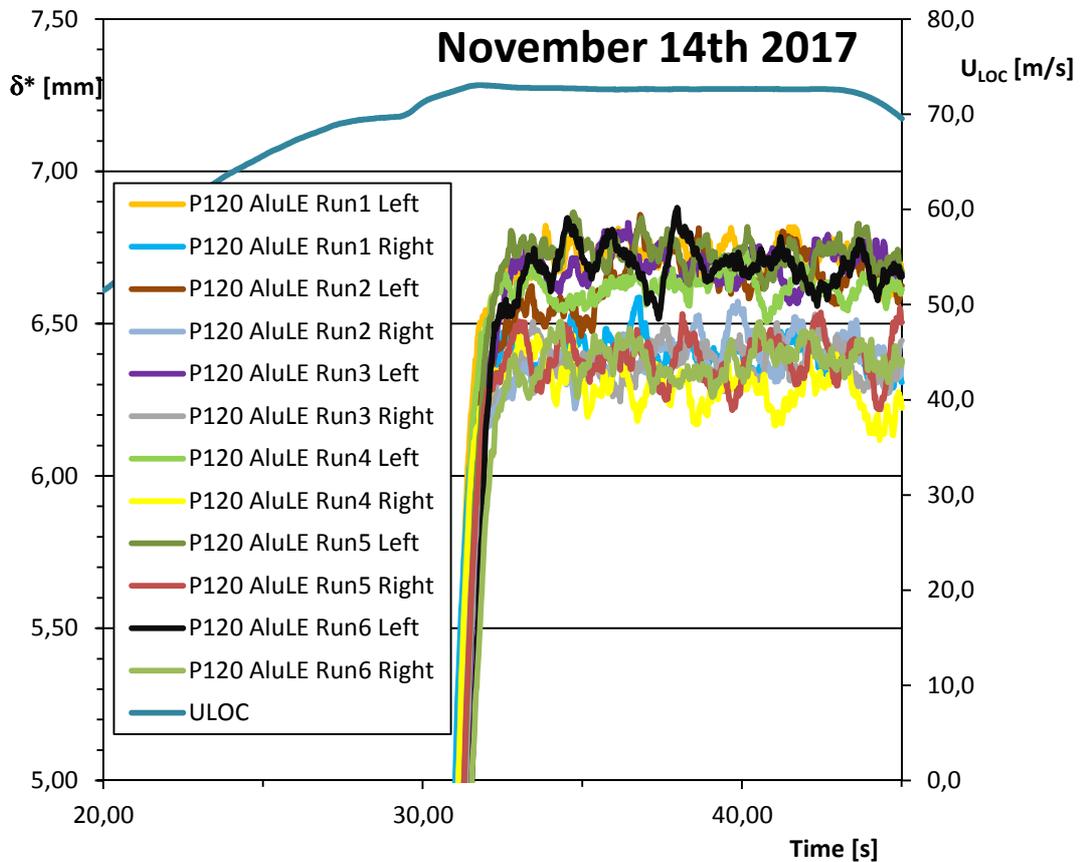
**Figure 48.** Boundary layer displacement thickness  $\delta^*$  as function of time during a simulated take-off with P120 sandpaper on the wing model.

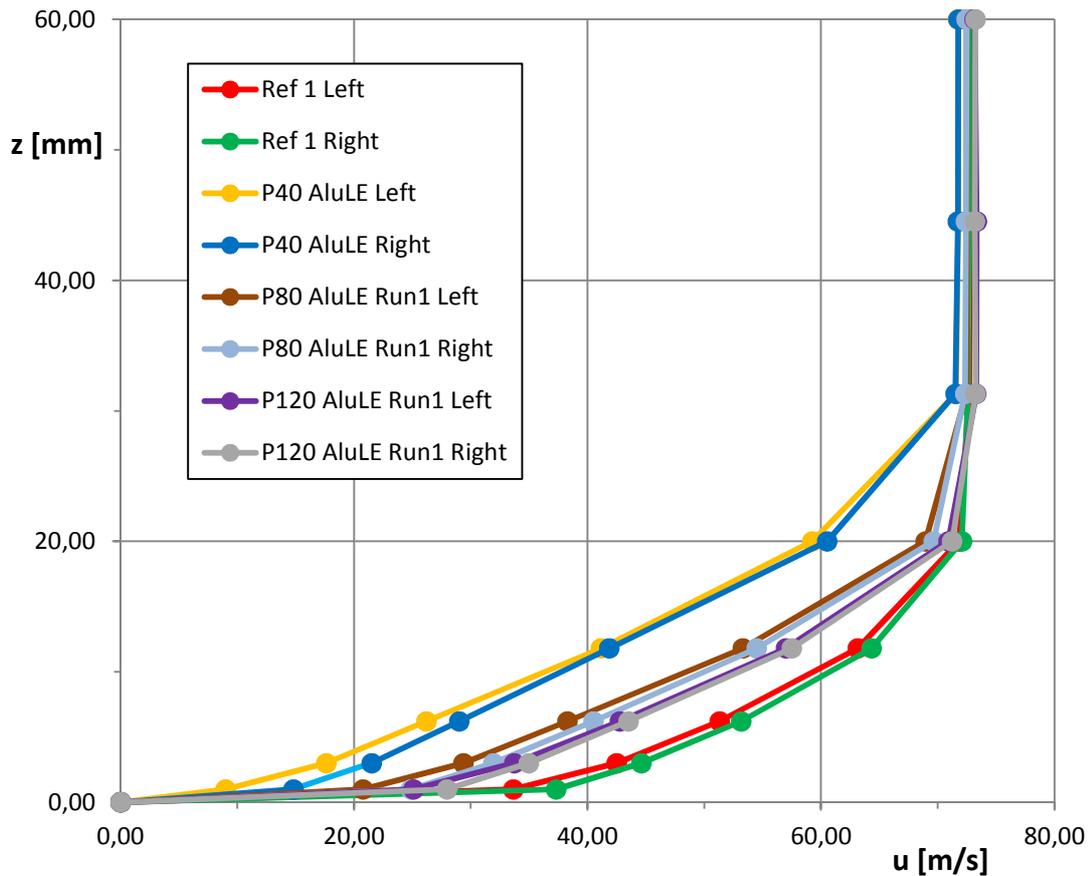
**Figure 49.** Boundary layer velocity profiles after wing model rotation.

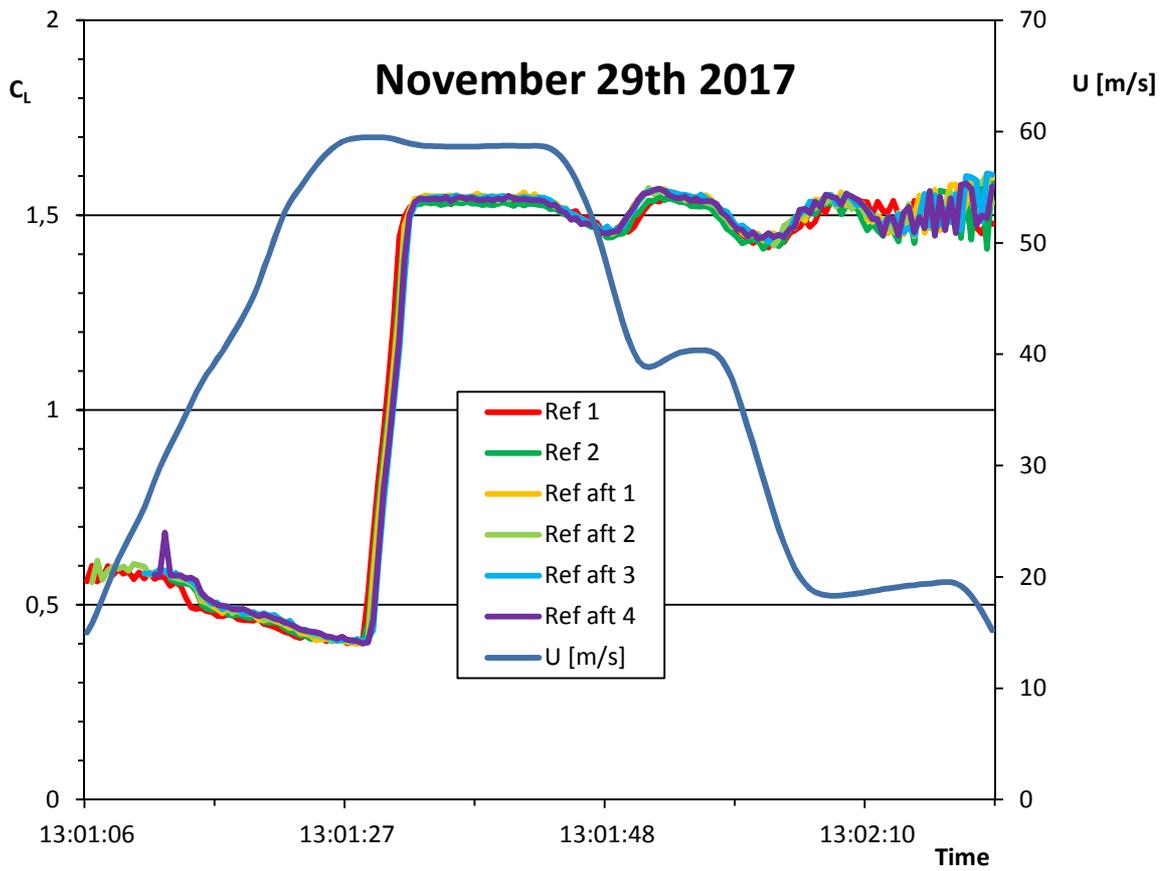
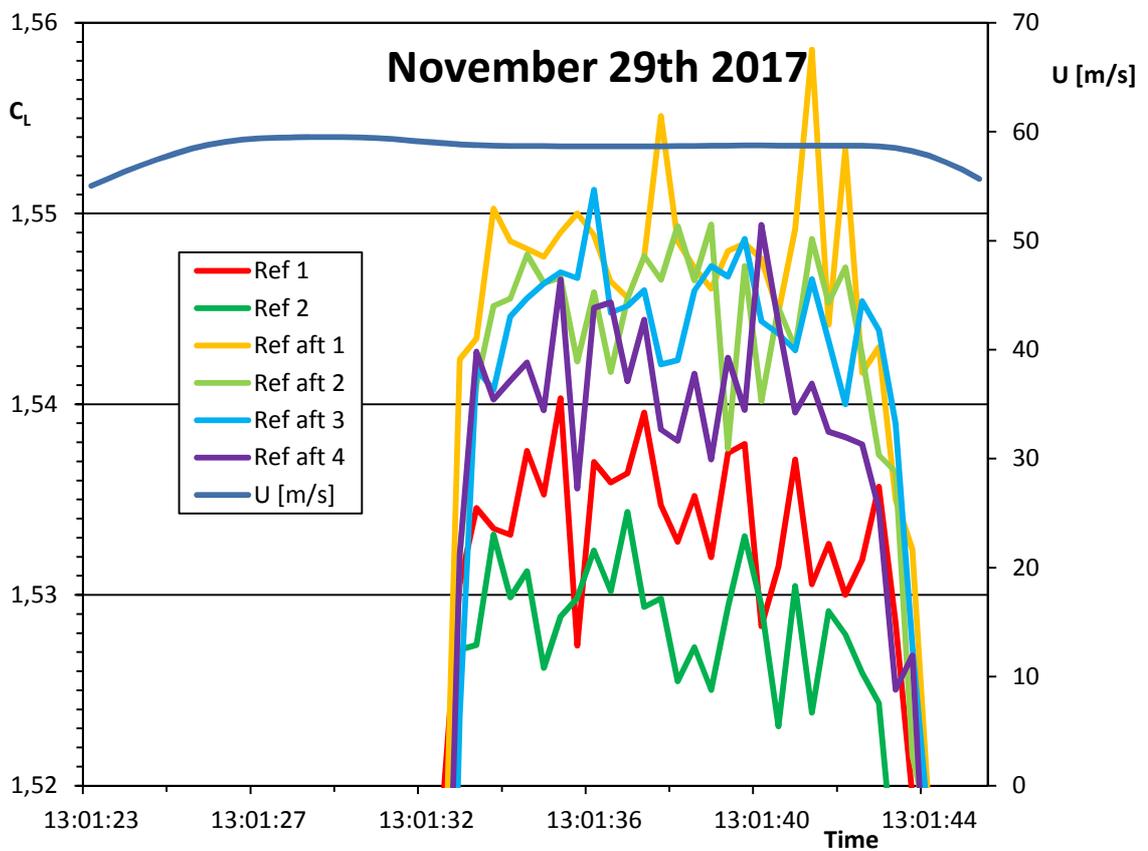
**Figure 52.** Lift coefficient  $C_L$  as function of time during a simulated take-off on a clean wing.
