# Oil-Flow and Distributed Roughness Experiments on CRM Wing Model

Erkki Soinne, Trafi

Title of publication <b>Oil-Flow and Distributed Roughness Experiments on CRM Wing Model</b>	
Author(s) Erkki Soinne	
Commissioned by, date Kari Wihlman, October 8th 2017	
Publication series and number <b>Trafı Research Reports 3/2018</b>	ISSN (online) 2342-0294 ISBN (online) ISBN 978-952-311-247-6 URN <a href="http://urn.fi/URN:ISBN:978-952-311-247-6">http://urn.fi/URN:ISBN:978-952-311-247-6</a>
Keywords aircraft, aerodynamics, anti-icing fluids	
Contact person Erkki Soinne	Language of the report English
Abstract This research report summarizes the oil-flow, sandpaper, anti-icing fluid and PVC plastic sheet wind tunnel experiments on the Common Research Model (CRM). The aerodynamic measurements were made with a force balance on lift and two wake rakes on the upper surface boundary layer displacement thickness aft of the model main wing. The oil-flow measurements investigated the qualitative flow characteristics.

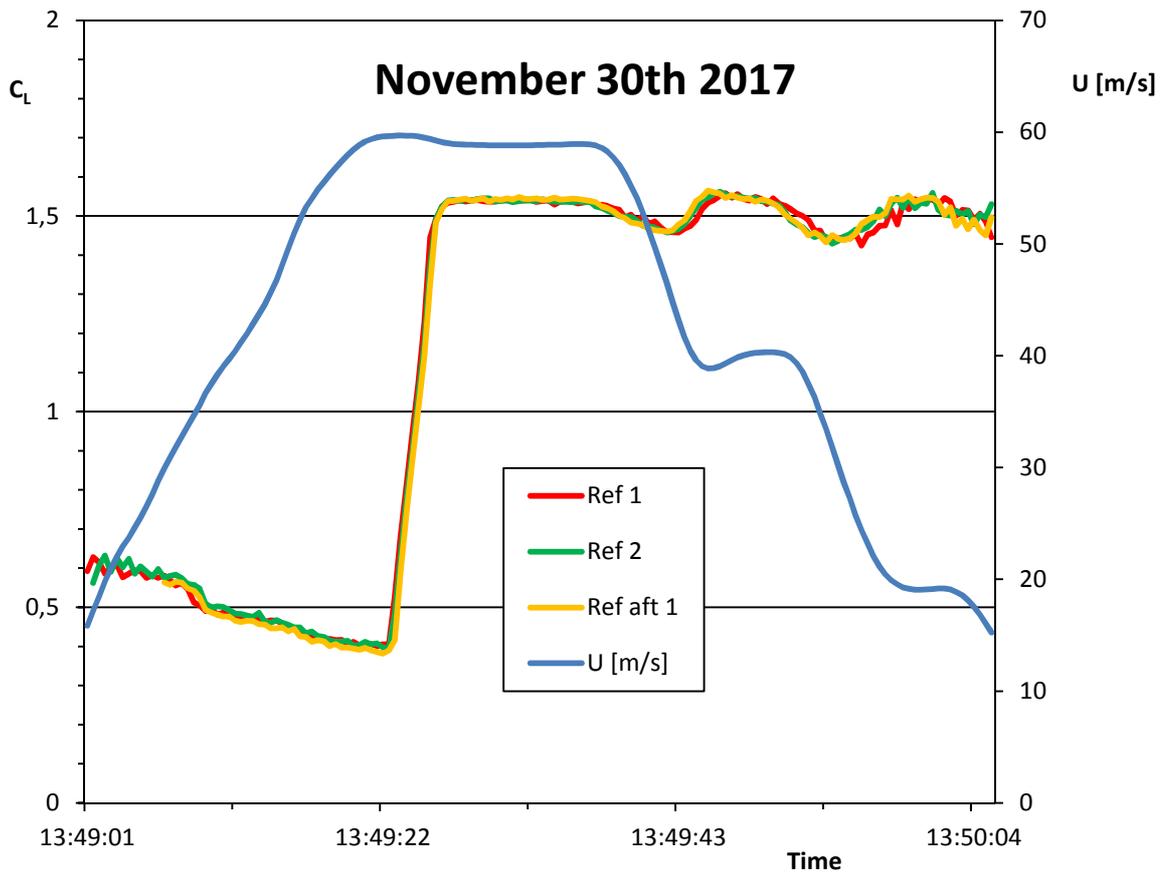
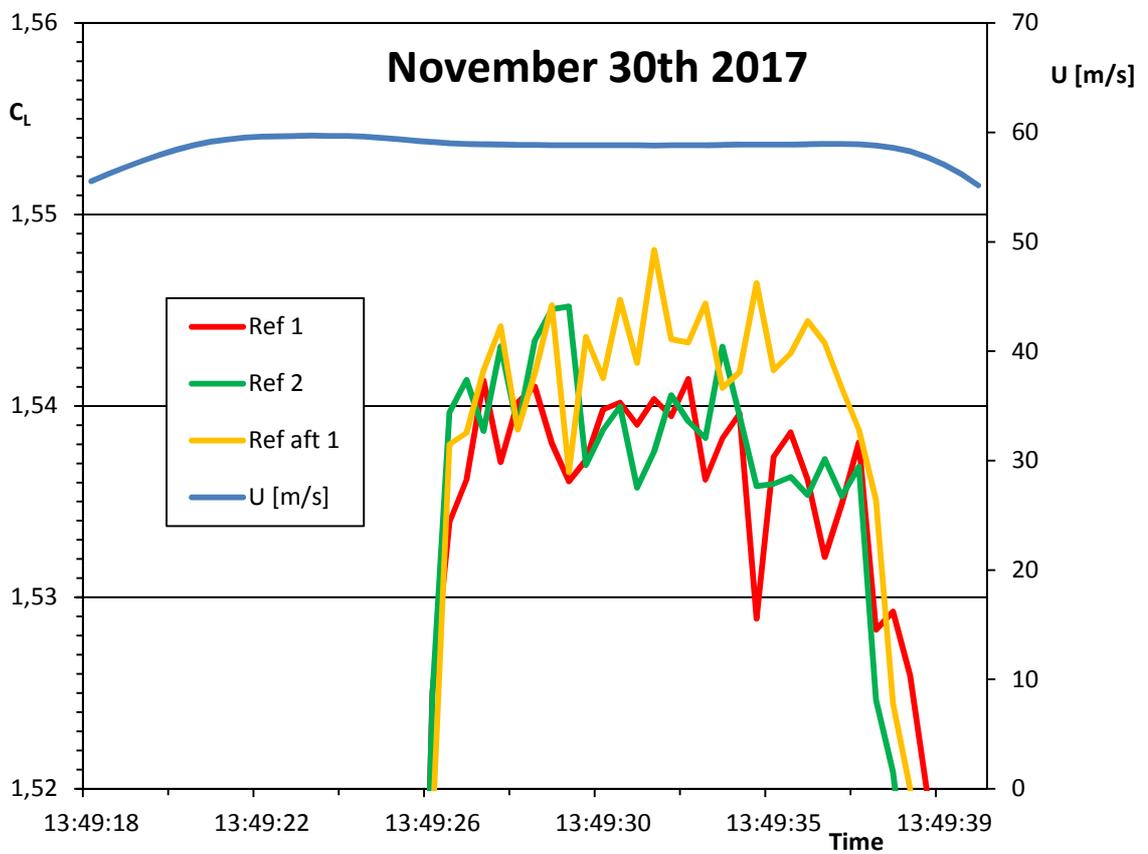
**Figure 53.** Lift coefficient  $C_L$  as function of time during a simulated take-off on a clean wing.

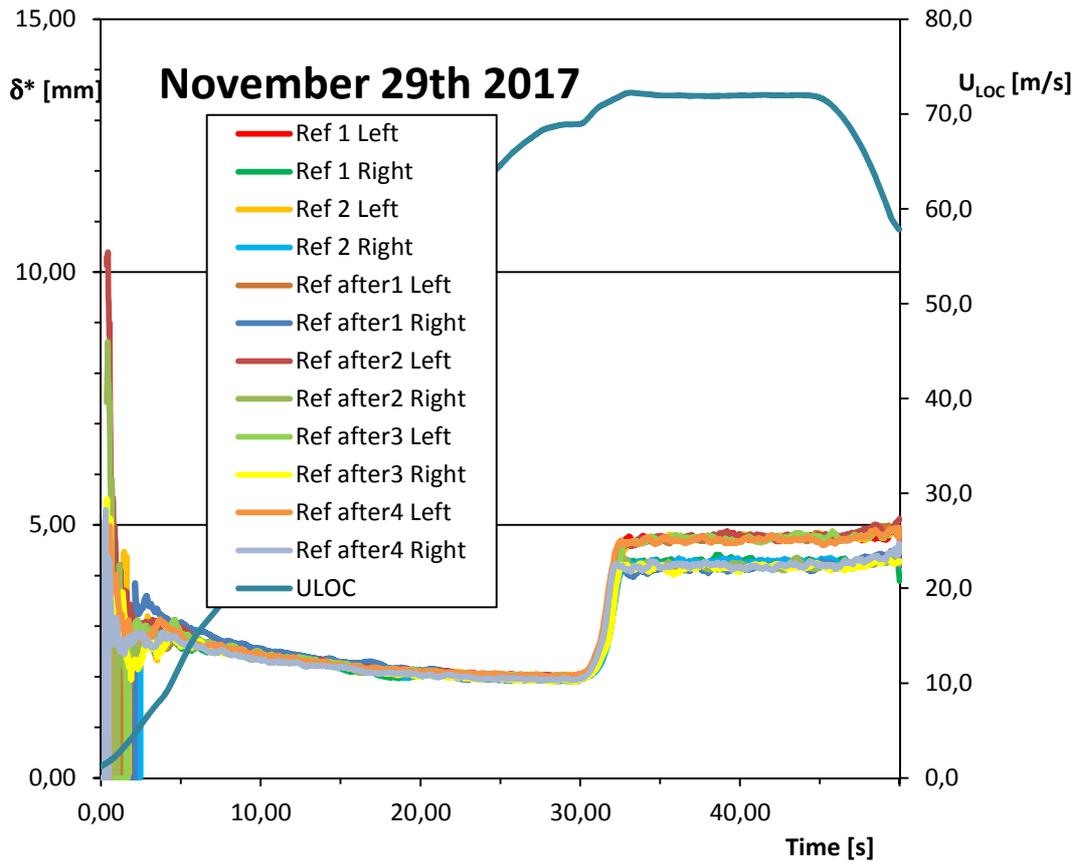
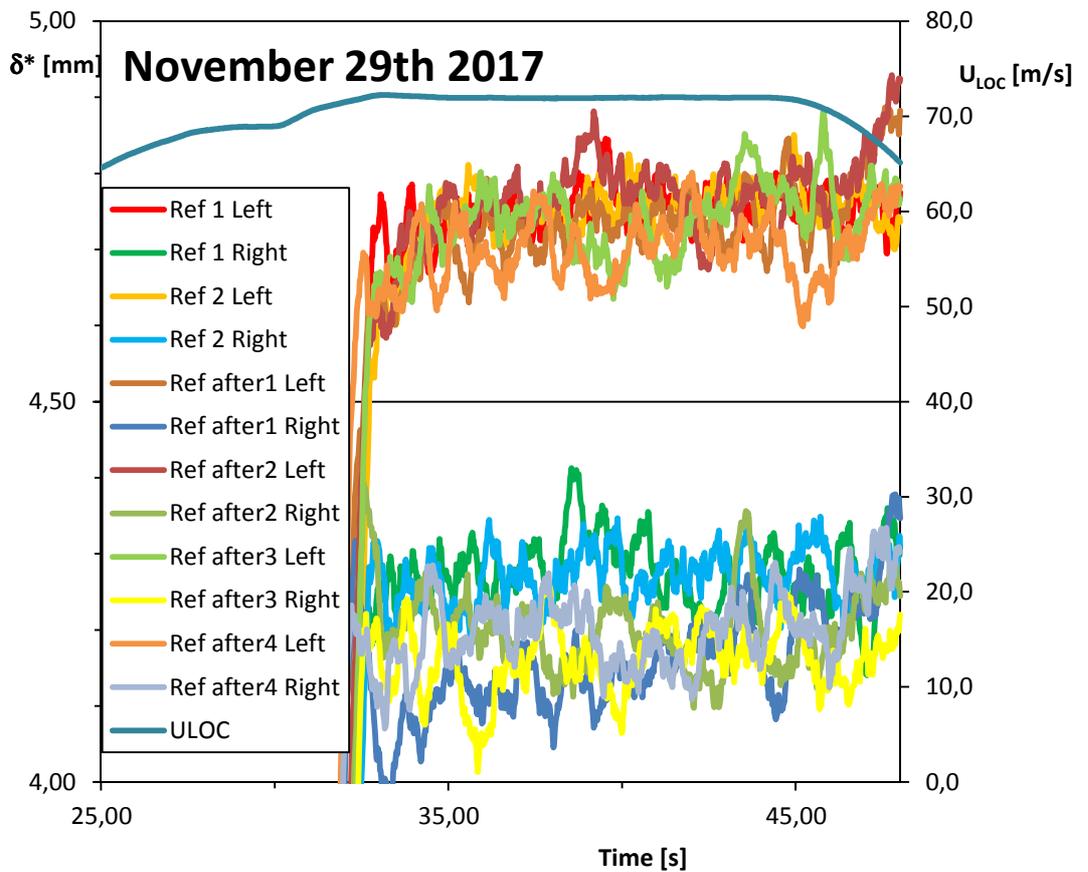
**Figure 56.** Boundary layer displacement thickness  $\delta^*$  as function of time during a simulated take-off on clean wing measurements.

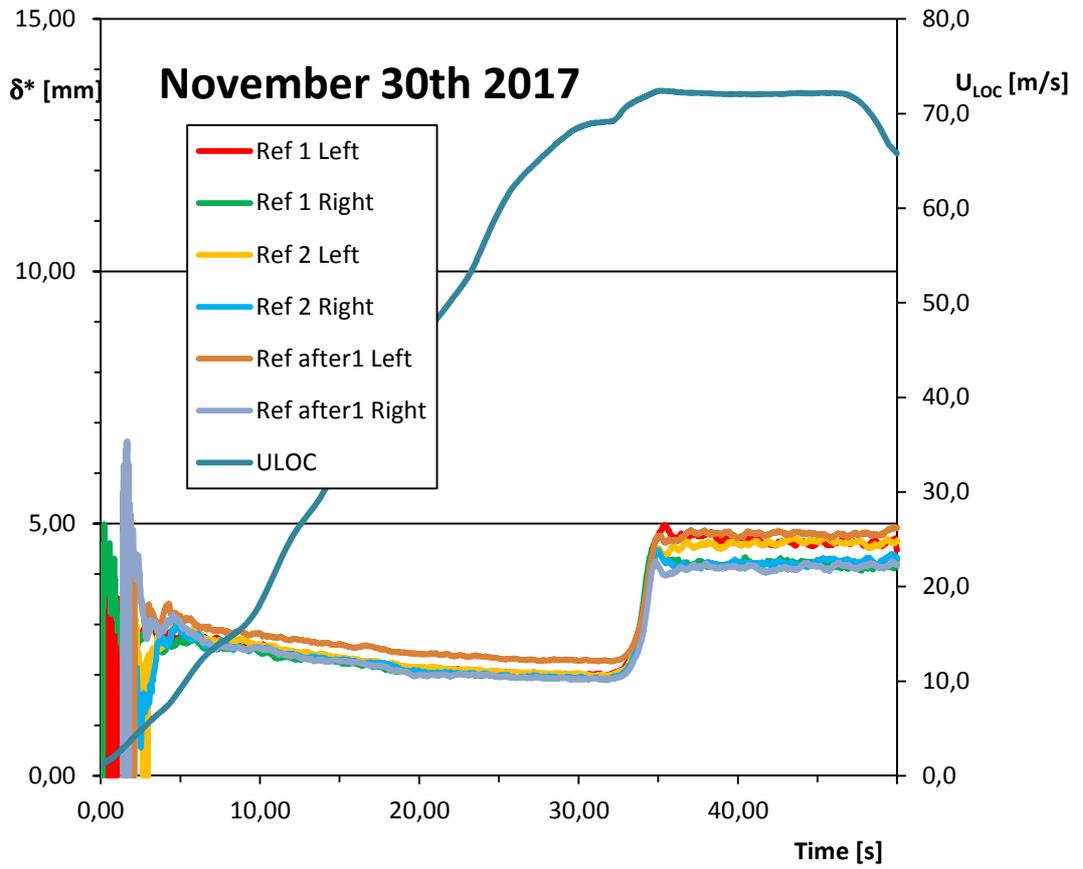
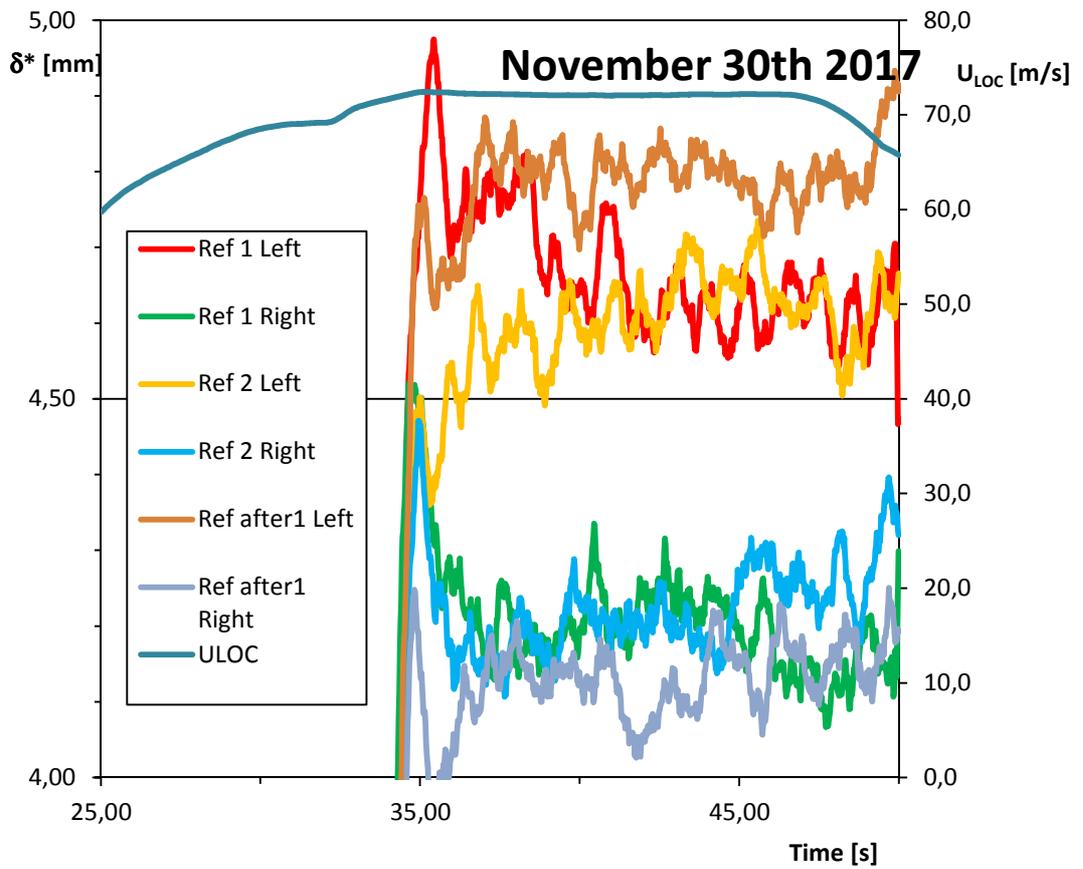
**Figure 57.** Boundary layer displacement thickness  $\delta^*$  as function of time during a simulated take-off on clean wing measurements.

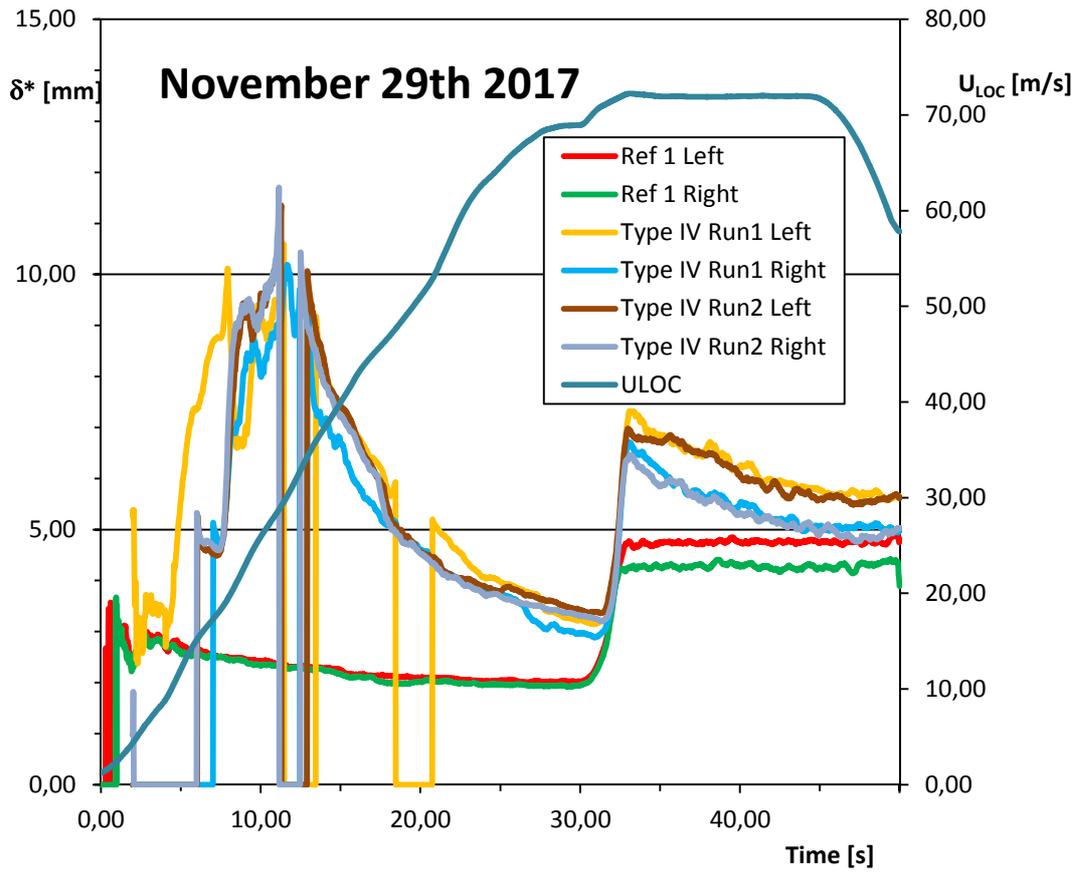
**Figure 58.** Boundary layer displacement thickness  $\delta^*$  as function of time during a simulated take-off with Type IV fluid on the wing.

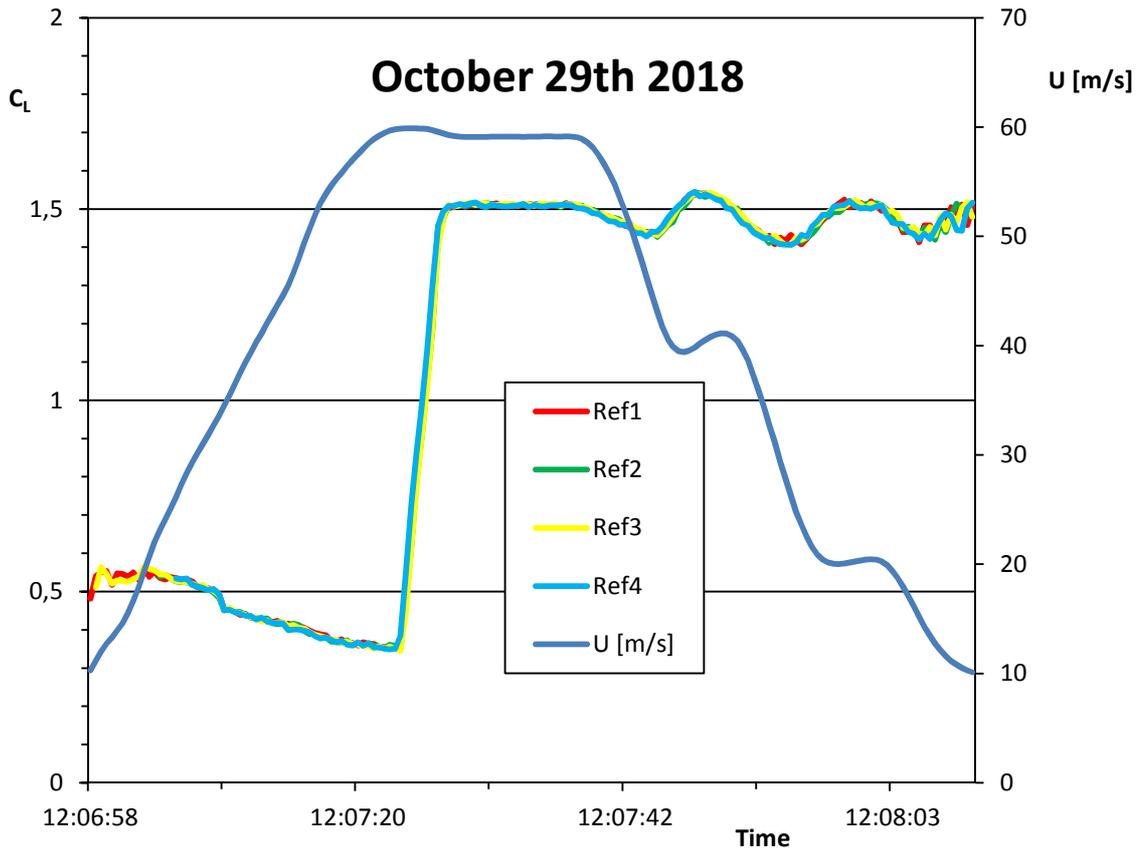
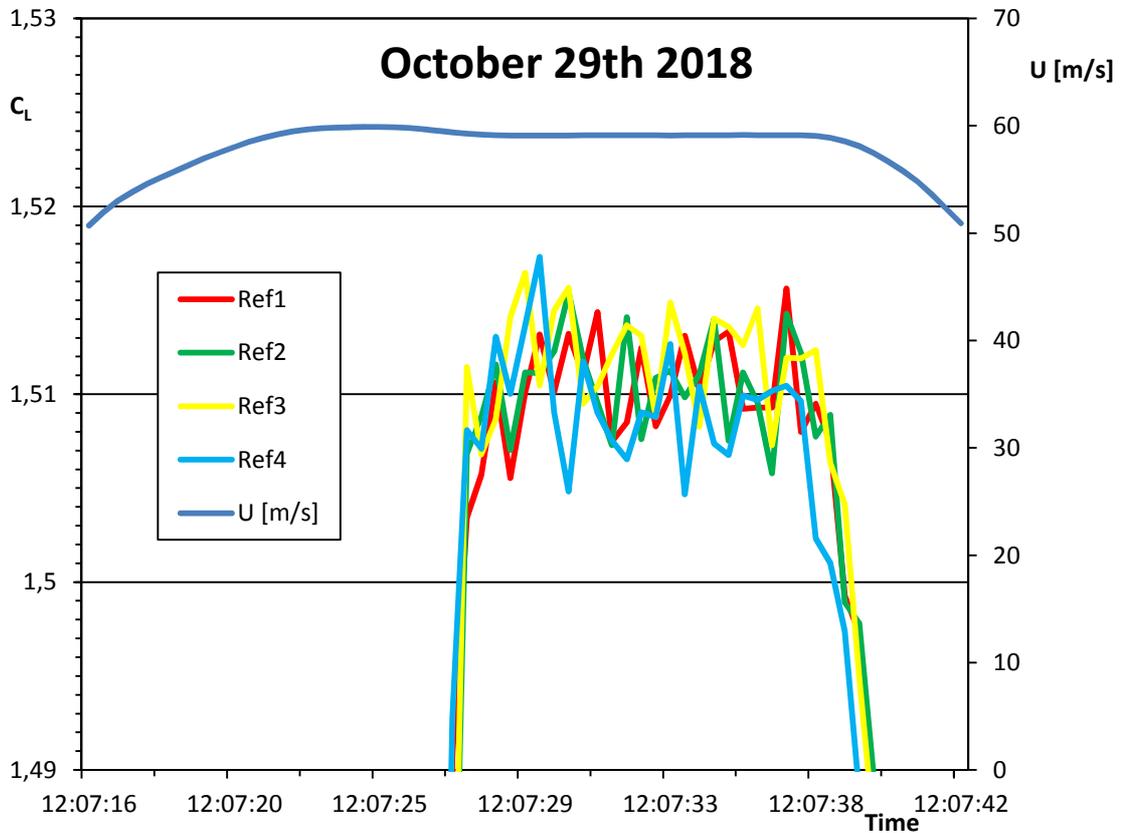
**Figure 64.** Lift coefficient  $C_L$  as function of time during a simulated take-off on a clean wing during the measurements on October 29<sup>th</sup>.

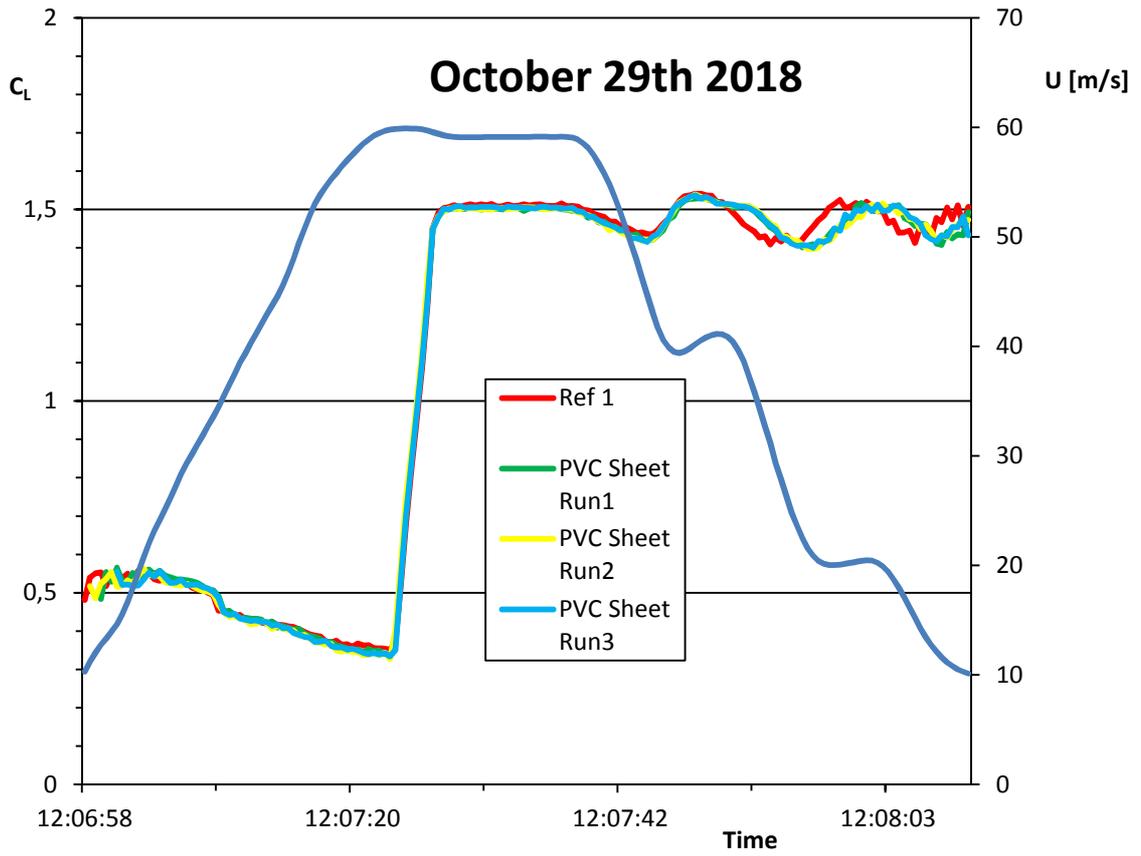
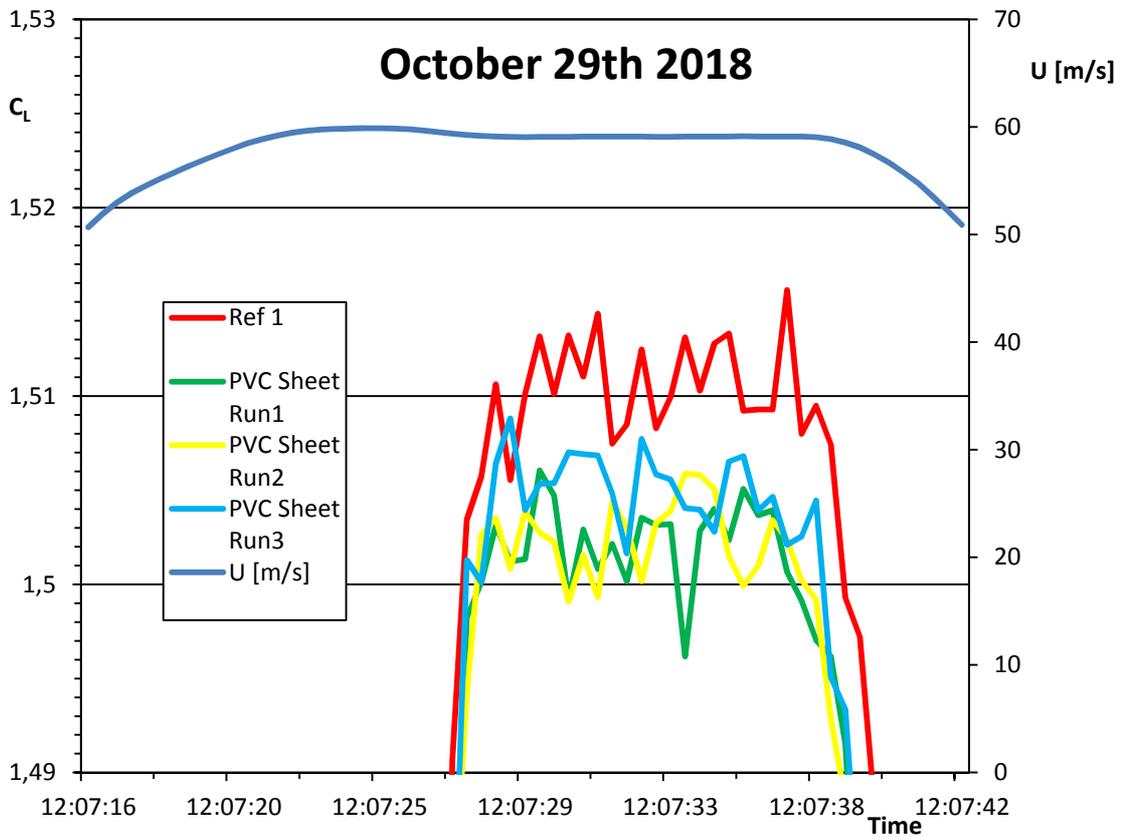
**Figure 65.** Lift coefficient  $C_L$  as function of time during a simulated take-off of PVC plastic sheet measurements.

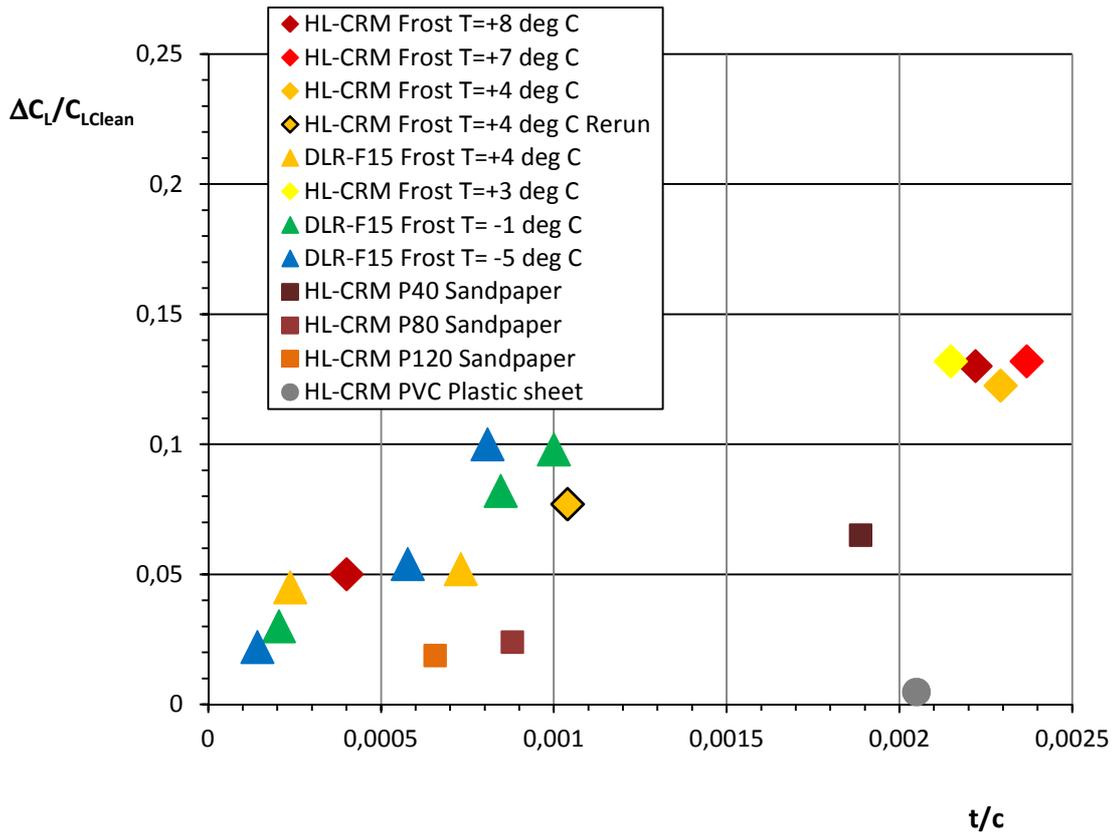
**Figure 66.** Relative Lift coefficient reduction as function of surface roughness added dimensionless thickness (data also from ref. [1], [2] and [16]).

The PVC plastic sheet effect on lift reduction is presented in Figure 66 and Figure 67 together with previous measurements on Cold Soaked Fuel Frost, sandpaper and anti-icing fluids results. There was no noticeable evaporation/melting of the frost before rotation in the tested temperatures. The first figure shows that the PVC sheet value sticks out of the group of other measured values when presented as function of dimensionless thickness. In the second figure the PVC sheet value fits fairly well the linear trend of growing lift loss, when presented as function of dimensionless roughness height. It seems that for a PVC sheet the effect of thickness increase is not significant, but the lift reduction is due to the fore edge step and its detrimental effect on the boundary layer.

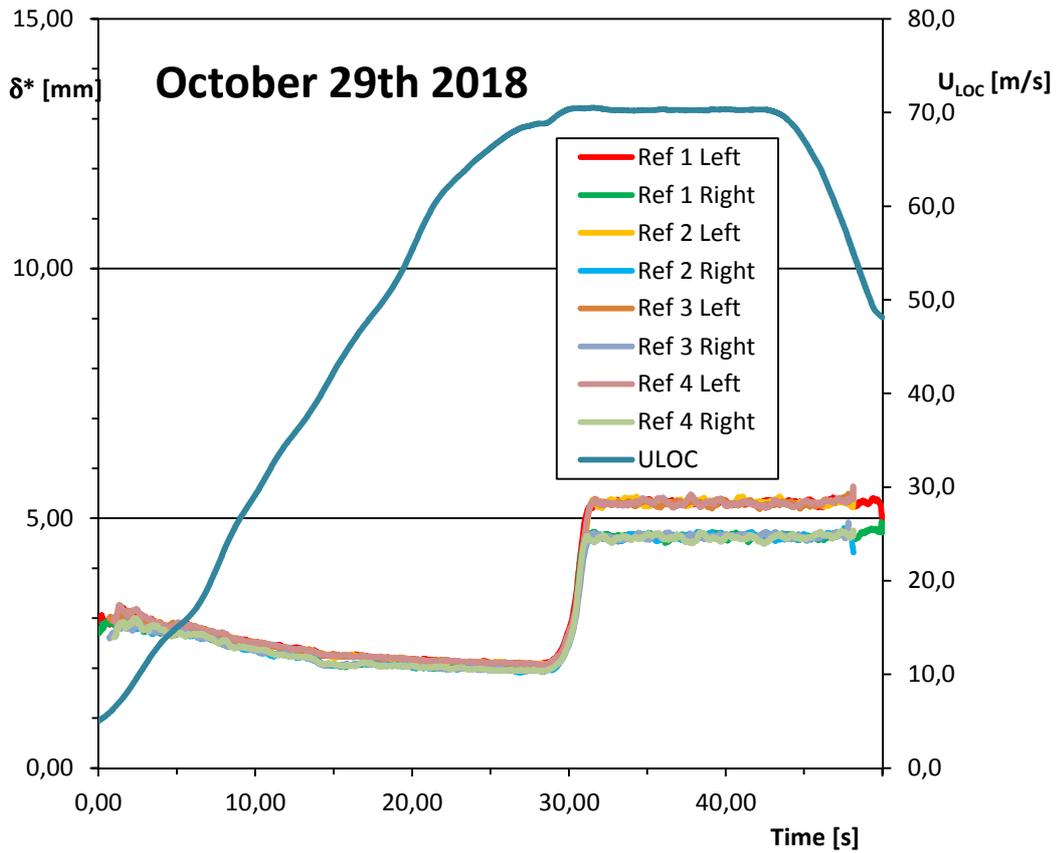
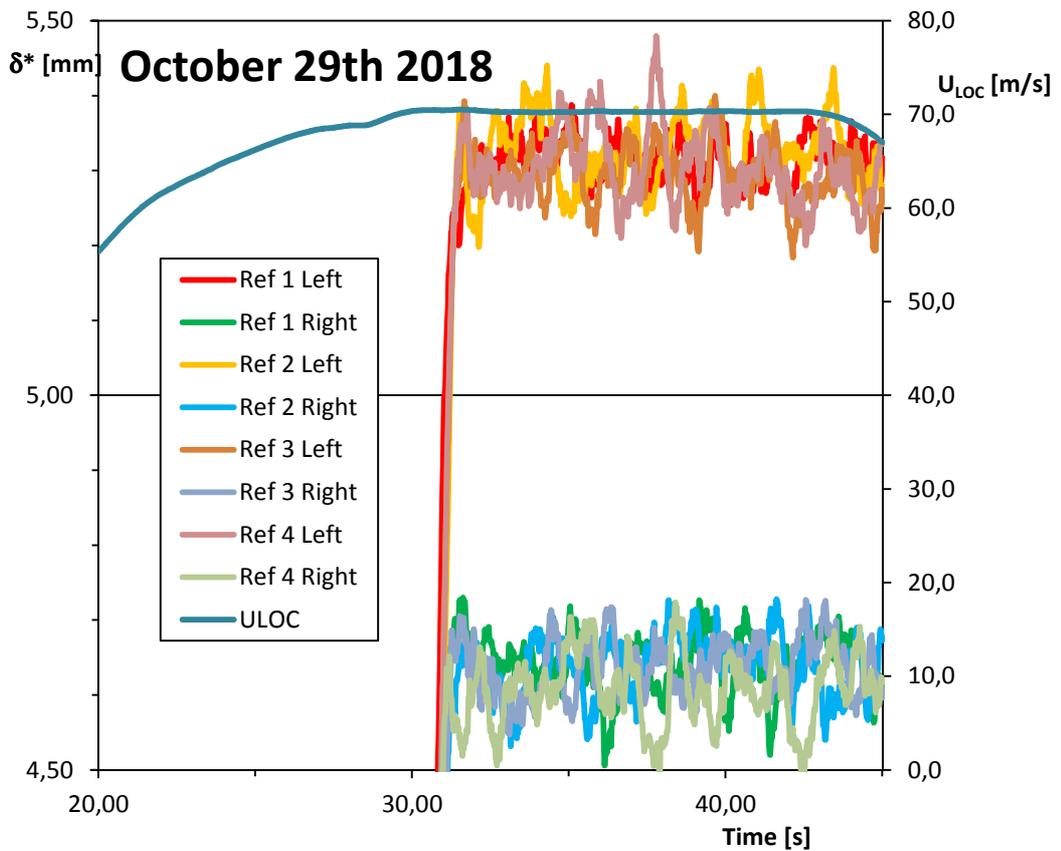
**Figure 68.** Boundary layer displacement thickness  $\delta^*$  as function of time during a simulated take-off on clean wing measurements.

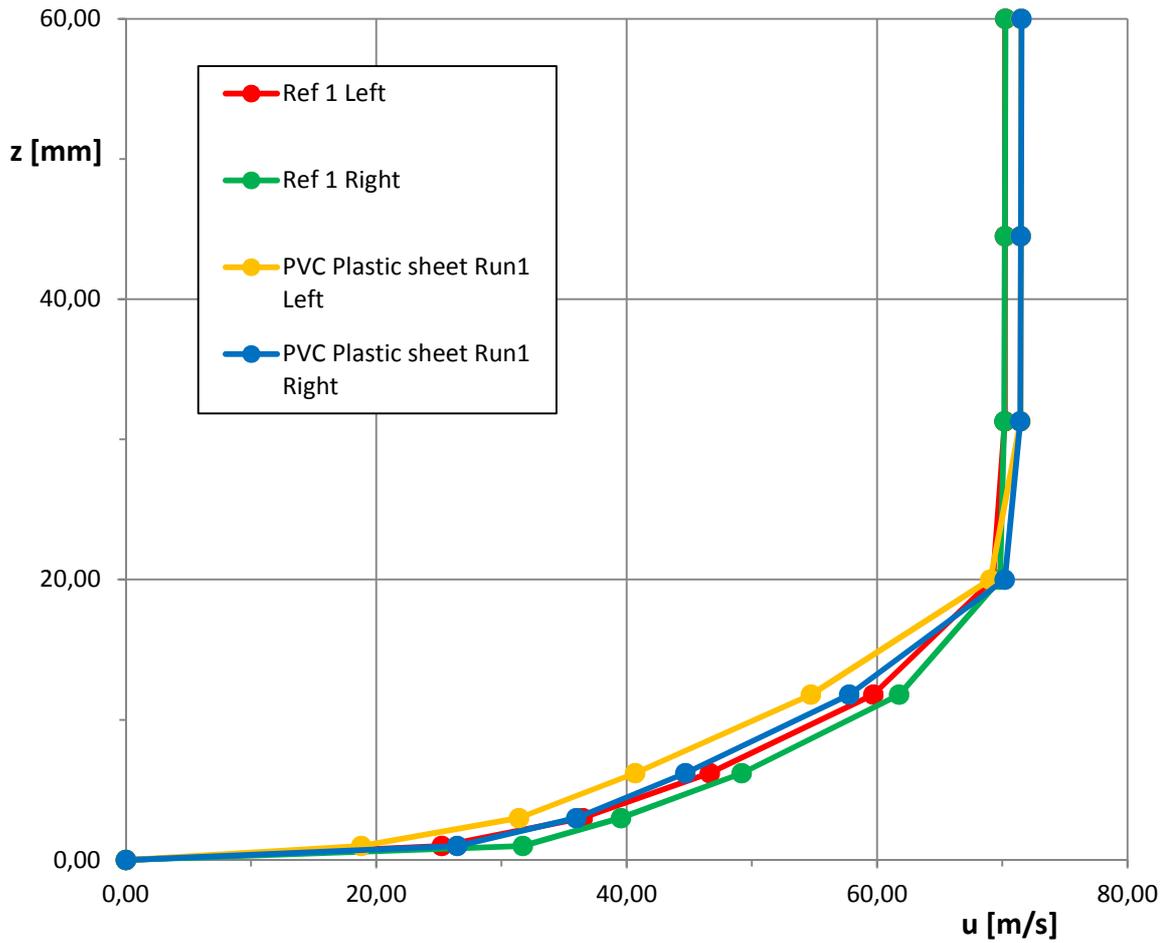
**Figure 70.** Boundary layer velocity profiles after wing model rotation.

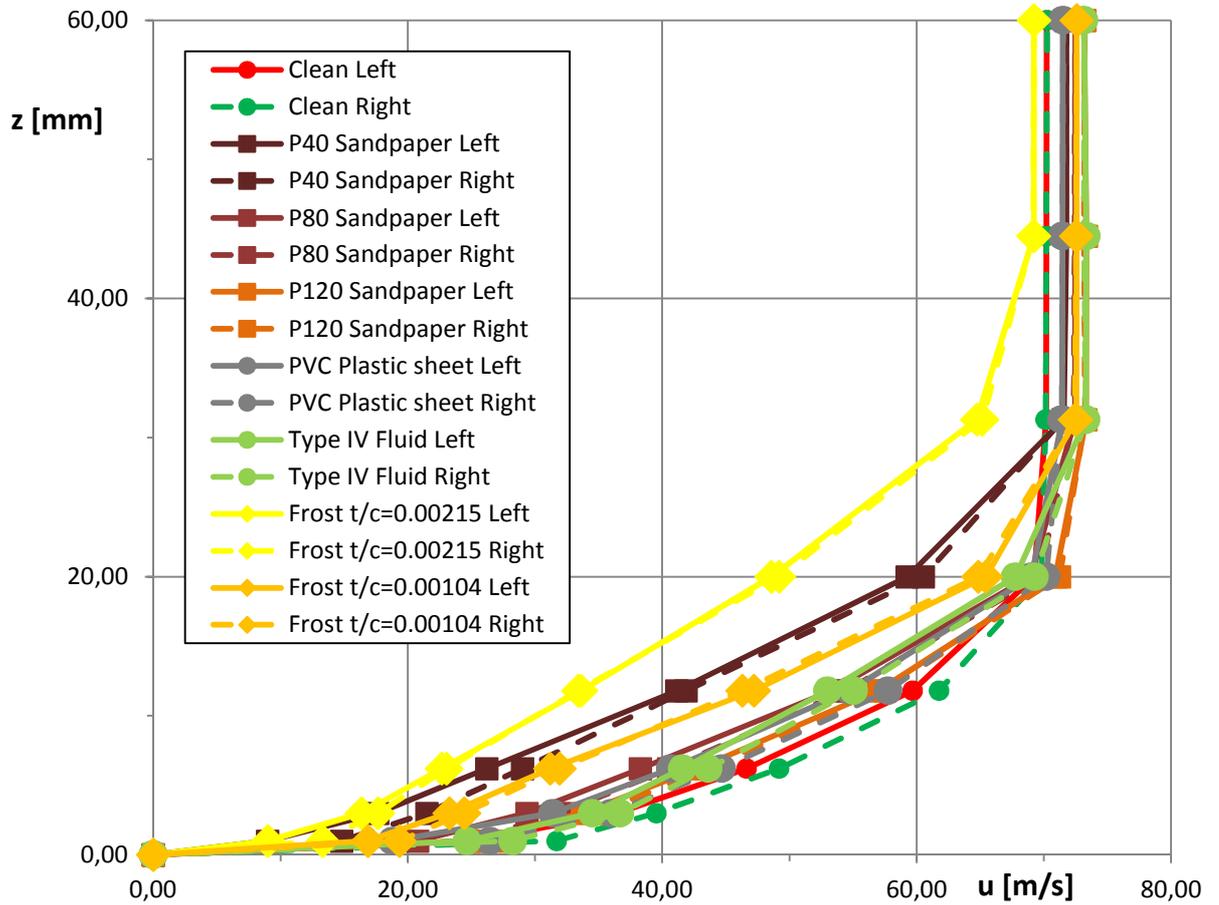
**Figure 71.** Boundary layer velocity profiles just after wing model rotation. The frost cases are from the measurements of March 21st and 24th of ref. [2].

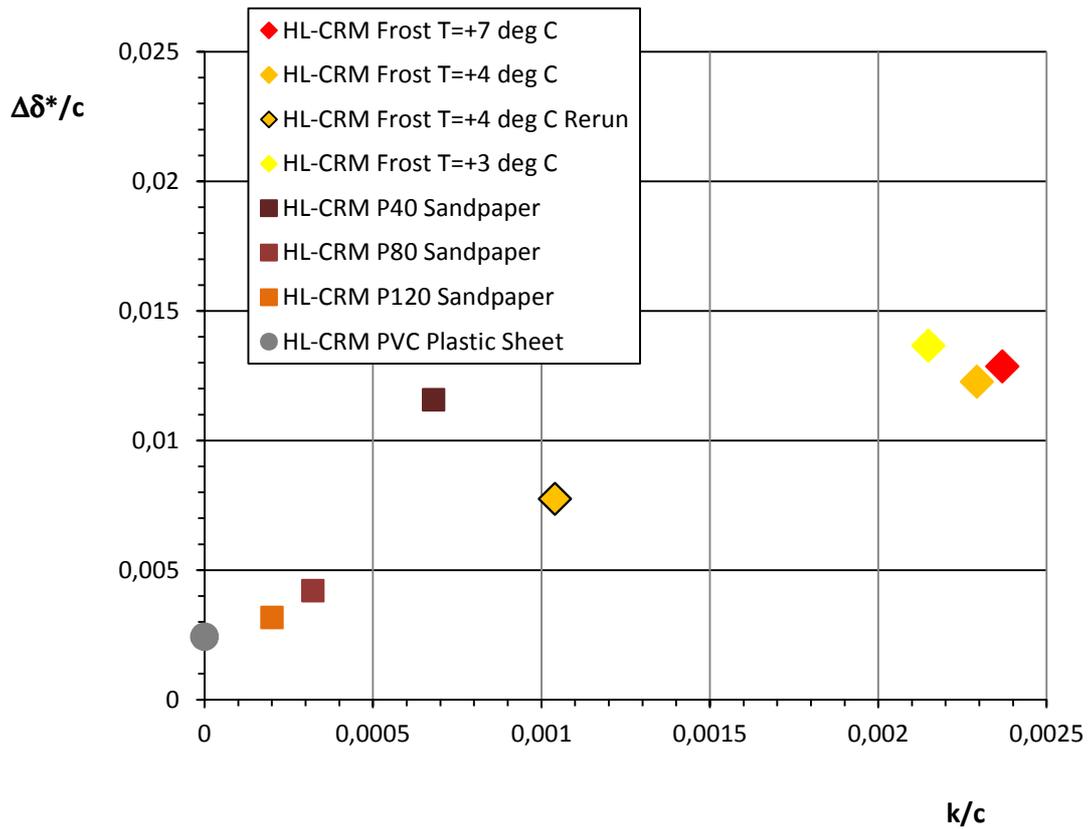
**Figure 72.** Dimensionless boundary layer displacement thickness increment as function of dimensionless surface roughness height (data also from ref. [2]).

The dimensionless boundary layer displacement thickness increment due the PVC plastic sheet is presented together with previous measurements of Cold Soaked Fuel Frost and sandpapers in Figure 72 as function of dimensionless roughness height, because this was the relevant parameter for lift reduction. There was no noticeable evaporation/ melting of the frost before rotation in the tested temperatures. The figure shows an increasing increment with increasing roughness height. Figure 73 shows the relative lift reduction as function of the dimensionless boundary layer displacement thickness increment. Here a
