Henri Kossi  
Jouni Raatikainen

**STUDY ON THE EFFECTS THAT THE DECREE ON TYRE STUDS HAS  
HAD ON CURRENTLY AVAILABLE STUDDED TYRES**

PIRKKALA, 2019

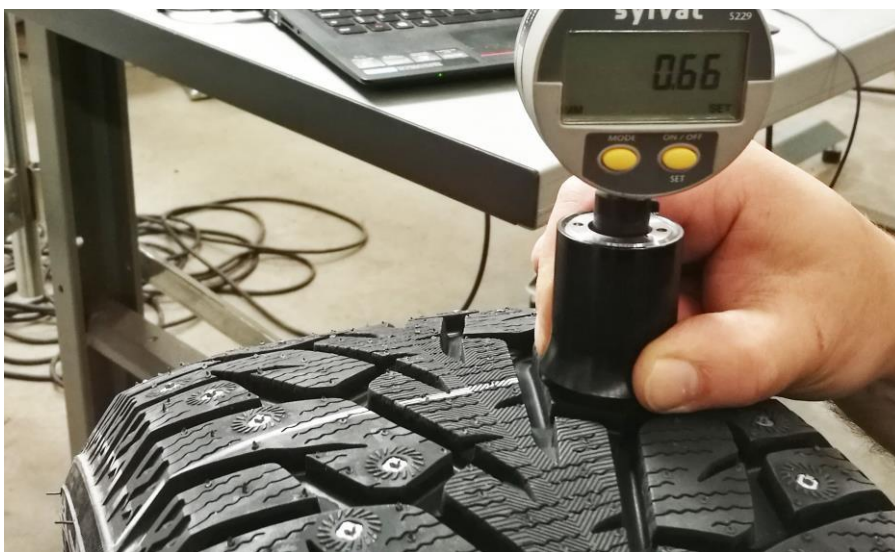
A delivery inspection was performed for every tyre. The tyres were inspected visually, their basic details were recorded, and the tyres' hardness, weight and every stud protrusion were measured. The tyres' delivery inspection records are presented in appendix 1.

*Figure 1. Measurement of stud protrusions*

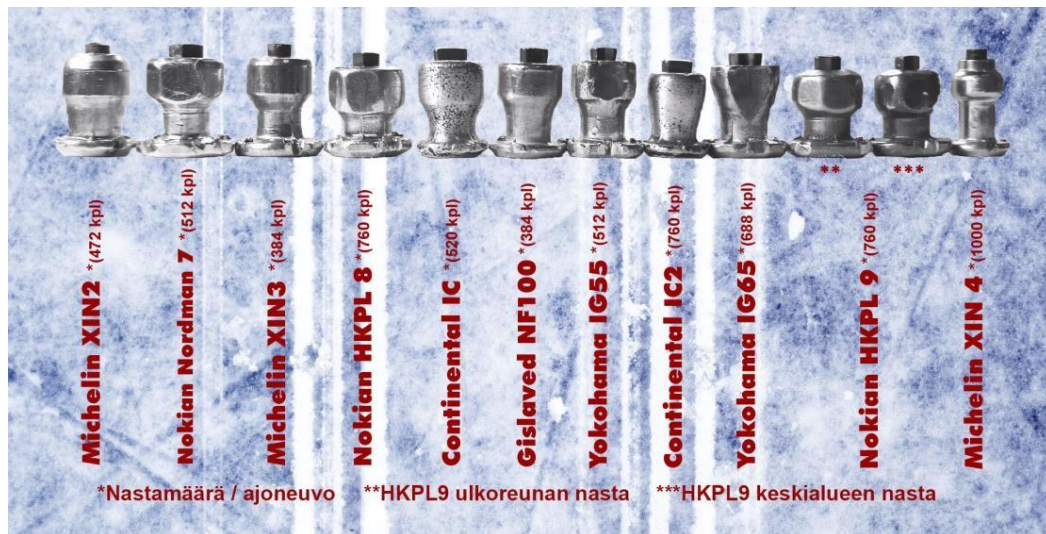
comes to their shape, size, material and weight. In addition, the same tyre can feature two different types of studs (Nokian Hakkapeliitta 9, Continental Ice Contact 3). Of the tyres that were inspected, the lightest stud weighed 0.77 g (Continental Ice Contact 2) and the heaviest 1.23 g (Michelin X-Ice North 4). Of the types of studs used, 11 featured aluminium frames and 1 featured a steel frame.

Figure 2. Stud types used in the tyres that were inspected

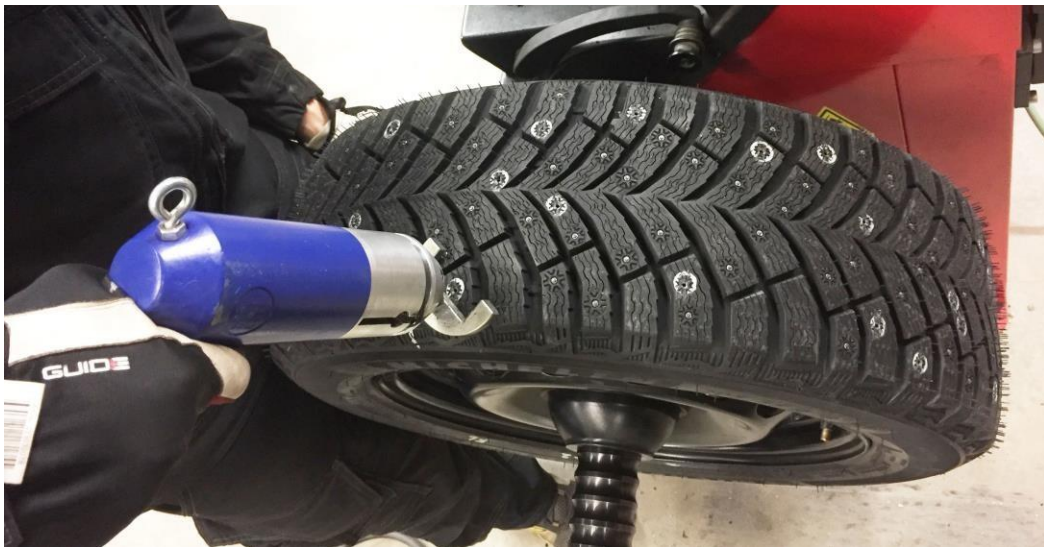
The studs were removed evenly from different stud rows in a proportional manner to the original emphasis model. If the original stud placement did not feature any identifiable stud rows, the tyre was divided transversely into several sectors, from which the studs were removed on a sectoral basis while following the original stud run. The goal was to remove the studs evenly from the differently sized sectors if the aforementioned requirements were first met.

*Figure 3. The studs were removed using a device designed for this purpose*

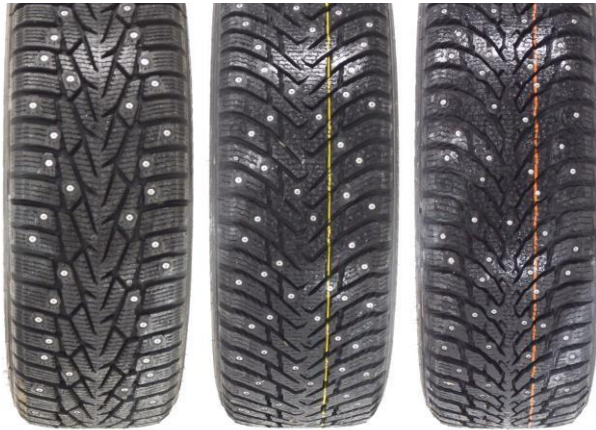
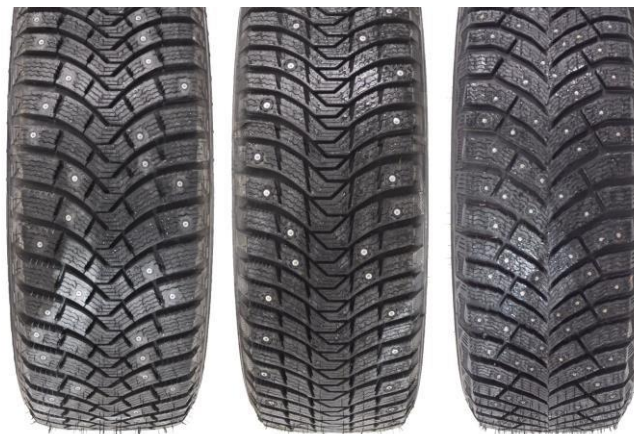
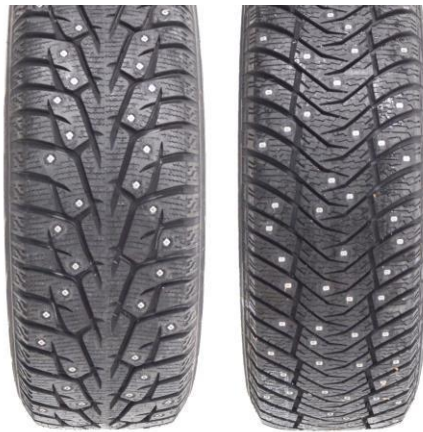
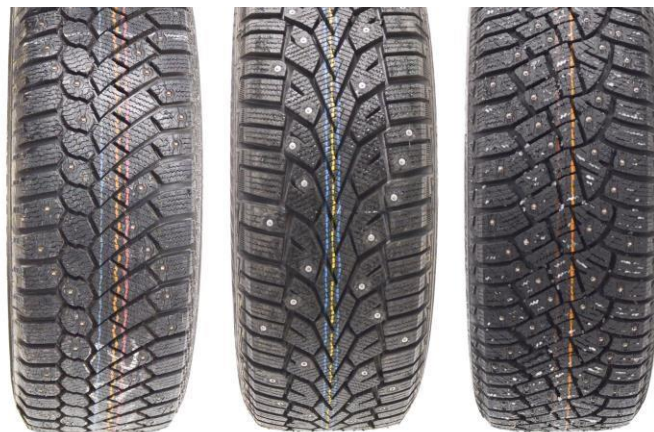
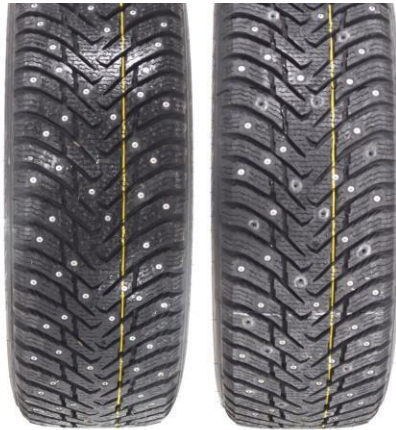
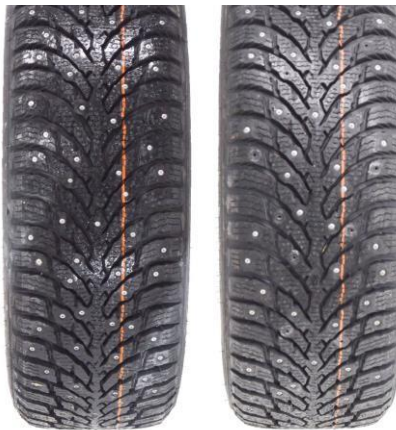
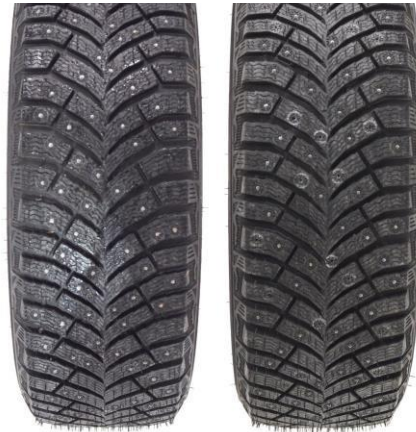
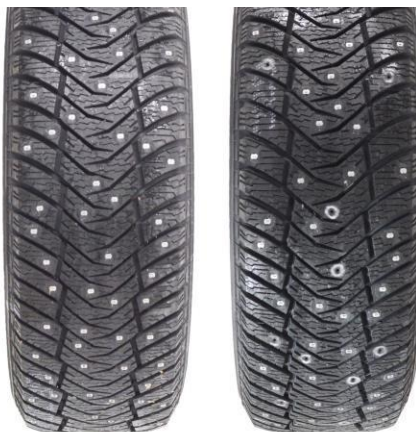
Each tyre was subjected to 5 consecutive measurements during the acceleration and braking tests, and each of these was conducted on an undriven icy surface. The results include the average of the measured results, which was then corrected on the basis of the change in conditions measured using the control tyre. The acceleration test measured the time spent on acceleration for speeds between 5–20 km/h, and the braking test measured braking distances for speeds between 20–5 km/h.

The circle test measured lap times. Along with the tyre's side grip, lap times are also affected by how predictably the tyre will perform when it is at the limit of its grip. The lap time is thus the joint result of both grip and handleability. Before the measurements were made, the ice was coarsened by driving a few laps on it with studded tyres. The test driver drove enough laps with each test tyre so that the tyre's driving behaviour could be ascertained and the lap time stabilised. During the circle test, the control measurements were conducted at the beginning and end of the testing series. Figures 4–8 present the test series of the ice grip tests.

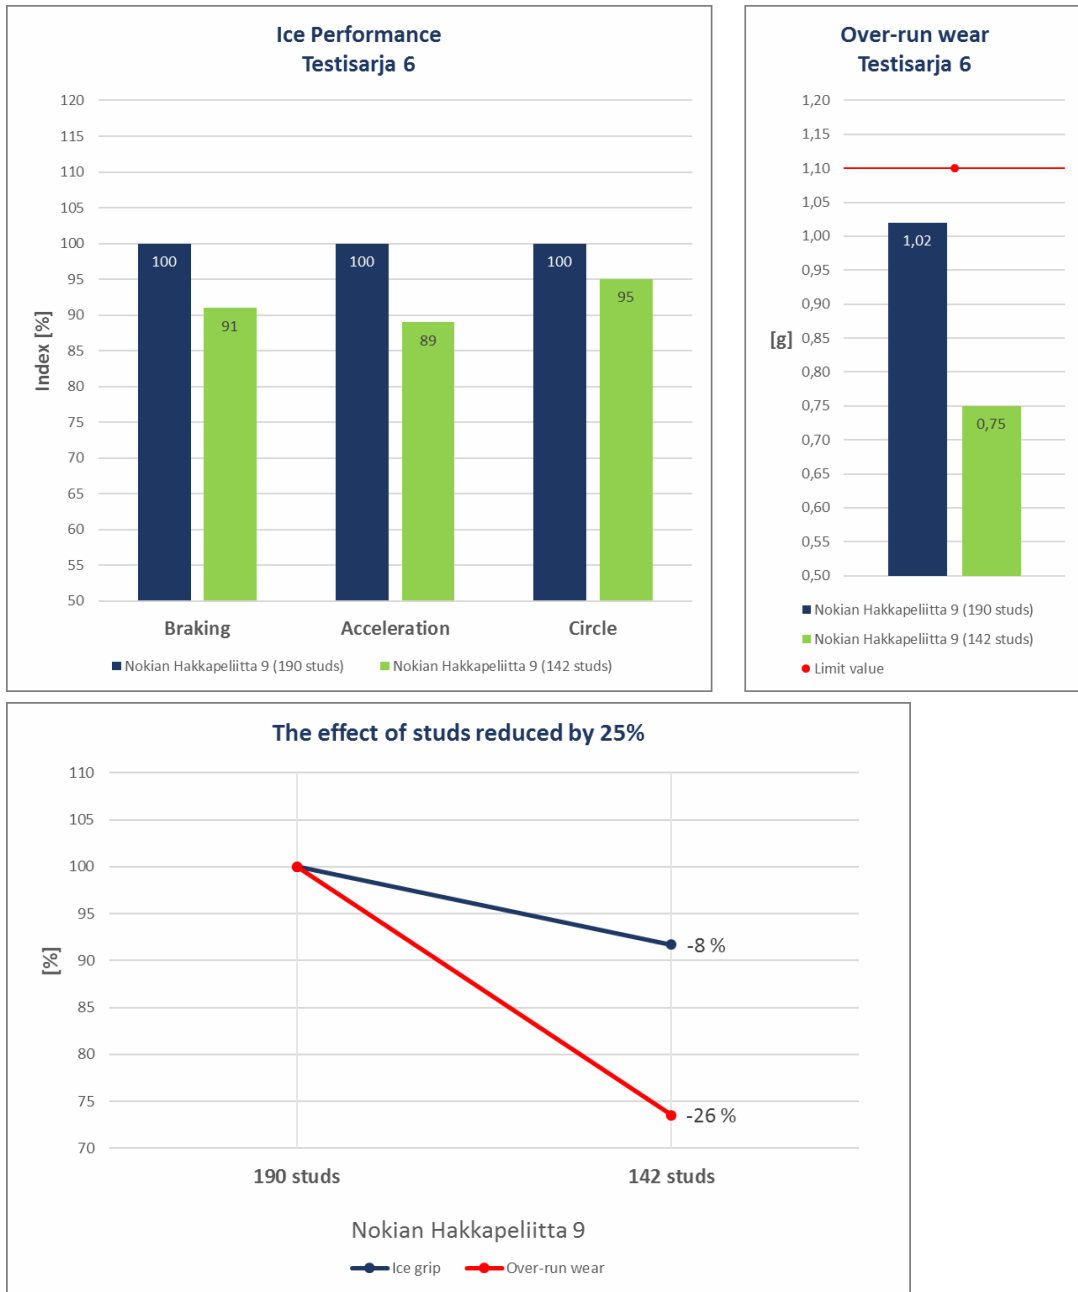
Figure 18. Number of studs reduced by 25%, Nokian Hakkapeliitta 9

Test series 6 compared the Nokian Hakkapeliitta 9 when it is equipped with its full number of studs (190 studs) and 25% fewer studs (142 studs). The results (Figure 18) demonstrate that its ice grip (avg.) decreased by 8% after the number of studs was reduced. Over-run wear

decreased by 26%.

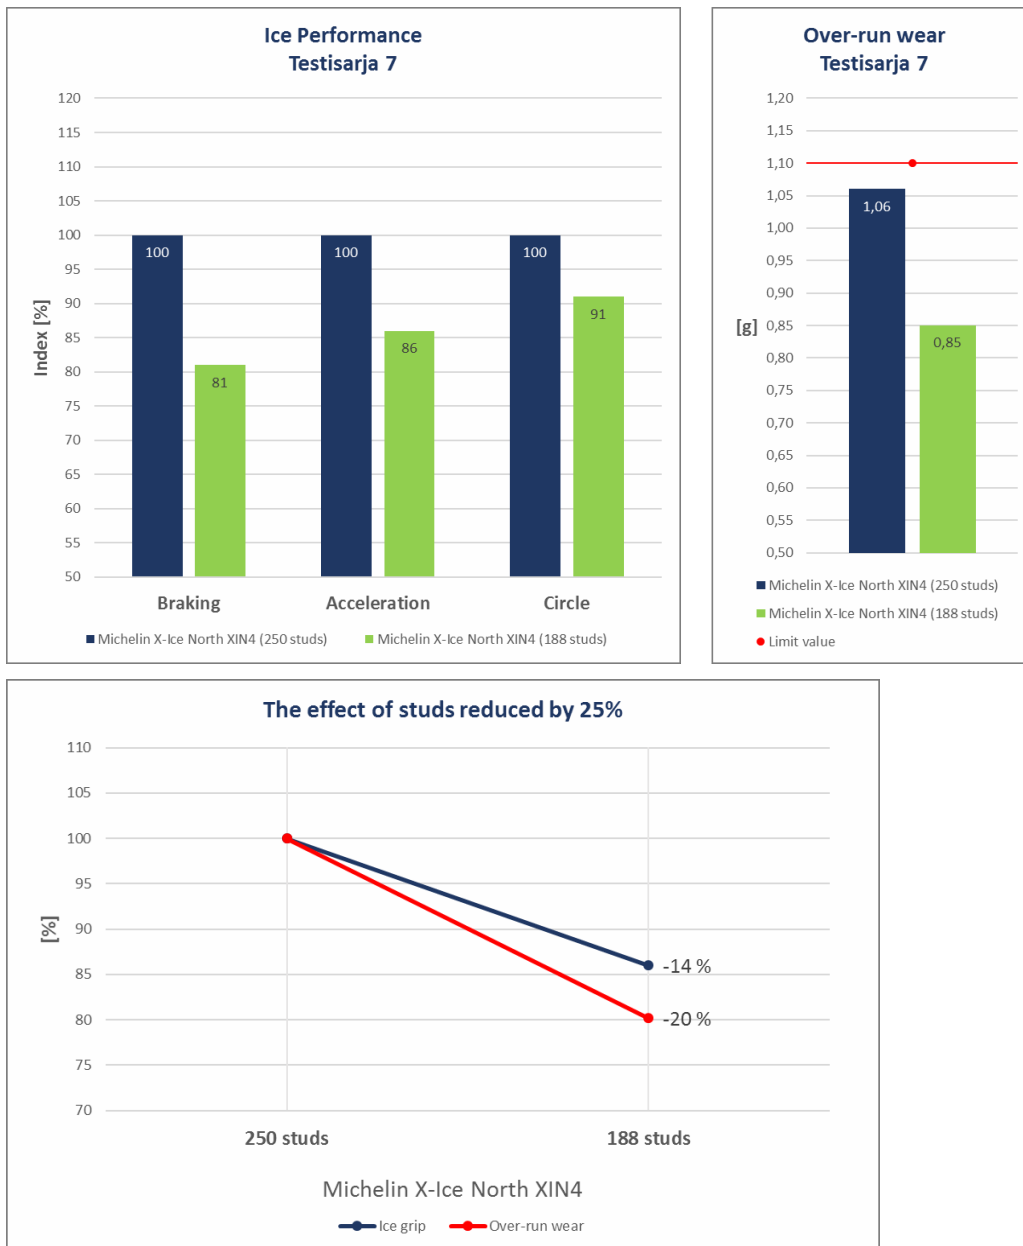
Figure 19. Number of studs reduced by 25%, Michelin X-Ice North XIN4

Test series 7 compared the Michelin X-Ice North XIN4 when it is equipped with its full number of studs (250 studs) and 25% fewer studs (188 studs). The results (Figure 19) demonstrate that its ice grip (avg.) decreased by 14% after the number of studs was reduced. Over-run wear decreased by 20%.

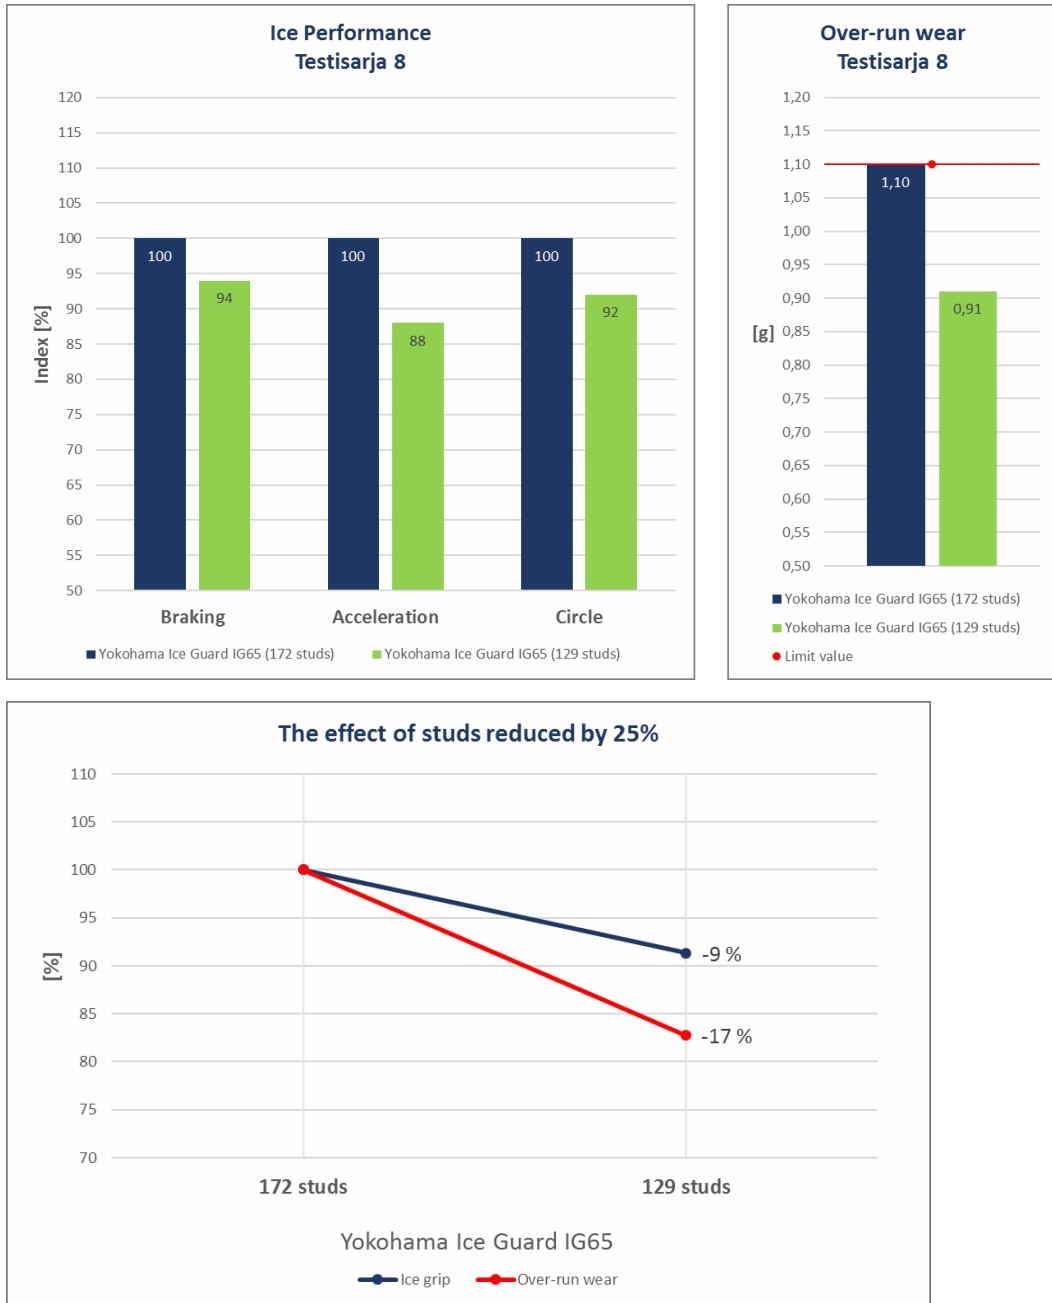
Figure 20. Number of studs reduced by 25%, Yokohama Ice Guard IG65

Test series 8 compared the Yokohama Ice Guard IG65 when it is equipped with its full number of studs (172 studs) and 25% fewer studs (129 studs). The results (Figure 20) demonstrate that its ice grip (avg.) decreased by 9% after the number of studs was reduced. Over-run wear decreased by 17%.

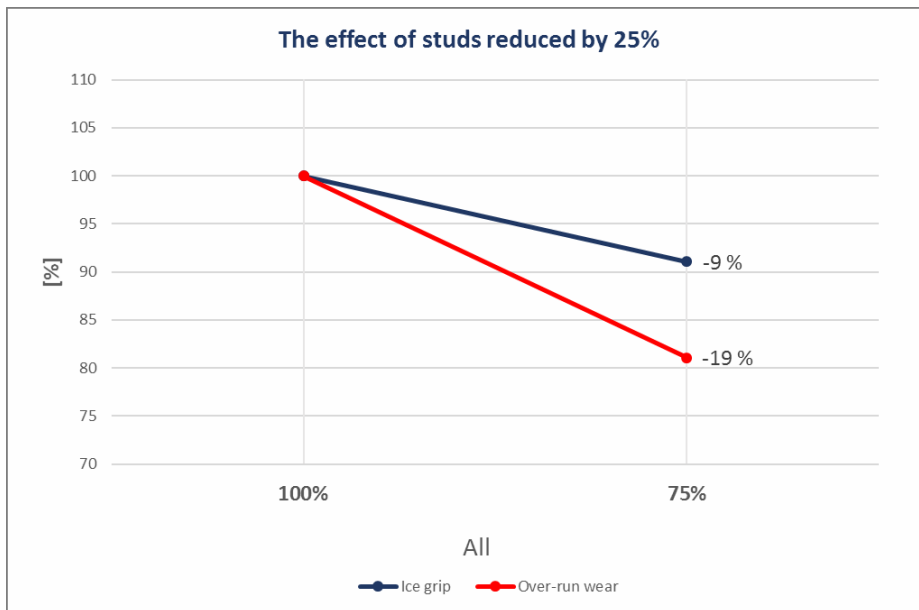
Figure 21. Number of studs reduced by 25%, average for all tyres

Figure 21 presents the average result for all stud number tests. A reduction of 25% in the number of studs used reduced ice grip (avg.) by 9% on average. Correspondingly, over-run wear decreased by 19%.

Even though the results of individual tests do differ from one another, the conclusion is clear. The effect that the reduction in the number of studs used has on ice grip is clearly smaller than its effect on over-run wear. This difference can be explained when we take into consideration that the over-run wear of a studless tyre has been observed to be only around 2% of the over-run wear of a studded tyre (Unhola et al. 2004, 28). However, a studless tyre still exhibits reasonable friction features when driven on ice. The share of studs in over-run wear is therefore almost 100%, but the share that studs have in relation to ice grip is noticeably smaller than this.

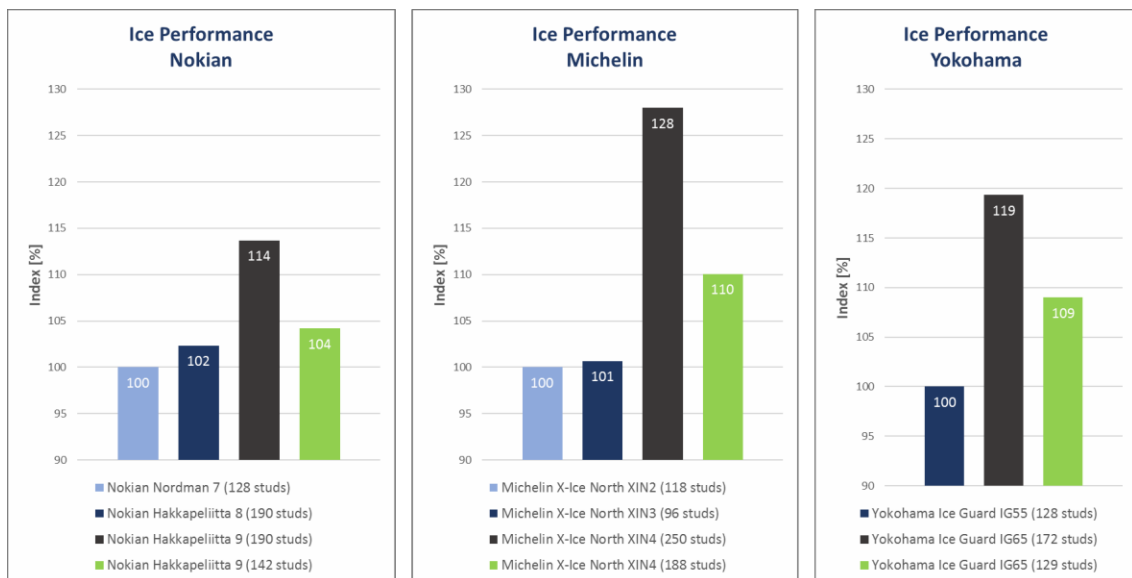
Figure 22. Product generation and stud number comparison

Figure 22 includes the product generations of three different manufacturers and presents their figures for ice grip (avg.) as well as the latest product's ice grip (avg.) with a reduced number of studs (-25%). For comparison, the descriptors also include the latest product with its full number of studs present. In each one of the three cases, the latest product with a reduced number of studs features more grip than previous product generations that include their stud numbers.

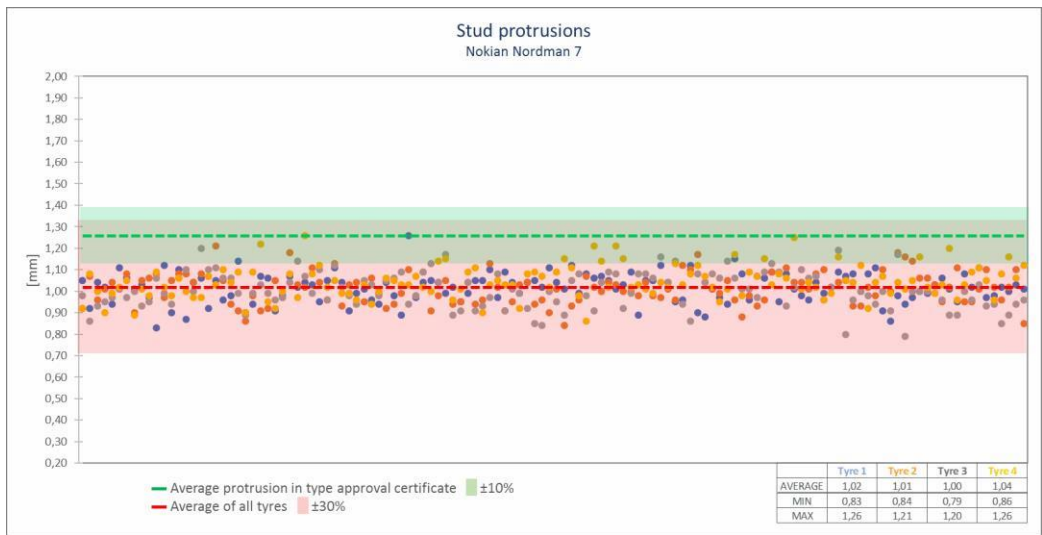
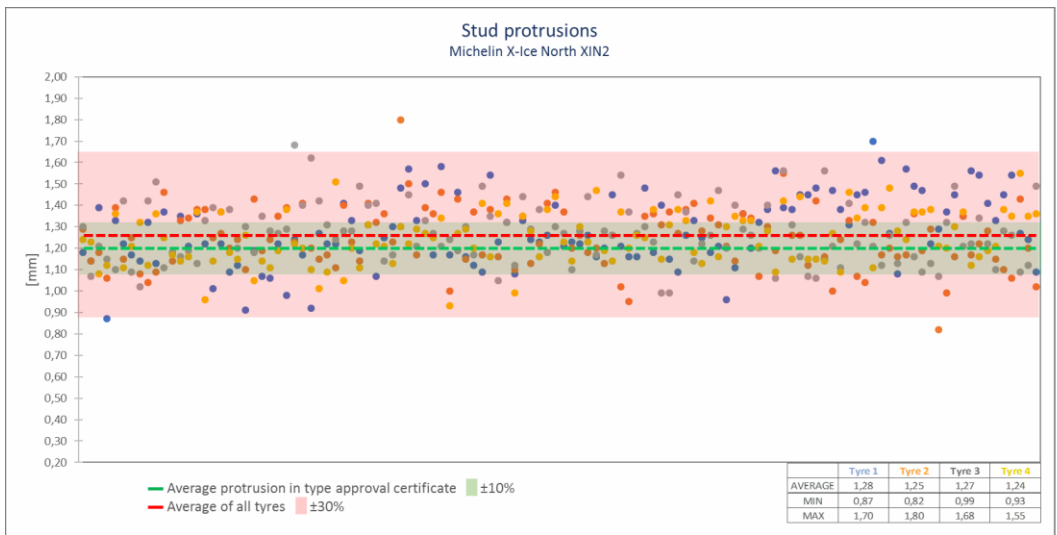
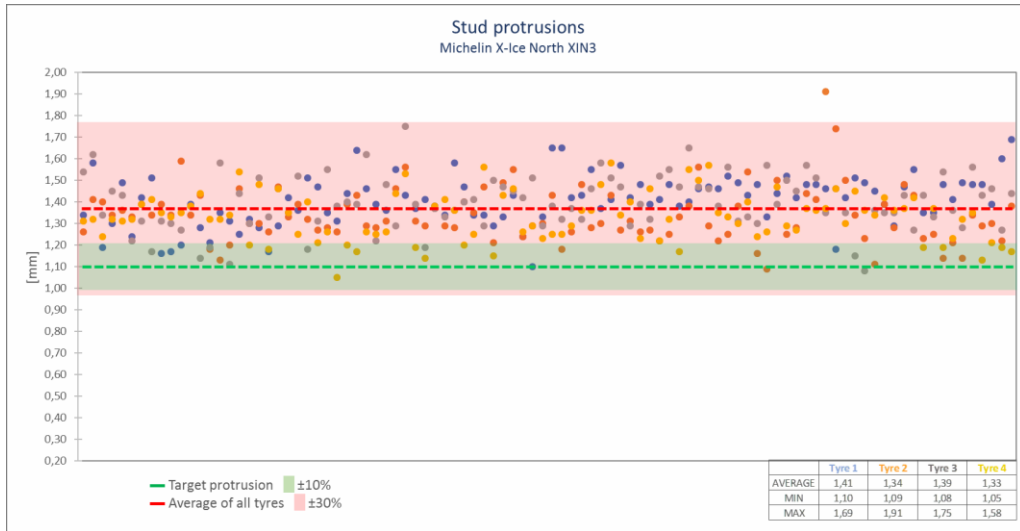
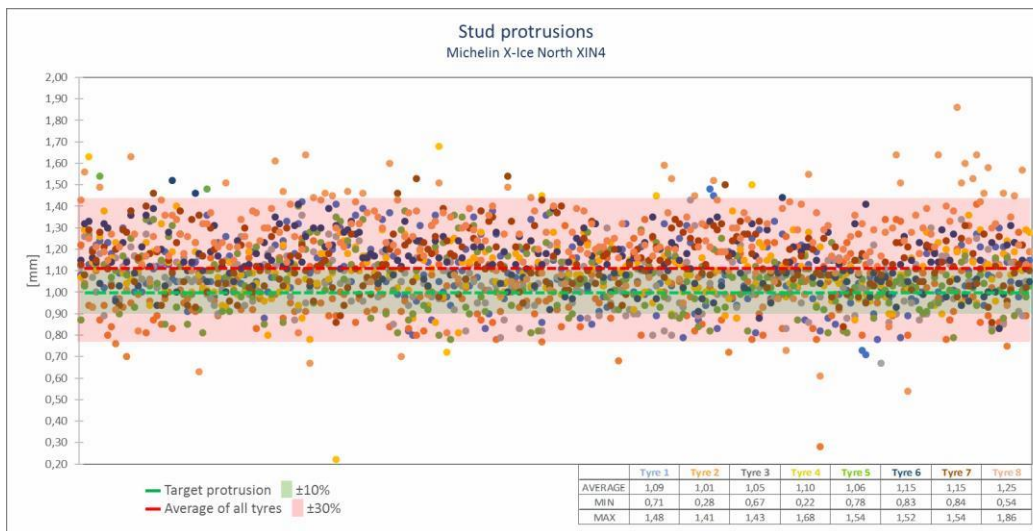
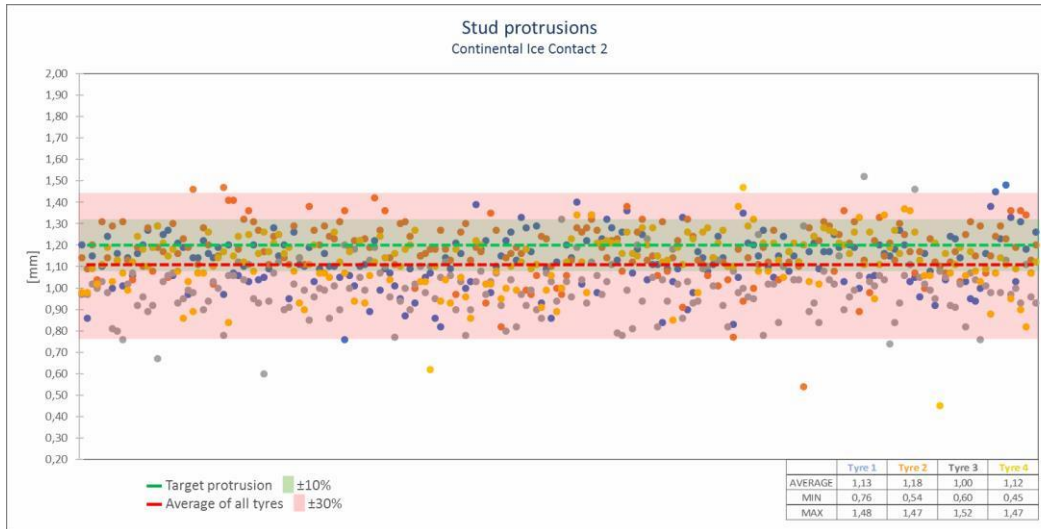
If no target protrusion rate has been declared, the comparative figure for the products in question is taken from the stud protrusion average declared in the type approval certificate or from section 2 of the tyre stud decree (LVM 2003/408), which specifies an average protrusion limit (1.2 mm).

There was very little variation in average protrusion rates for individual test tyres under each product. However, when compared to the protrusion value declared in the type approval certificate, only a few products were able to remain within the 10% variance range when it came to their average protrusion rates.

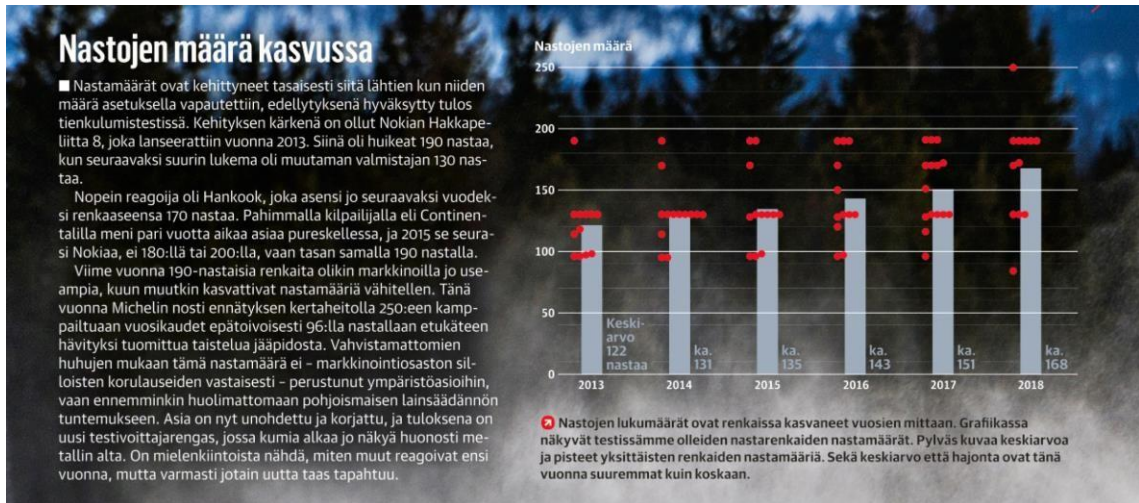
Figure 35. Rising number of studs used (Antila, Tekniikan Maailma 17/2018, 27)
