PIK-20D Fatigue Evaluation

Erkki Soinne

Finnish Transport Safety Agency
Liikenteen turvallisuusvirasto Trafi
Trafiksäkerhetsverket Trafi
Helsinki Helsingfors 2015

This research report is focused on the fatigue evaluation of the glider PIK-20D. It forms the basis for a special inspection requested by EASA.

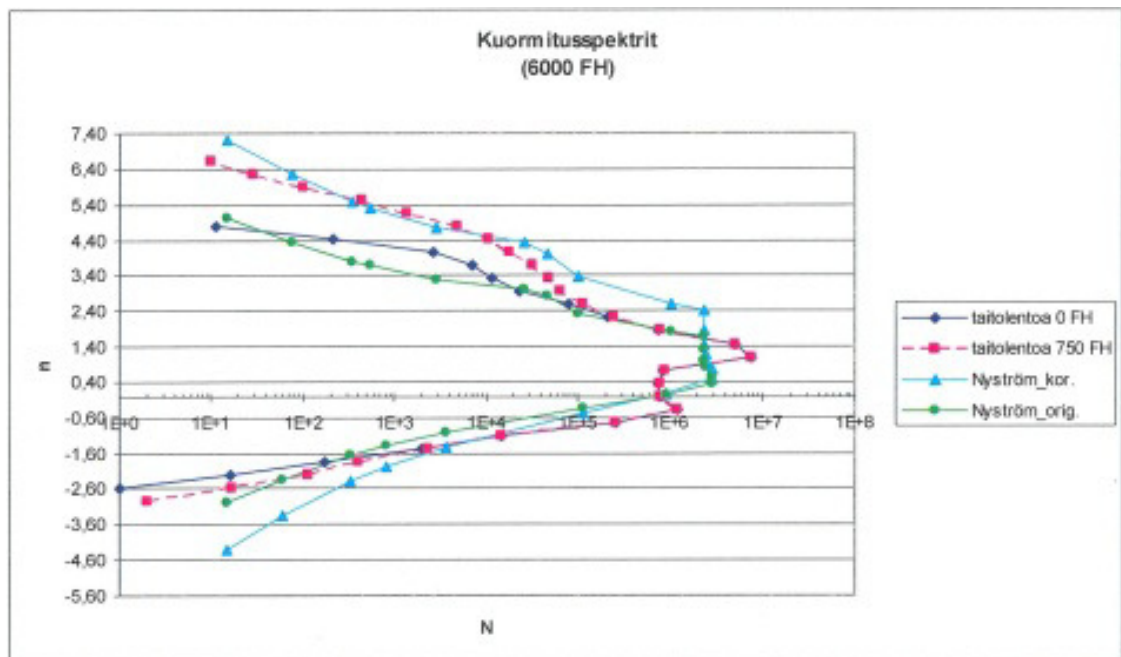
Figure 5. Comparison of spectra, ref. Lukkarinen page 98.

There are several comparisons of spectra in the thesis works of Lumppio and Lukkarinen, one of which is shown in Figure 5. Nyström's original and elevated spectra have been converted to 6000 FLH for comparison with the Kossira-Reinke spectra. As is seen in the figure Nyström's original spectrum (green dotted symbols) fits fairly well with the Kossira-Reinke spectrum without aerobatic flight (dark blue)

diamond symbols). The Kossira-Reinke spectrum, in which 750 FLH (12,5%) of aerobatic flight has been added is shown with red square symbols. Nyström's 44% elevated spectrum (light blue triangular symbols) exceeds the amplitudes of the Kossira-Reinke spectrum, which includes also aerobatic flight, at almost all load factor levels. This is not quite true at very low load factors $n=-1,0...0$ where it really does not matter. It seems that the Kossira-Reinke spectrum's maximum number of load cycles around 1g level flight is higher than in the theoretically derived Franzmeyer and Nyström spectra. This seems to be due the flight measurements and extrapolation to the entire spectrum time. The high number of low load cycles emerges from mountain flying, see ref. Kossira & Reinke fig. 145.

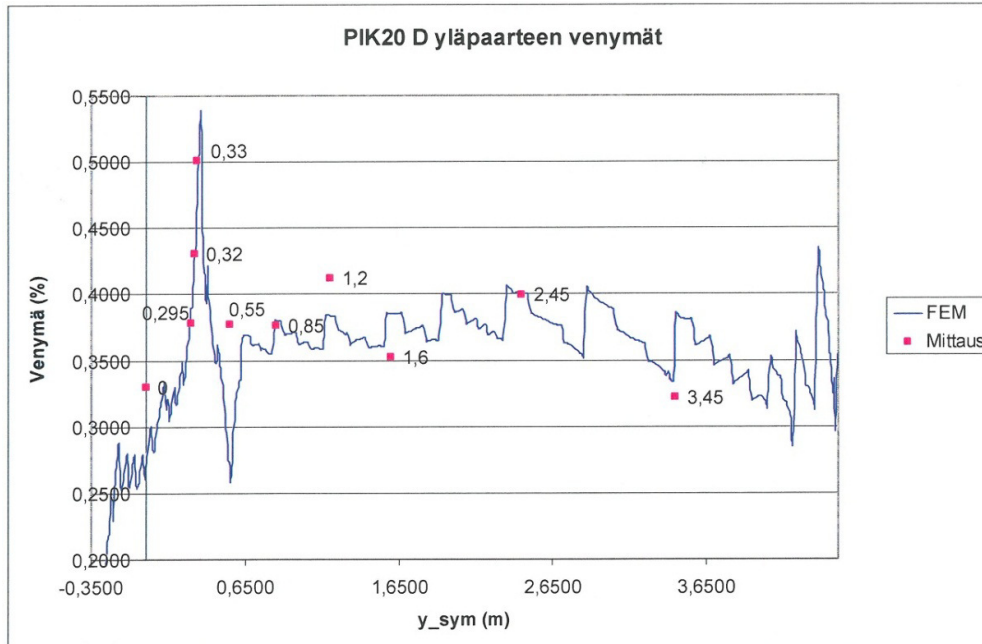
Figure 7. PIK-20D upper spar cap strains at limit load $n=6,62$ computed with a FEM model (FEM) and measured in the static test (Mittaus). The numbers indicate the location of the measurement from the symmetry axis, ref. Lukkarinen page 69.

The computations are within 10% of the measurements and the computations show a peak in the distribution outboard of the root rib that the strain gages did not catch up. The strain gages were glued on the wing surface whereas the spar caps remain somewhat inside the surface due to the direction changes of the cap. Inboard of the root rib the strain gages were glued on the wing spar surface with somewhat better matching. The computed strain peak of $\epsilon=0,5393\%$ at limit load ($n=6,62$ at maximum take-off weight $m=450\text{kg}$, ref. Lukkarinen page 68) seems to be real and is conservatively taken into account in the fatigue life computations.

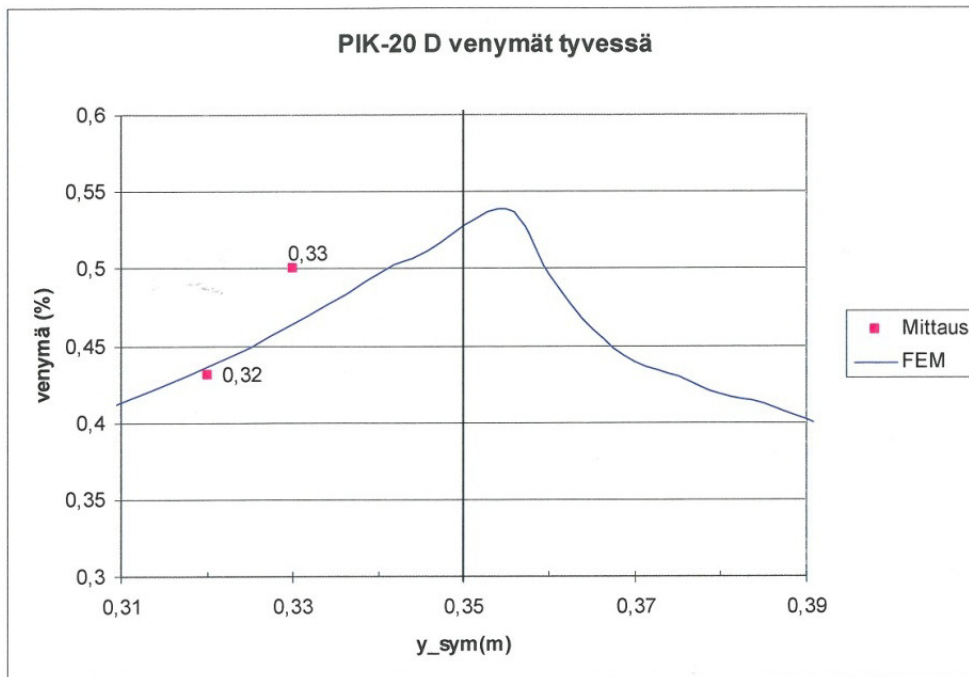
Figure 8. PIK-20D upper spar cap strains computed at limit load $n=6,62$ with a FEM model (FEM) and measured in the static test (Mittaus). The numbers indicate the location of the measurement from the symmetry axis, Ref. Lukkarinen page 70.

Before reinforcing the wing root area there were about 30 static loadings performed for calibration, strain measurements and deflection purposes, ref. Nyström page 79. The strain measurements give useful comparison for FEM calculations as the internal stress distribution is appropriate in the test. It can be identified, that for the unreinforced wing a load case with load factor $n=6,62+20\%=7,944$ was applied 9 times and the case with $n=6.62+15\%$ once (ref. Nyström pages 64...66, Appendices 12, 15a1...h2). The applied static load cases are summarized in Table 2. The wing spar cap maximum strain is the peak value predicted by the FEM calculation, see Figure 8.

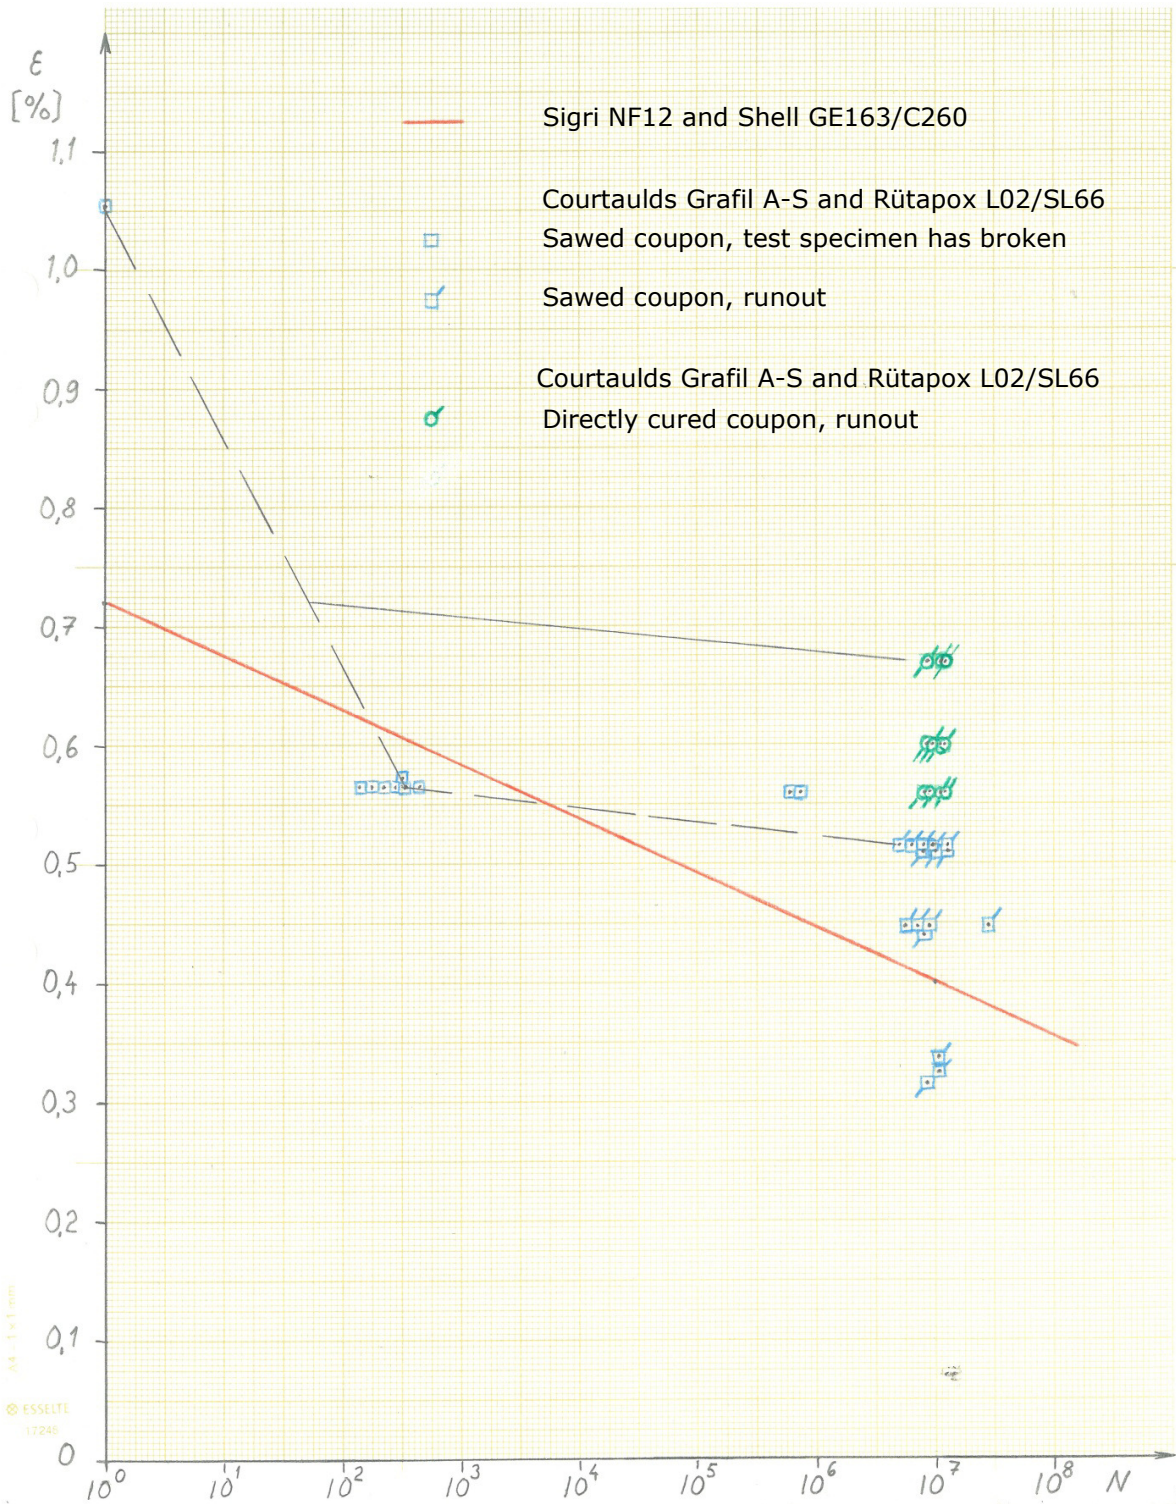
Figure 10. Fatigue strain as function of number of cycles, references Lukkarinen page 107, Perälä "Bending fatigue strength..." and Tammi.

Fatigue tests on the PIK-20D carbon fiber spar cap material were performed at Helsinki University of Technology in several phases using a fatigue bending test and stress ratio $R=-1$. First the test coupons were sawed from fabricated spar caps. Also the thickness of the coupons was a result of the sawing operation. If the filaments were not perfectly aligned in the right direction the sawing cut through the filaments at the coupon surface. On a 2 mm thick coupon this brought a reduction in the fatigue strength. The latest results on these tests are presented in ref. Tammi. To avoid cutting through the fibers the test coupons were later on cured under pressure in the same way as on the PIK-20D wing spar to directly produce the test coupon thickness. These results are reported in ref. Perälä "Bending fatigue strength...". Both sets of results are converted from fatigue strength to fatigue strain by dividing with the bending modulus 106 GN/m^2 of ref. Tammi and presented in Figure 10 together with the S-N curve of CFRP: Sigri NF12 and Shell

The usage of Sigrí NF12 and Shell GE163/C260 laminate S-N curve instead of Courtaulds Grafil A-S and Rütapox L02/SL laminate curve is about factor 50 (in life) conservative. This conservatism is eliminated by using the appropriate S-N curve for the PIK-20 spar cap material as shown in Figure 10.

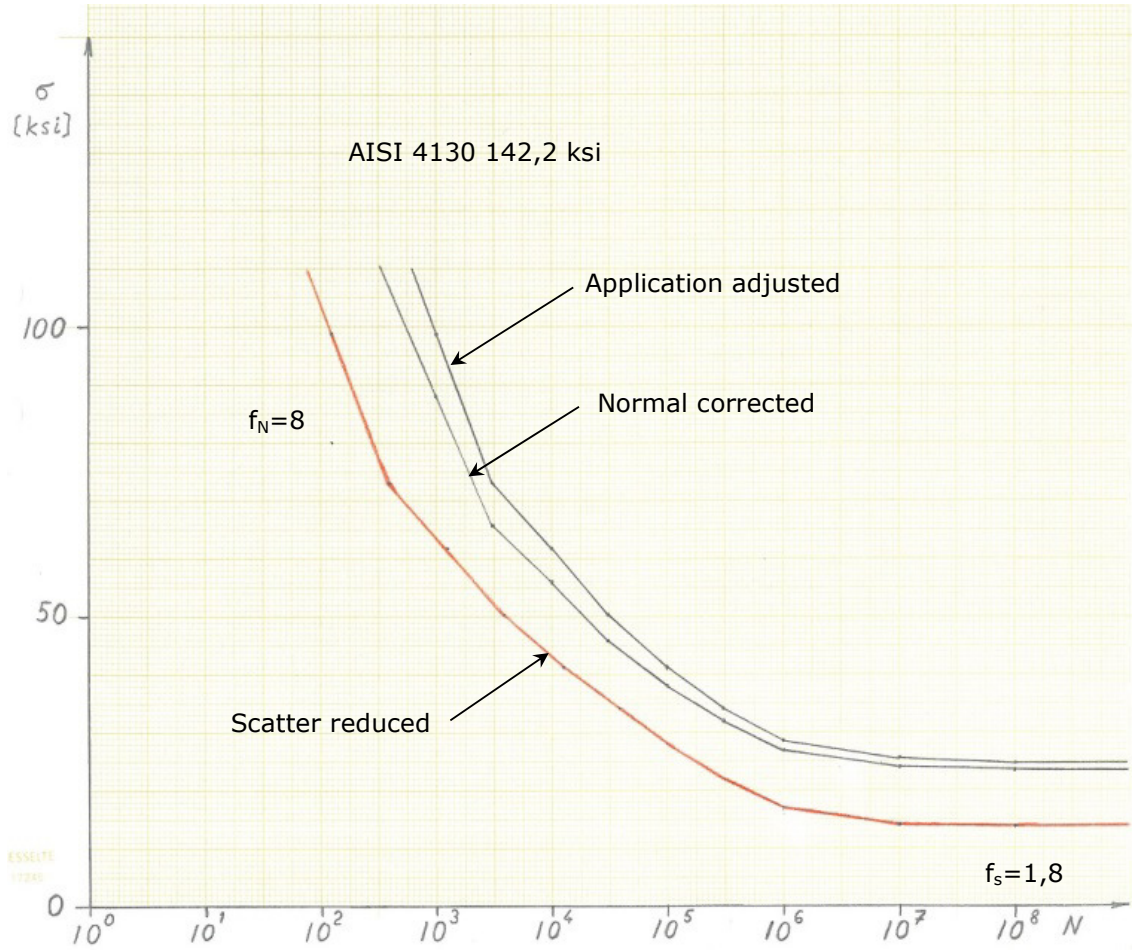
Figure 15. Wing spar end fitting S-N curves.

stresses. The ratio of the mean stress and the stress amplitude at different numbers of loading cycles N was calculated using the Kossira-Reinke spectrum including 12,5% of aerobatic flight, see ref. Lukkarinen page L18-1. Using these values S-N curves, having a varying stress ratio for the mean stress and the stress amplitude, representative for the Kossira-Reinke spectrum including 12,5% aerobatic flight, were constructed for the 120 ksi and 180 ksi material data. The S-N curve for the 142,2 ksi material was interpolated from these two curves and is shown in Figure 15 as the Normal corrected curve.

The application adjusted and scatter reduced curves of the wing spar main fitting pin, presented in Figure 15, can now be scaled in amplitude to apply for the present case by a factor

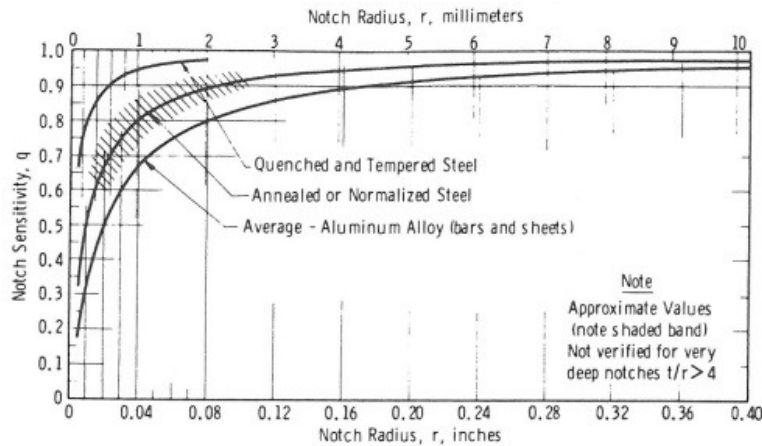
Figure 21. Average fatigue notch sensitivity, ref. Peterson page 10.

where K_f is the acting fatigue notch factor and α is the geometrical stress concentration factor. Notch sensitivity factor may be considered as a measure of the degree to which the theoretical effect is obtained. Reasonable values for design use are obtained in Figure 21, where the following simple formula has been used

$$q = \frac{1}{1 + \frac{a}{\rho}} \quad (14)$$
