# **Secondary wave lift degradation**

Pekka Koivisto, Aalto University

Finnish Transport Safety Agency  
Liikenteen turvallisuusvirasto Trafi  
Trafiksäkerhetsverket Trafi  
Helsinki Helsingfors 2015

This research report is focused on the role of a secondary wave in lift degradation during simulated take-off for a wing section that has been applied with anti-icing fluid. It forms part of the third year studies in the Icing project initiated by the Finnish Transport Safety Agency, Trafi.

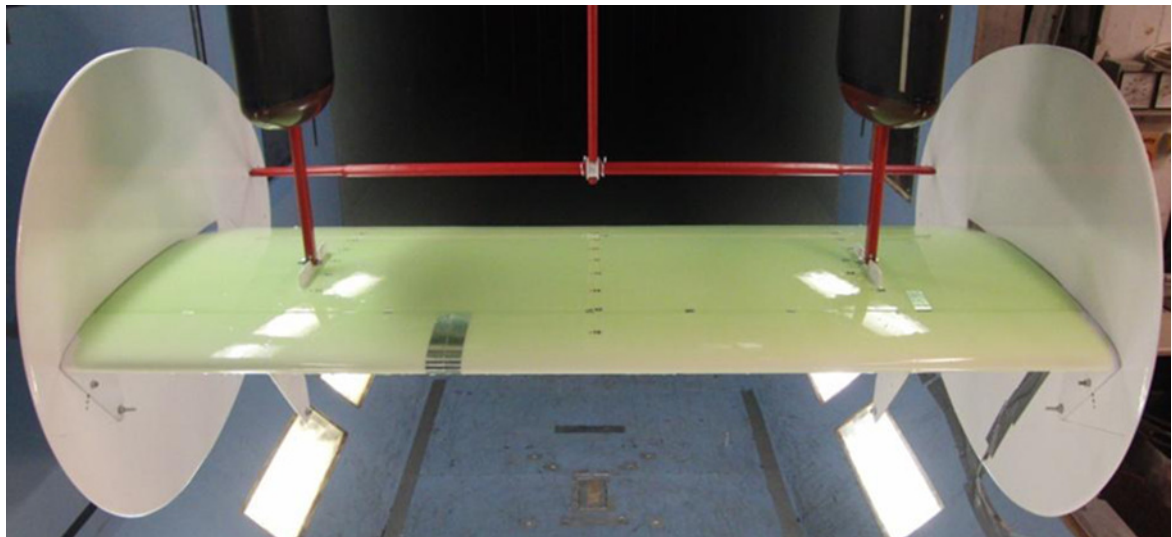
**Figure 1. Rotating wing section model in wind tunnel.**

The wing section model has the geometry of a DLR-F15 (Ref. 6) profile and a chord of 0.65 m. The model span was 1.5 m which implies an area of 0.975 m<sup>2</sup>. Anti-ice fluid was applied on the whole upper surface area during the tests (Fig 1.).

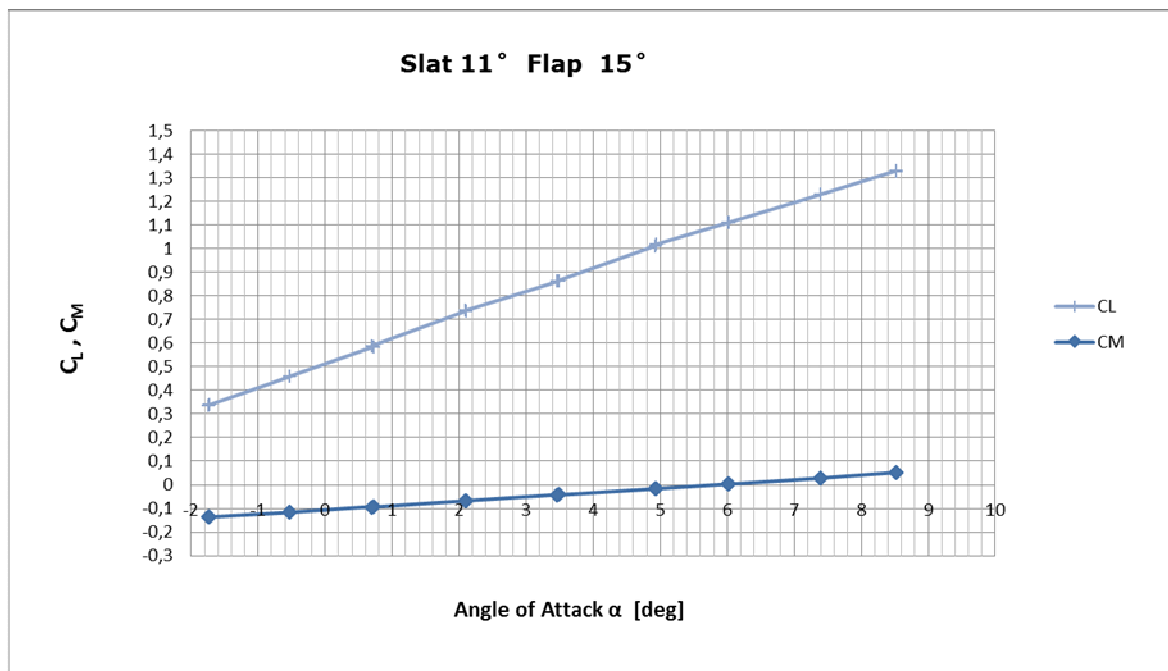
**Figure 2.** Lift and moment coefficient variation with  $\alpha$  at a speed of 60 m/s ( $Re\ 2.9\ 10^6$ ) for the wing model.

For the same reason it was impossible to reach the stall with a rotation speed of 60 m/s. Stall with lower speeds would have led to incomparable Reynolds numbers. As the chord of the model was relatively large the stall situation was not considered to be risk free regarding the wind tunnel diffuser flow. The lift and moment coefficients for a clean wing model are presented in Fig. 2.

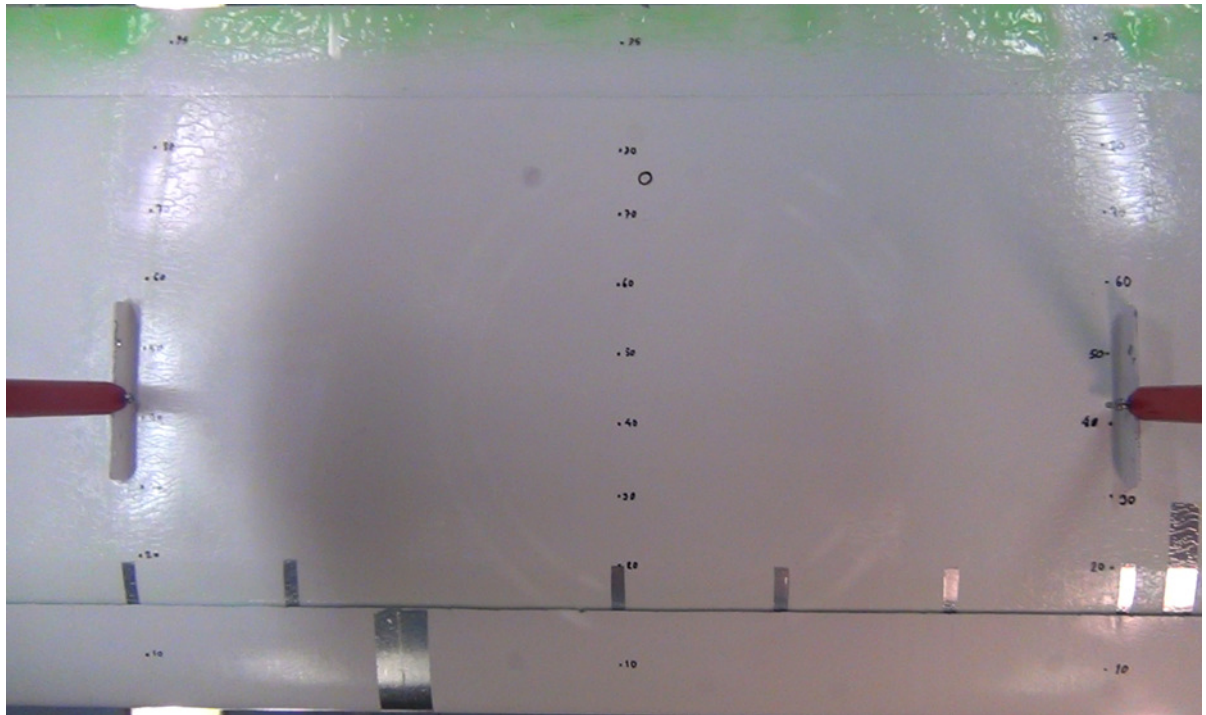
**Figure 3.** Fluid distribution just prior to rotation.

Most of the wing main section is clear of the fluid when the speed has reached 60 m/s just prior to the rotation (Fig. 3). However, there is still a clearly visible fluid layer at the trailing edge area. Within one second after the rotation a secondary flow wave appears from the lower side of the wing section through the slat gap. The secondary wave is visible in Fig. 4 at a 47-50 % chord position. In Fig. 5 there is a graphical presentation of the secondary wave movement in case of Type II fluid. The average speed (linear fit

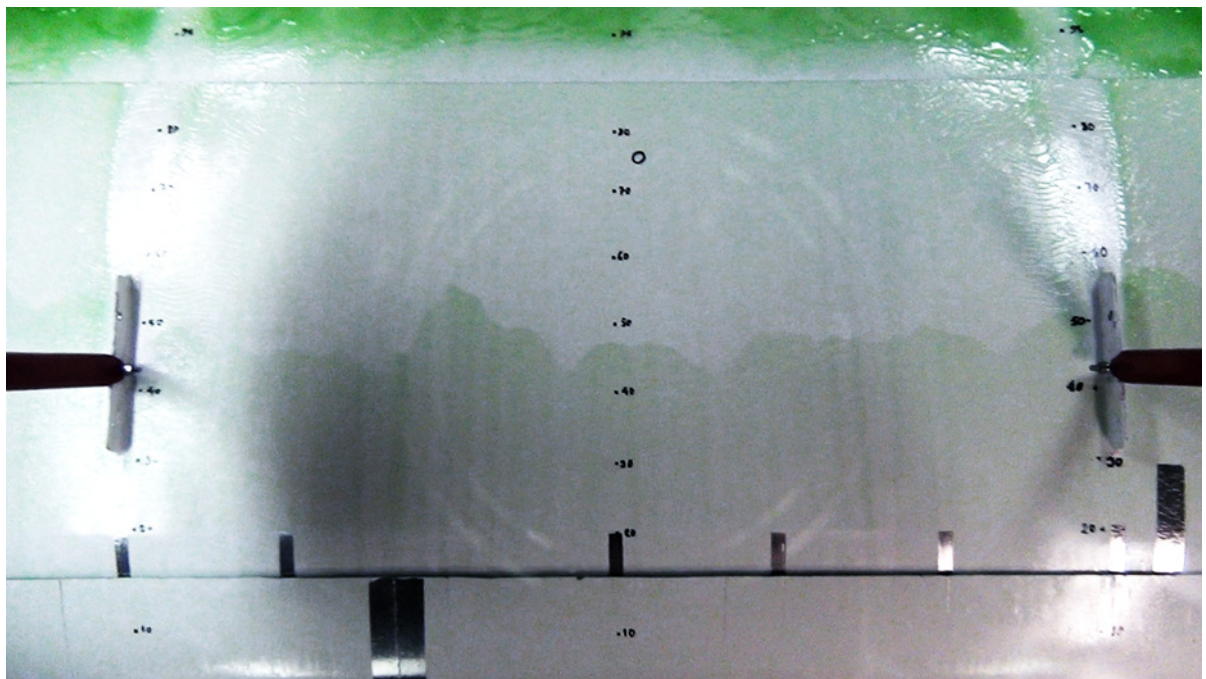
**Figure 4.** Secondary wave at a chord position of 47-50%.

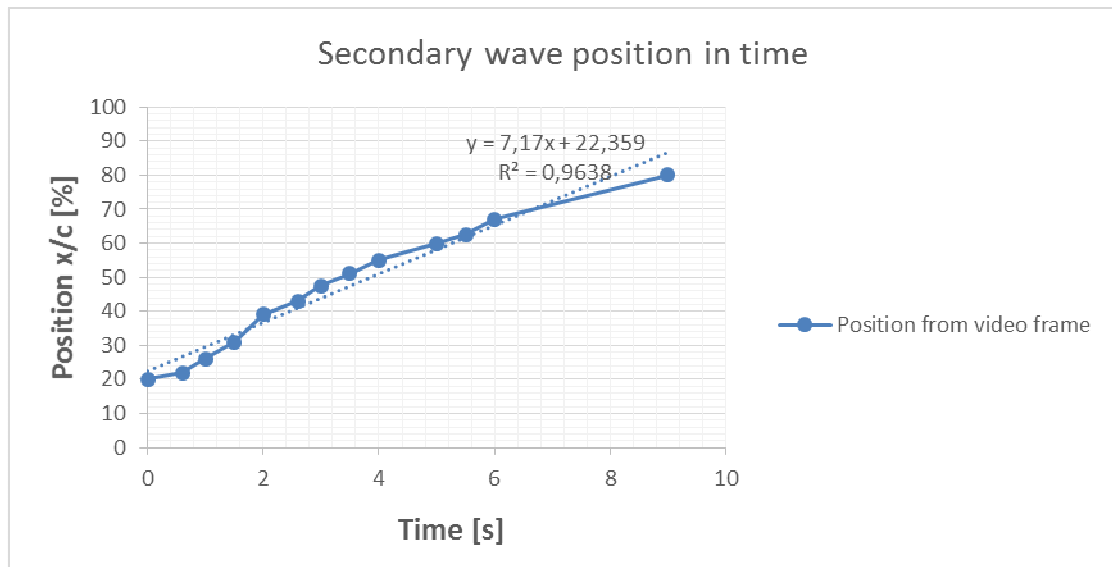
**Figure 5.** Secondary wave movement along the wing section chord. The dotted line is a linear fit of the measured curve. Time is measured from the point when the wing model has reached the angle of attack of  $\alpha=8^\circ$  after rotation

in Fig. 5) of the secondary wave is 7.2 % of chord per second = 0.047 m/s. This means that the secondary wave reaches the trailing edge within about 10 s after rotation.

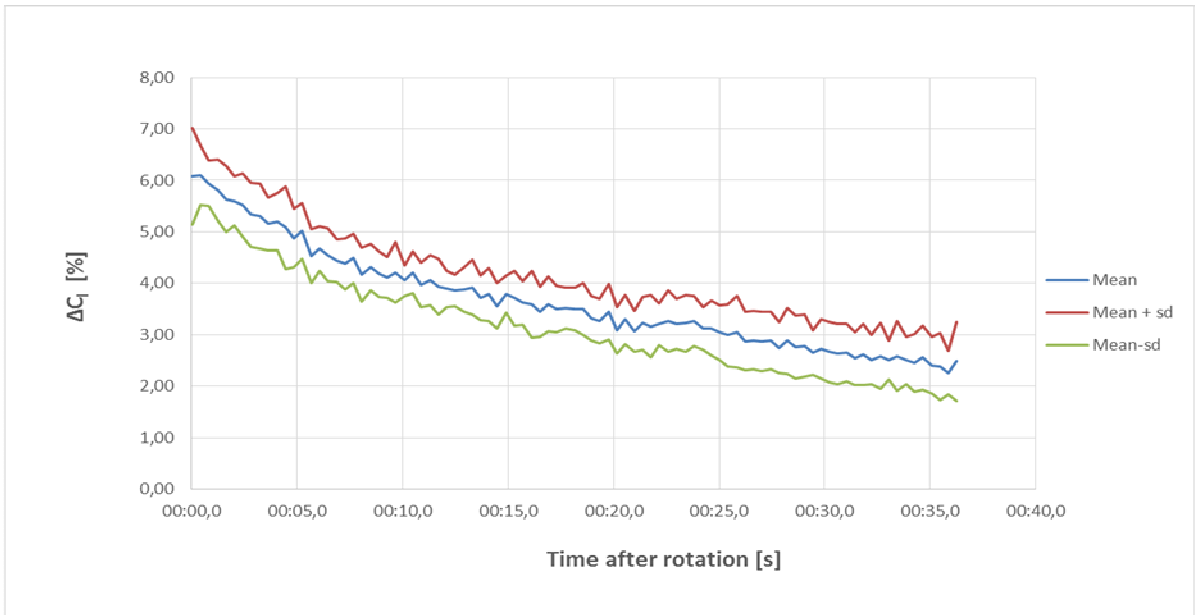
**Figure 6.** Mean lift degradation and its deviation in time for all fluid tests

Along with the differences in the lift degradation results the similarities between all of the fluid tests in Ref 7 (20 different tests) open up some new aspects. The behavior of all fluid tests followed evidently a clear pattern as seen in Fig 6. The initial lift loss mean value of 6 % decreases down to 4 % within 10 first seconds after the rotation. The next 1.5 percentage point decrease to the value of 2.5 % takes an additional 25 seconds. The curve shows almost asymptotic behavior with relatively low and evenly distributed standard deviation (mean value of 0.52 percentage units). This result supports the conclusion that the secondary wave which was earlier observed to prevail on the upper surface for the 10 first seconds after the rotation may account for a significant part of the initial lift loss.

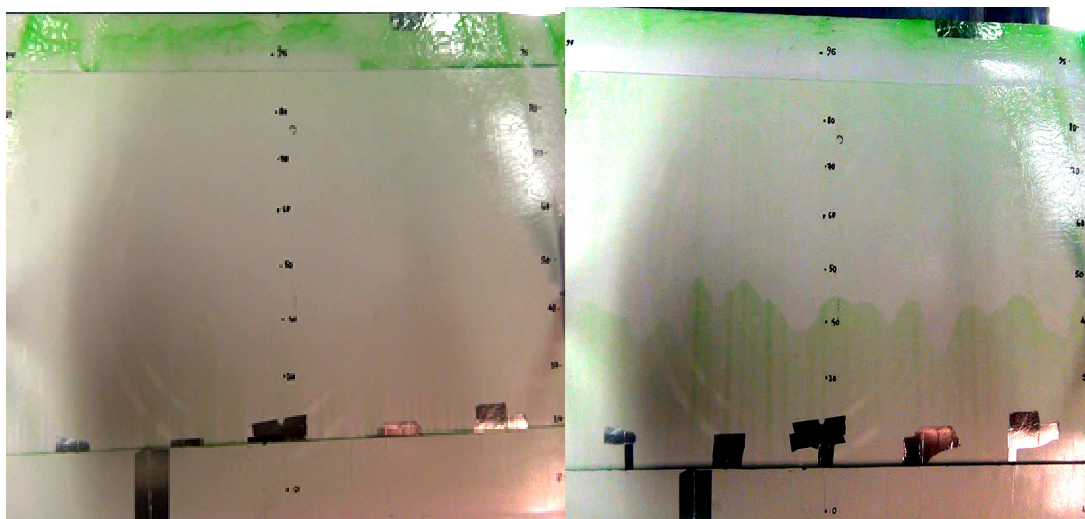
**Figure 7.** Slats, flaps retracted (left): no secondary wave. Slats  $11^\circ$ , flaps  $15^\circ$ : a clear secondary wave visible (right)

During the secondary wave tests the fluid movements were videotaped from two different directions: from the ceiling of the test section and through the test section Plexiglas door to get a view from the lower side of the wing section. The video recordings from the test section sealing confirmed that no secondary wave appeared on the wing section upper side when the slats and flaps were retracted and the slat gap sealed whereas on the slats  $11^\circ$ , flaps  $15^\circ$  configuration a secondary wave appeared just as during all the tests in Ref. 7, see Fig. 7. The trailing edge area in the configuration slats and flaps retracted seem to have more anti-ice fluid left due to the closed gap between the flap and the main element of the wing section.

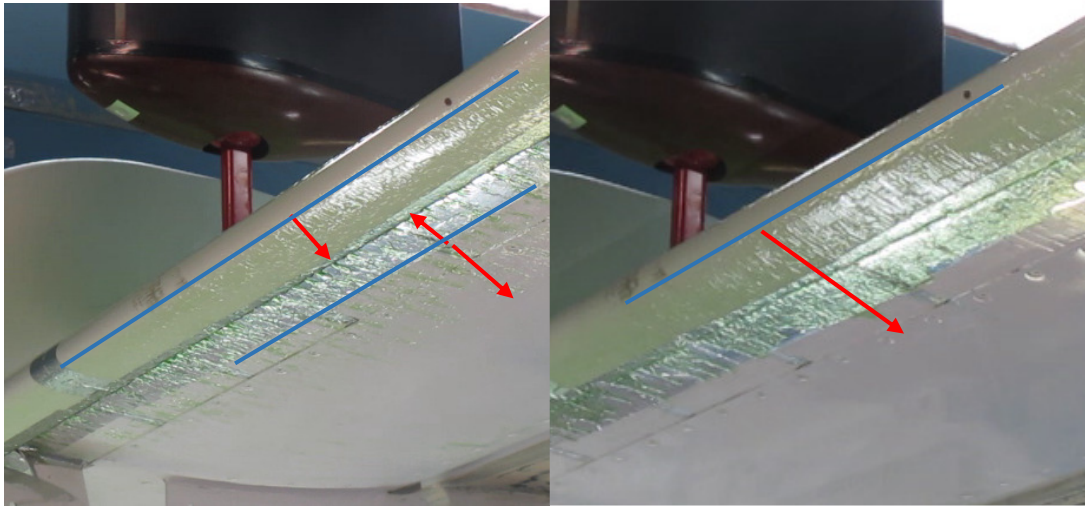
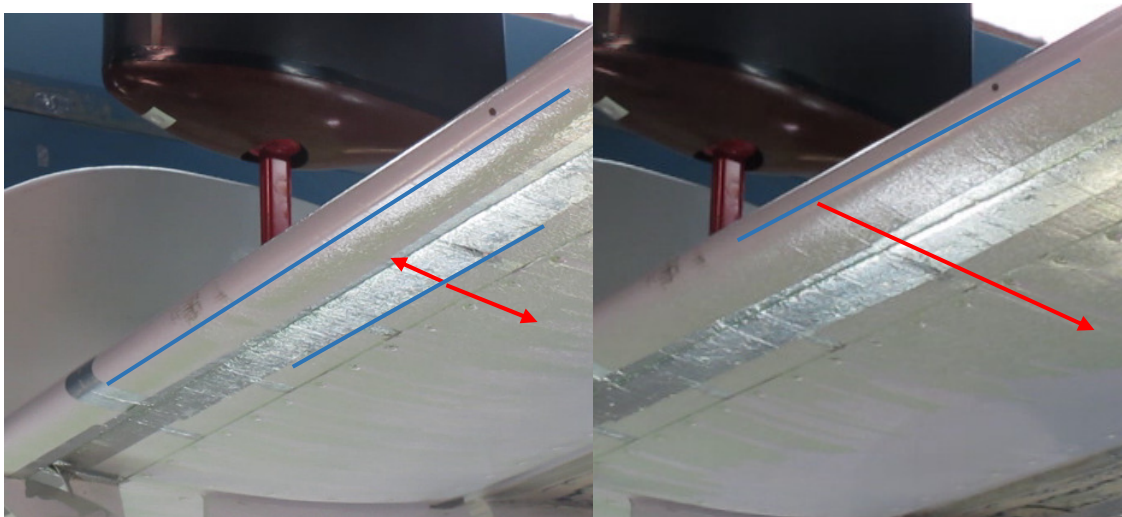
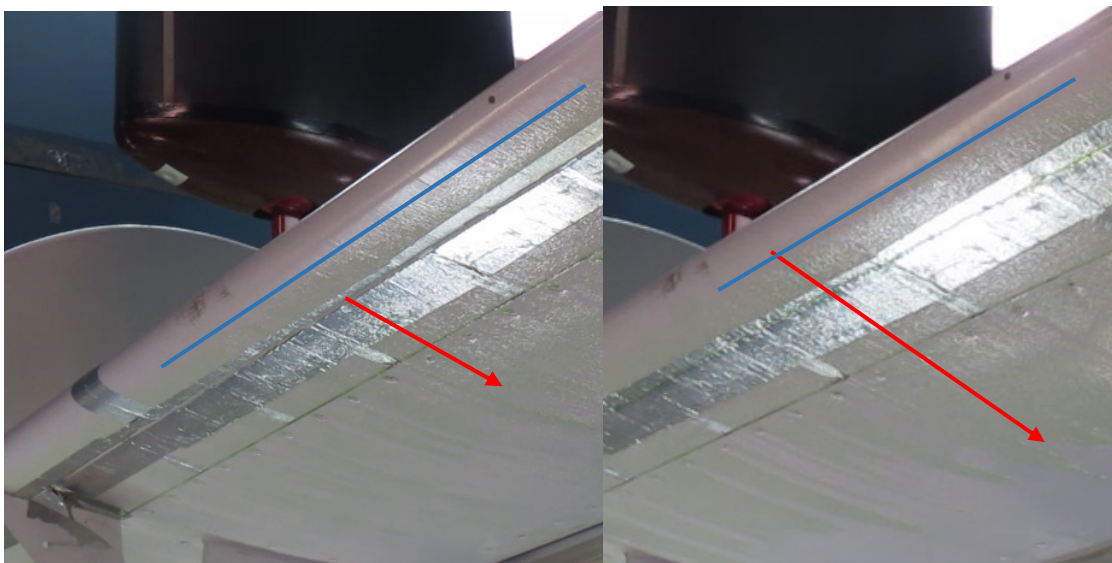
A. Wind tunnel speed 30 m/s

B. Wind tunnel speed 60 m/s just prior to rotation

C. Just after rotation

**Figure 8.** Flow directions (red arrows) and stagnation line (blue line) during the acceleration phase and after the rotation. Left figures: configuration slats  $11^\circ$  and flaps  $15^\circ$ , right figures: configuration slats and flaps retracted and slat gap sealed.

What is seen before the rotation is that the fluid is moving during the whole take-off run phase towards the slat gap. It most probably is collected to the slat cove and be then depleted to the upper side after the rotation when the flow configuration in the slat gap changes. The positions and movement of the stagnation lines and flow direction before and after the rotation is shown in Figure 8. In the case of slats and flaps retracted configuration the stagnation line moves somewhat backwards as expected. However, the wing section nose area is clean of fluid at the point of rotation and there is not any fluid left for a secondary wave to build up, see Fig. 8 B and C.

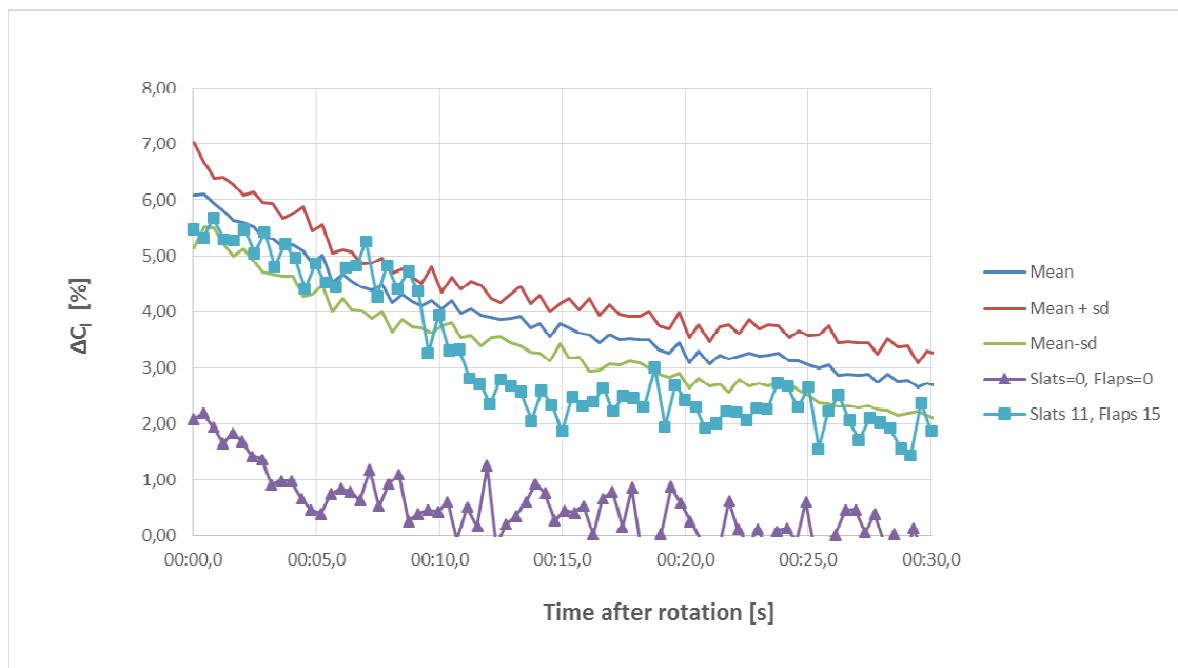
**Figure 9.** Lift degradation after rotation for configurations slats  $11^\circ$ , flaps  $15^\circ$  and slats, flaps retracted. All the lift degradation measurements of Ref. 7 are plotted in the background (Mean +/-sd)

To estimate the contribution of the secondary wave to the lift degradation the lift loss due to the fluid application was measured for both configurations – slats and flaps retracted and extended. In both cases the fluid applied was Type IV. The results are presented in Fig. 9. There are the mean values (+/- standard deviation) of measurements in Ref. 7 plotted in the background of Fig. 9 as for reference. The lift loss of the configuration, with the slats and flaps retracted, begins immediately after rotation approximately with a value that the lift loss of the configuration, with slats  $11^\circ$  and flaps  $15^\circ$ , ends with 30 seconds after rotation.

As the different configurations represent two different wing sections the comparison between the results is not straightforward. However, as the difference between the two configurations is so remarkable it supports the assumption that a secondary wave has a considerable contribution to the lift degradation after rotation.
